RAI 3.6.2.2.2-1a (High Voltage Insulators)

LRA 3.6.2.2.2 Degradation of Insulator Quality due to Presence of Any Salt Deposits and Surface Contamination, and Loss of Material due to Mechanical Wear

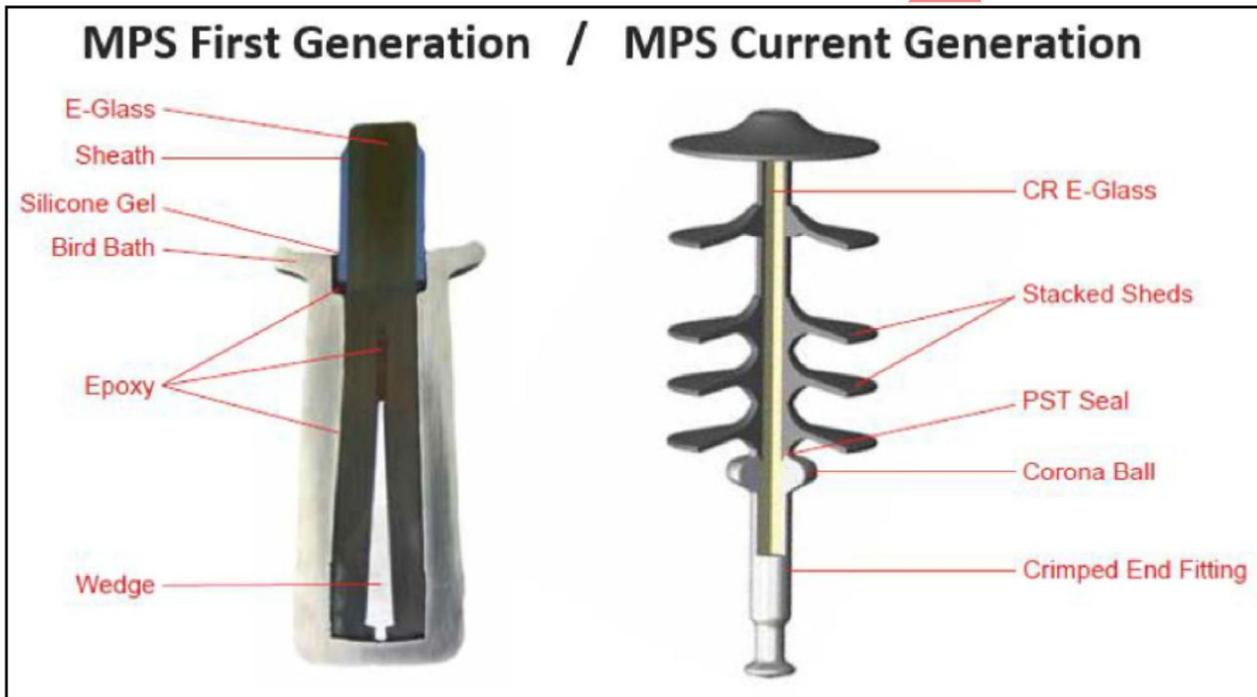
The RBS polymer high-voltage insulators are a recent generation of MPS polymer insulators that have been manufactured since 2007. The RBS polymer insulators do not use epoxy. The following figure shows the difference between the first generation of MPS polymer insulators and the generation of MPS polymer insulators that are used at RBS.

The MPS polymer insulators in service at RBS use a PST sealing system, which is a triple seal design. The triple seal or PST seal comprises the primary seal (P), the secondary seal (S), and the tertiary seal (T). The primary seal is a silicone rubber sheath compressed into the chamfer of the crimped end fitting. The secondary seal is RTV (room temperature vulcanizing) silicone applied to the rod, sheath, and end fitting interface. The tertiary seal is a final external RTV silicone seal applied to the sheath and end fitting interface. The RBS polymer insulators do not utilize silicone gel. The response to RAI 3.6.2.2.2-1 included silicone rubber, but did not explicitly identify RTV silicone as a type of silicone rubber. The silicone rubber material includes the RTV silicone that is part of the PST seal system. The RBS polymer insulators do not include silicone gel or sealants other than RTV silicone.
