**22. EVALUATION OF FIRE RATING FOR
VENTILATION DUCTS IN TURBINE BUILDING AND BATTERY ROOMS
SURRY POWER STATION**

AD-HOC FIRE ENDURANCE TEST OF UNPROTECTED STEEL DUCT SYSTEMS

SwRI PROJECT NO. 01-2427-001

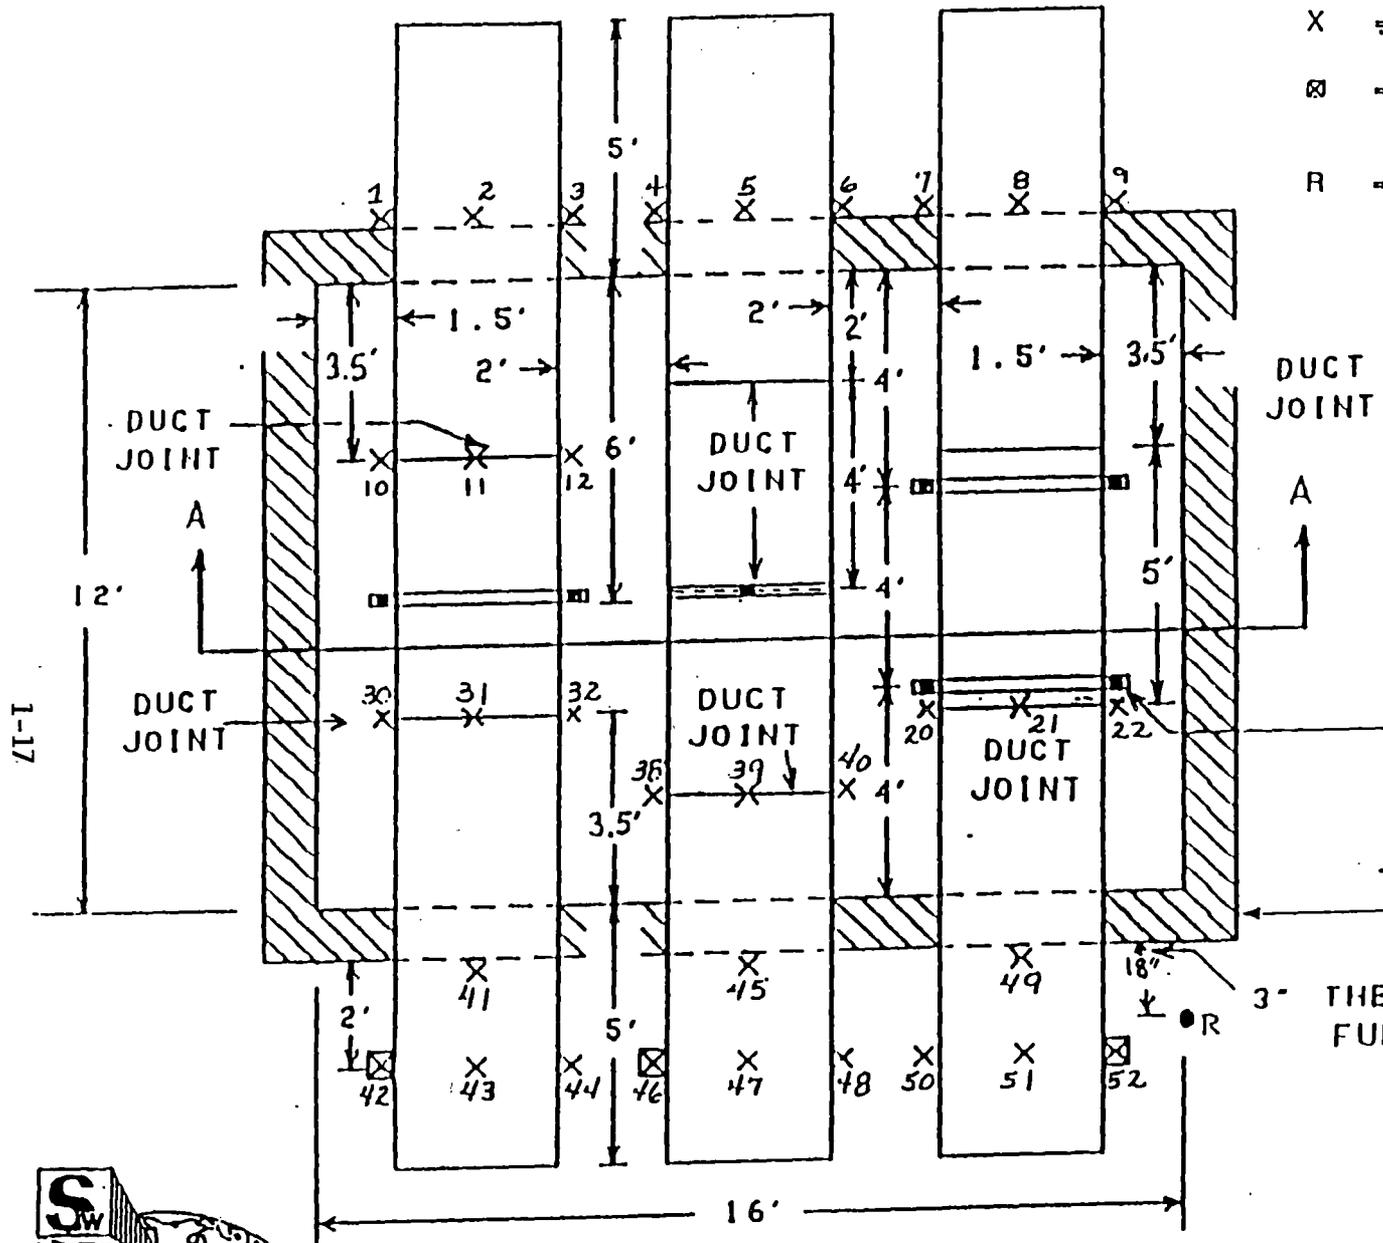
DUCT 1 DUCT 2 DUCT 3

- X = THERMOCOUPLE LOCATIONS
- ⊗ = THERMOCOUPLE LOCATIONS WITH STANDARD PAD (ASTM E119)
- R = RADIOMETER VIEWED A 9" DIAMETER AREA OF THE CENTER OF THE DUCT WALL

ROD & Z HANGERS,
DUCTS 1 & 3

A rectangular steel duct, constructed of 36 x 30-in. x 22-ft long 22-gauge galvanized steel sheet, was comprised of three 5-ft sections and two 3.5-ft sections. The duct construction conformed to the Sheet Metal and Air Conditioning Contractors National Association, Incorporated (SMACNA), HVAC Duct Construction Standards, Metal and Flexible, First Edition, 1985. The longitudinal seams were of the

A circular duct, constructed of 36-in. diameter x 22-ft long 20-gauge stainless steel sheet, was comprised of four 4-ft sections and two 3-ft sections. All joints between the duct sections were continuously welded together. The duct construction conformed to SMACNA, HVAC Duct Construction Standards, Metal and Flexible, First Edition, 1985. It was supported at the mid-point (6 ft from the furnace walls) by a 3-in. wide x 20-gauge stainless steel band wrapped around the duct which was attached to an adjustable clevis type hanger suspended from a 0.5-in. diameter steel hanger rod. The hanger assembly was adjusted so that the top surface of the duct was located approximately 24 in. below the underside of the insulated cover slabs.

top surface of the duct was located approximately 30 in. below the underside of the cover slabs. They were insulated with 0.5-in. diameter x 1-in. thick x 14-lb/ft³ Manville Thermo-12 calcium silicate pipe insulation. The insulation was cut to fit on-site and the longitudinal joints were tightly butted together and wired in place with 16-gauge stainless steel wire, 12 in. on center.
