License # DPR 31 & 41 Amend: Proposed change to tech specs consisting of revisions concerning tendon inspections.....
notarized 9-29-77.....

PLANT NAME: Turkey Point 3 & 4

FLORIDA POWER & LIGHT CO.
 TURKEY POINT NUCLEAR POWER PLANT
 UNIT 3
 POST-TENSIONING SYSTEM
 SURVEILLANCE TENDONS
 LOCATION AND IDENTIFICATION
 FIGURE 1

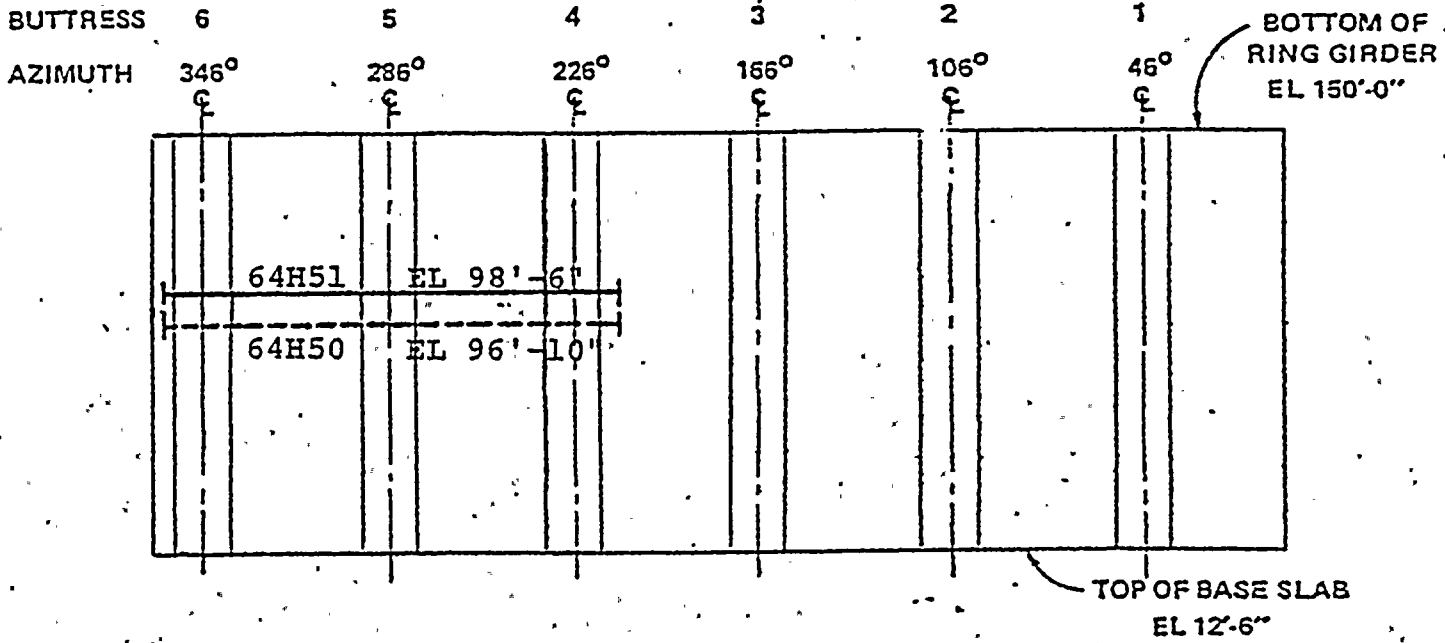
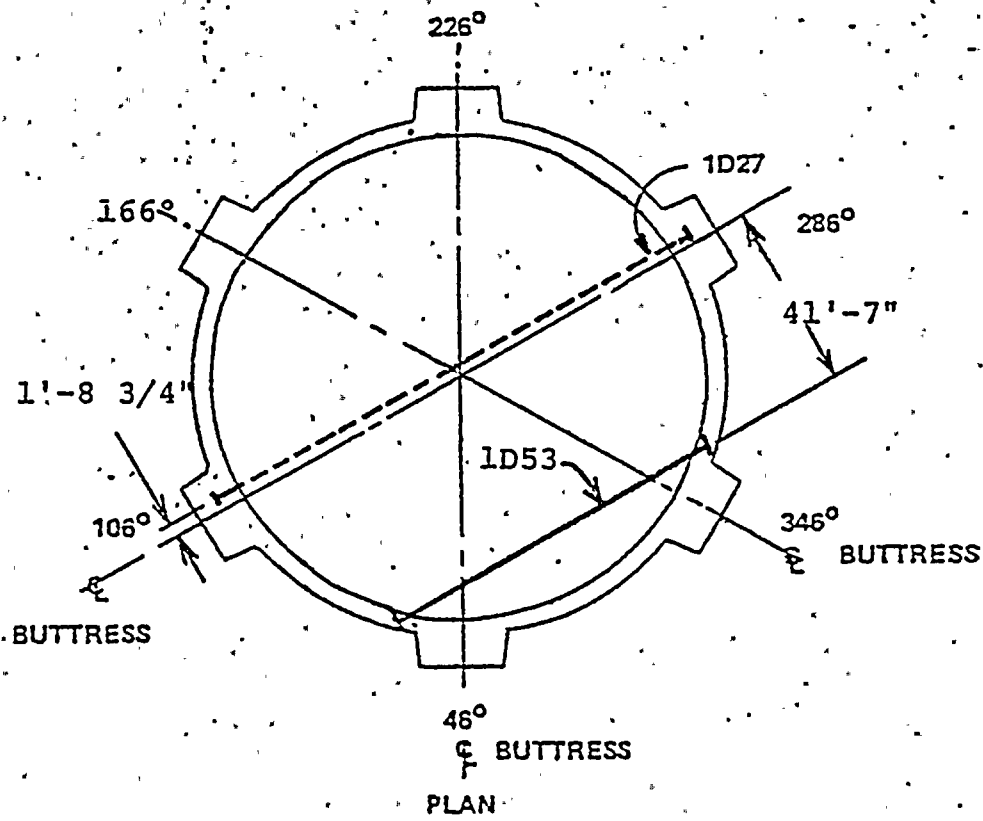
DEVELOPED EXTERIOR ELEVATION
HOOP AND VERTICAL TENDONS

DOMES TENDONS

KEY
 ——— replacement surveillance tendon
 - - - - - original surveillance tendon

Tendons 64H50 and 64H51 are both located between azimuths 226° and 346° . Tendon 64H50 is at elevation 96'-10" and tendon 64H51 is at elevation 98'-6". Since both tendons are located between the same azimuths at approximately the same elevation, they experience essentially the same environmental conditions.

Two wires have been removed from tendon 64H51, but no wires have been removed from 64H50. Since both tendons are in approximately the same location, wire samples from either one would satisfy the intent of Specification 4.4.6. There are no structural safety related consequences associated with having tested tendon 64H51 instead of 64H50.

Tendons 1D27 and 1D53 are from the same dome group, have their ends anchored at approximately the same elevations within the same 60-degree angles, and experience essentially the same environmental conditions. Since the influences on both tendons are approximately equal, wire samples from either one would satisfy the intent of Technical Specification 4.4.6. Two wires have been removed from tendon 1D27, but as discussed above, there are no structural safety related consequences associated with terminating the surveillance of 1D27 and instead surveilling 1D53. Thus, substituting tendon 1D53 for 1D27 will meet FSAR commitments and will not compromise the inservice tendon inspection program.

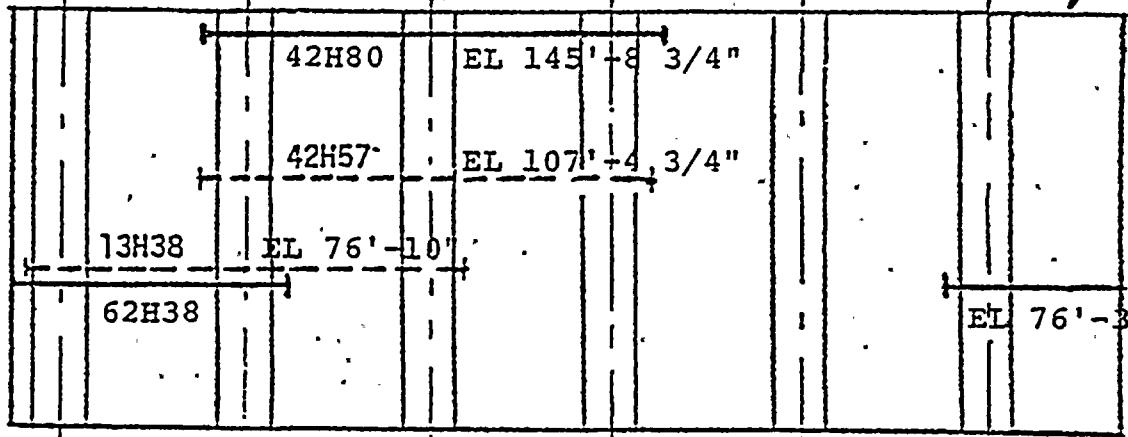
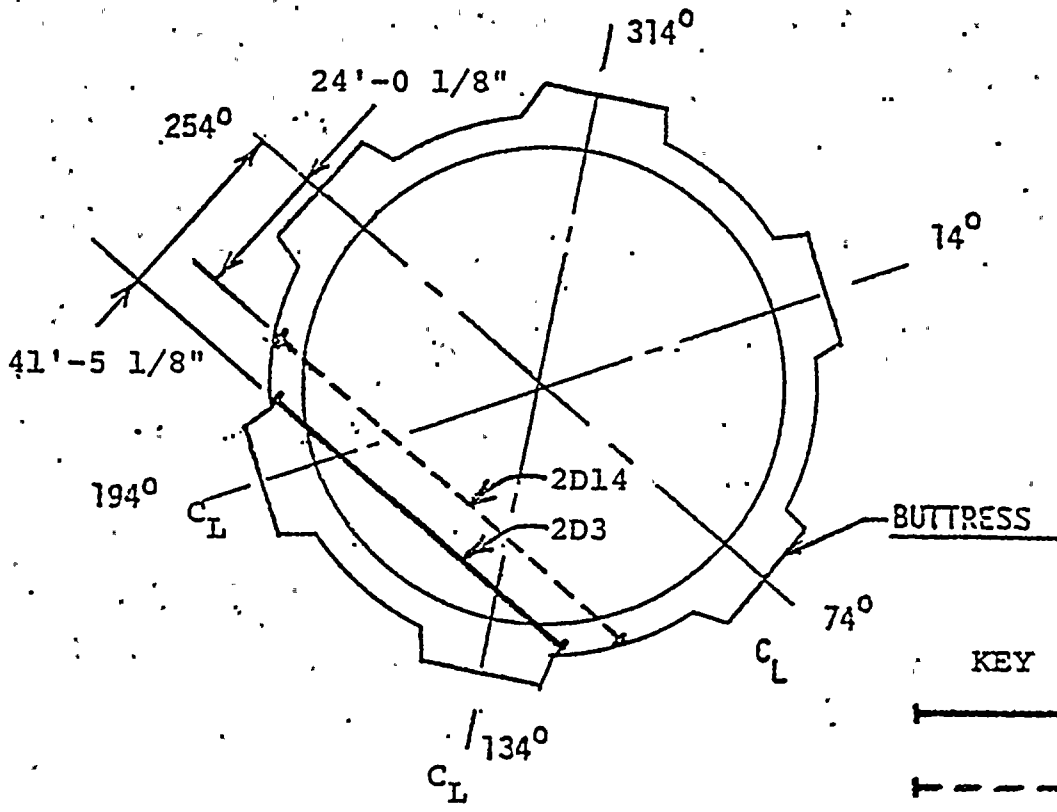
FIGURE 2

DEVELOPED EXTERIOR ELEVATION
HOOP AND VERTICAL TENDONS

- KEY
- replacement surveillance tendon
 - original surveillance tendon

PLAN
DOME TENDONS

FLORIDA POWER & LIGHT CO.
TURKEY POINT NUCLEAR POWER PLANT
UNIT 4
POST-TENSIONING SYSTEM
SURVEILLANCE TENDONS
LOCATION AND IDENTIFICATION

Tendon 42H80 and 42H57 are both located between azimuths 314° and 74°. Tendon 42H80 is located at elevation 145'-8 3/4" and tendon 42H57 is located at elevation 107'-4 3/4". Although the change in elevation is notable, it is felt to be insignificant with regard to environmental exposure and is necessary to protect the personnel performing the surveillance. There have been no wires removed from 42H57. Thus, the substitution of tendon 42H80 in lieu of 42H57 will continue to meet FSAR commitments and will not compromise the inservice inspection program.

Tendon 62H38 is located between azimuths 74° and 194° at elevation 76'-3 5/8". Tendon 13H38 is located between azimuths 14° and 134° at elevation 76'-10". The tendons are at approximately the same elevation, however, the butress anchorage locations are shifted 60-degrees and might thus experience slightly different environmental exposure. Nevertheless, the change is deemed beneficial in that the new group of horizontal tendons will comprise one complete hoop and will thus provide more representative information during future surveillances. Two wires have been removed from tendon 13H38, but as discussed above, there are no structural safety related consequences associated with terminating the surveillance of 13H38 and instead surveilling 62H38.

Tendons 2D3 and 2D14 are from the same dome group, have their ends anchored at approximately the same elevations within the same 60-degree angles, and experience essentially the same environmental
