SUBJECT: Submission of IP2 Steam Generator Examination Program Results for the 2018 (2R23) Refueling Outage in Accordance with Technical Specification 5.6.7

Indian Point Unit No. 2
Docket No. 50-247
License No. DPR-26

The scope of the inspection included all four steam generators, which are Westinghouse Model 44F with thermally treated Alloy 600 tubes. At the time of the inspection, the steam generators had accumulated approximately 170 effective full power months (EFPM) of operation since the first in-service inspection performed in 2002. Based upon the inspection results, all four steam generators were found to be in compliance with Condition Monitoring requirements.

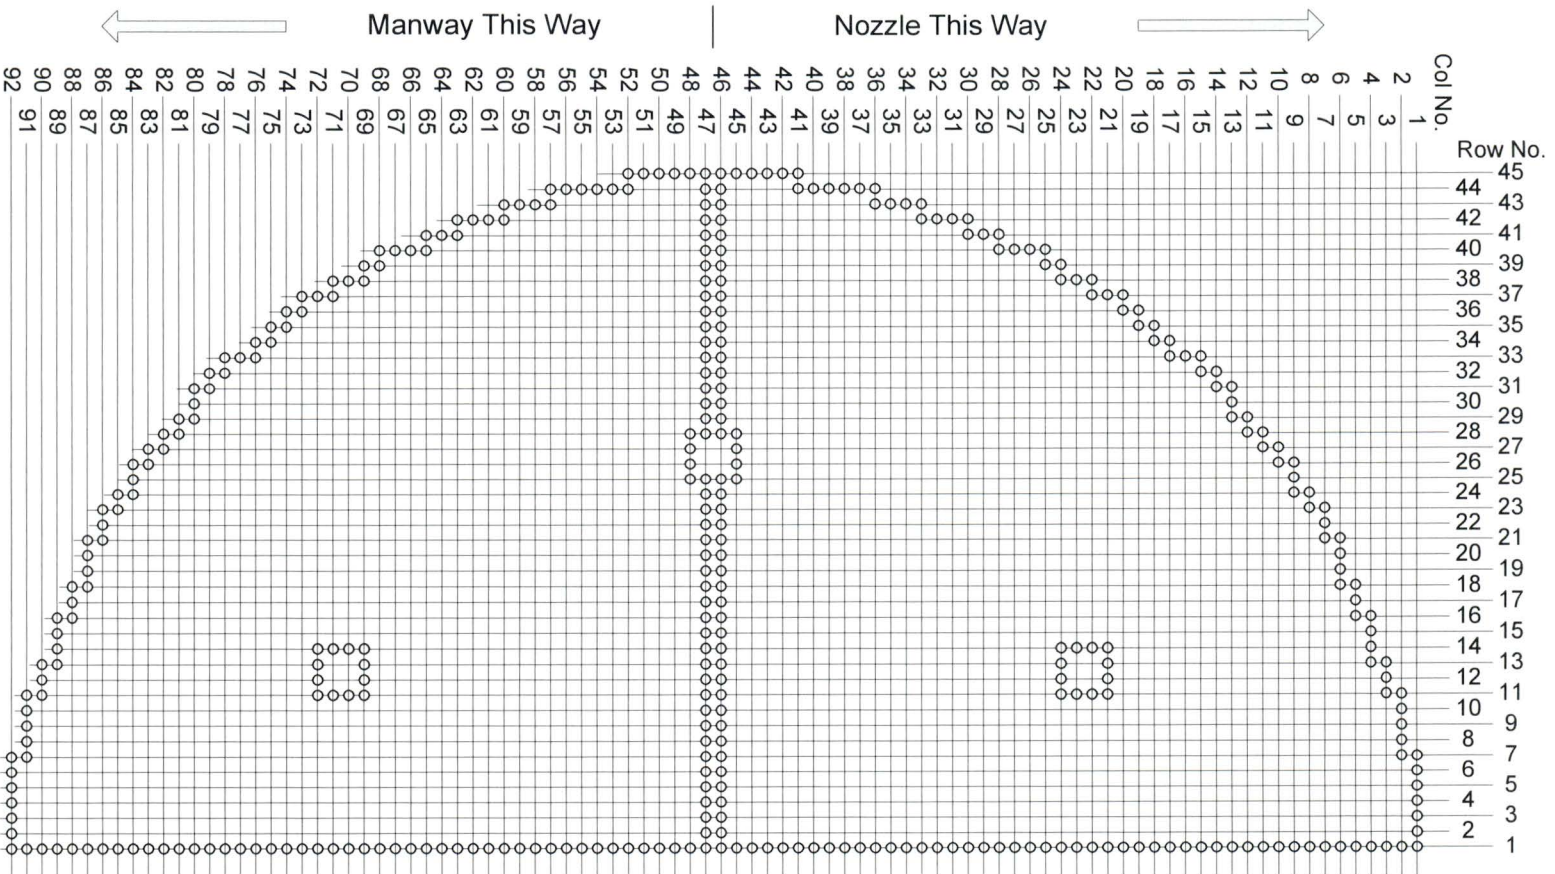
Indian Point 2 Steam Generator Tubesheet Map

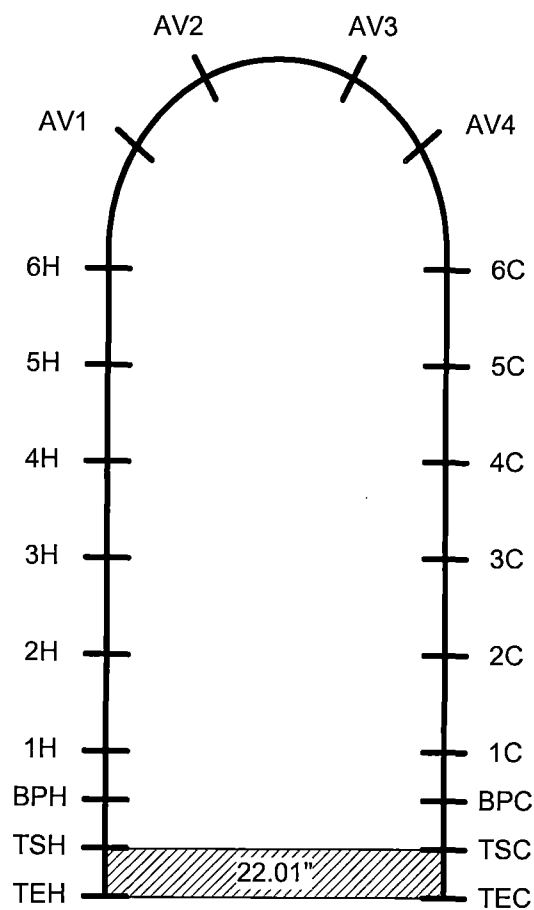
Indian Point 2 Steam Generator Landmark Information

Indian Point 2 Steam Generator Location Landmarks

Westinghouse Model 44F
Steam Generator
