NRC INSPECTION MANUAL

OPERATING EXPERIENCE SMART SAMPLE (OpESS) 2018/01

EVALUATION OF LICENSEE ACTIONS TAKEN IN RESPONSE TO 10 CFR PART 21 NOTIFICATION OF THE POTENTIAL EXISTENCE OF DEFECTS RELATED TO CONTROL ROD DRIVE MECHANISM (CRDM) THERMAL SLEEVES

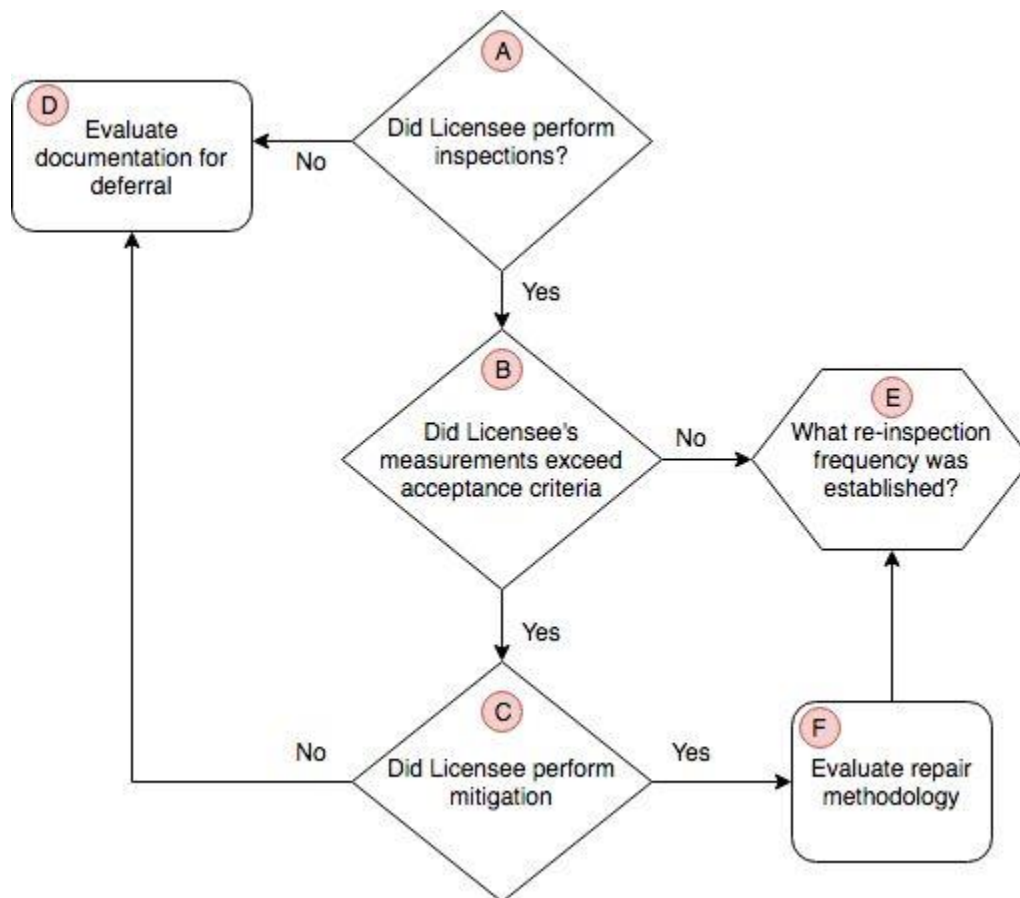
The guidance for this inspection follows the flowchart shown in Figure 1. This guidance is provided to help inspectors evaluate the effectiveness of licensee collective actions in response to NSAL-18-1. A description of the inspection and reporting expectations are as follows:

- a. Determine if the licensee performed initial inspections for CRDM thermal sleeve wear
 1. Did the licensee perform measurements of the lowering of all thermal sleeves using a method that is capable of determining the relative distance between a known reference point on the head and the bottom surface of the thermal sleeve guide funnel?

- f) Wear rate
- b. Determine if the licensee's measurements exceed acceptance criteria
 1. Determine if licensee used acceptance criteria in PWROG-16003-P or plant specific criteria was used.

- c. Review the licensee developed mitigation or repair plans
 1. Review mitigation or repair plans to determine if licensee considered actions to ensure the plant remains consistent with their license renewal commitments. Specifically, has the licensee initiated actions to evaluate this issue for incorporation into License Renewal Programs that are credited for management of age related degradation that affects vessel internals components?

- e. Review re-inspection frequency
 1. Did the licensee develop a re-inspection frequency based on the measurements and calculated wear rates from A. and any plant-specific data used to develop plant-specific acceptance criteria (as applicable from B.).
