CYCLE 3 STARTUP TEST REPORT

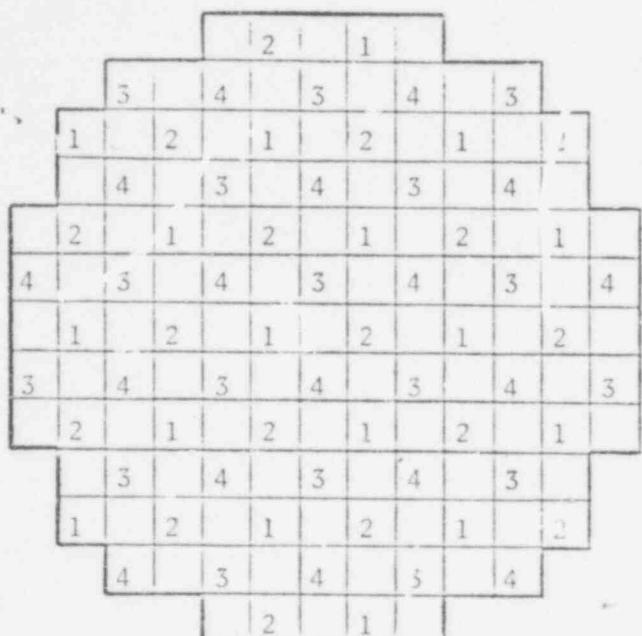
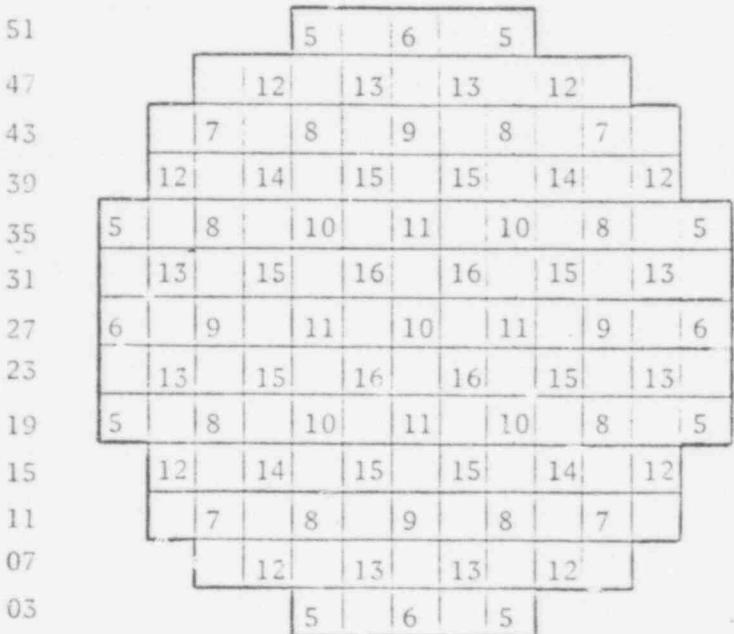
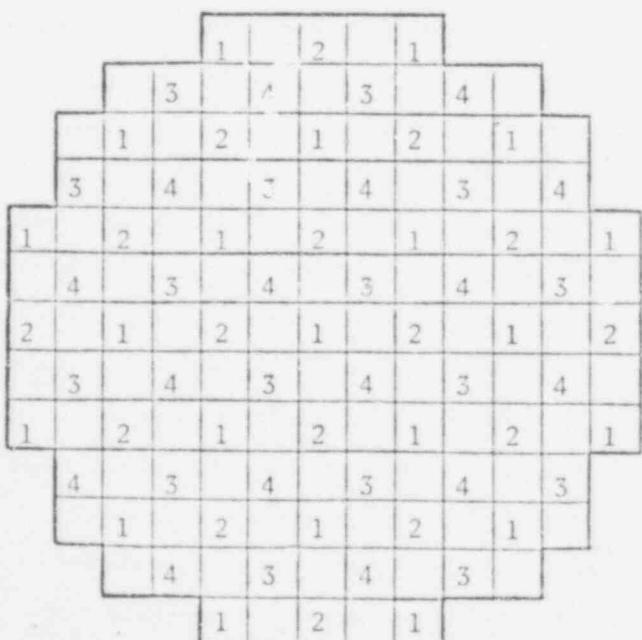
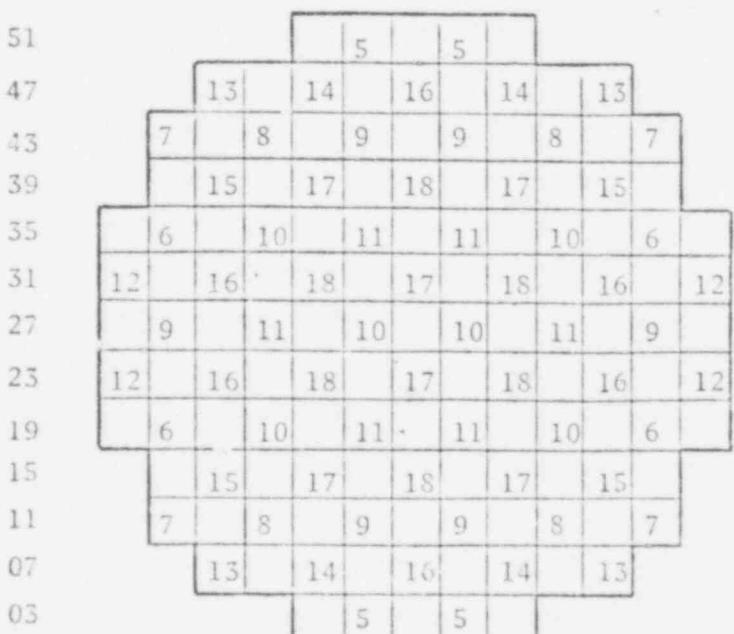
Fig. 3

ROD SEQUENCE CONTROL SYSTEM GROUP DESIGNATIONS

A SEQUENCE

B SEQUENCE

Figure 3 shows the rod sequence control system (RSCS) designations for the A and B rod withdrawal sequences.
