Rensselaer

RCF 19-04
August 22, 2019

Reportable Occurrence (NRC Event Number 54222)
at the Rensselaer Polytechnic Institute Critical Experiments Facility

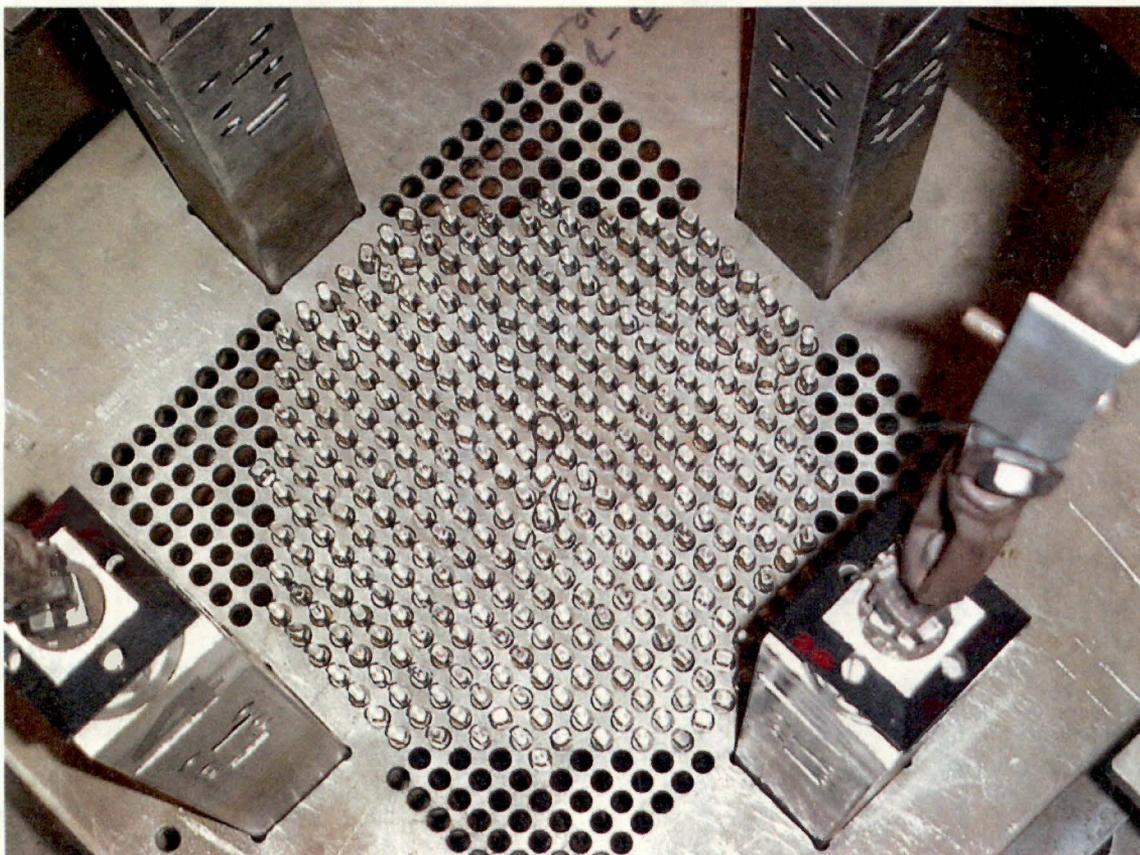
The Rensselaer Polytechnic Institute (RPI) Critical Experiments Facility (RCF) is a low power, 100-watt license limit, research and training reactor located in Schenectady, NY. The RCF uses four control rods and five nuclear instrumentation channels for reactor control. Figure 1 shows the four control rods spaced around and outside the array of fuel pins. The neutron detectors for the five nuclear instrumentation channels are not in view but are also outside the fuel array.

Figure 1: Top View of RCF Fuel Array (333-pins) and Control Rods
