Subject: Transmittal of MRP-227-A-Related Interim Inspection Guidance Regarding PWR
Core Barrel

MRP Materials Reliability Program _____ MRP 2019-009

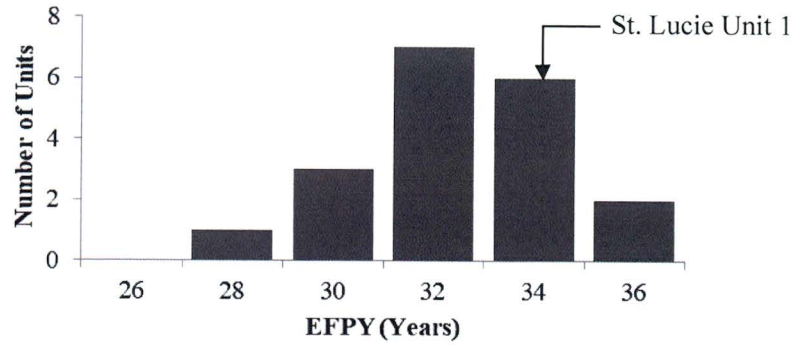
Figure 7: Operating Time at Baseline Barrel Weld Inspections

Figure 7 summarizes the effective full power year (EFPY) and unit age data from [25], [26], [27], and [28] corresponding to the date of the baseline barrel weld inspections. From these data, operating time alone may not be a reliable indicator for barrel flange and girth weld cracking potential, because units similar in age and EFPY to the unit with confirmed cracking showed no indication of cracking in the girth welds inspected. Only three plants have completed EVT-1 inspections of the axial welds, to date. As noted above, only one of these plants identified core barrel weld indications. With only one data point for confirmed detection of cracking for either the girth welds or axial welds and a limited number of axial weld inspections, meaningful assessments cannot be made at this point. Considering the measured crack lengths and the expected growth rates, it is possible that the initiating mechanism for the observed condition at St. Lucie Unit 1 could be related to the early-life thermal shield failure that occurred at that plant and caused earlier CSB cracking. However, without further confirmatory inspections or analysis, the conservative approach is to assume that the flaws observed at St. Lucie Unit 1 could be applicable to all of the units of similar design and age.
