UNIVERSITY OF MISSOURI
RESEARCH REACTOR FACILITY

REACTOR OPERATIONS
ANNUAL REPORT

August 1979

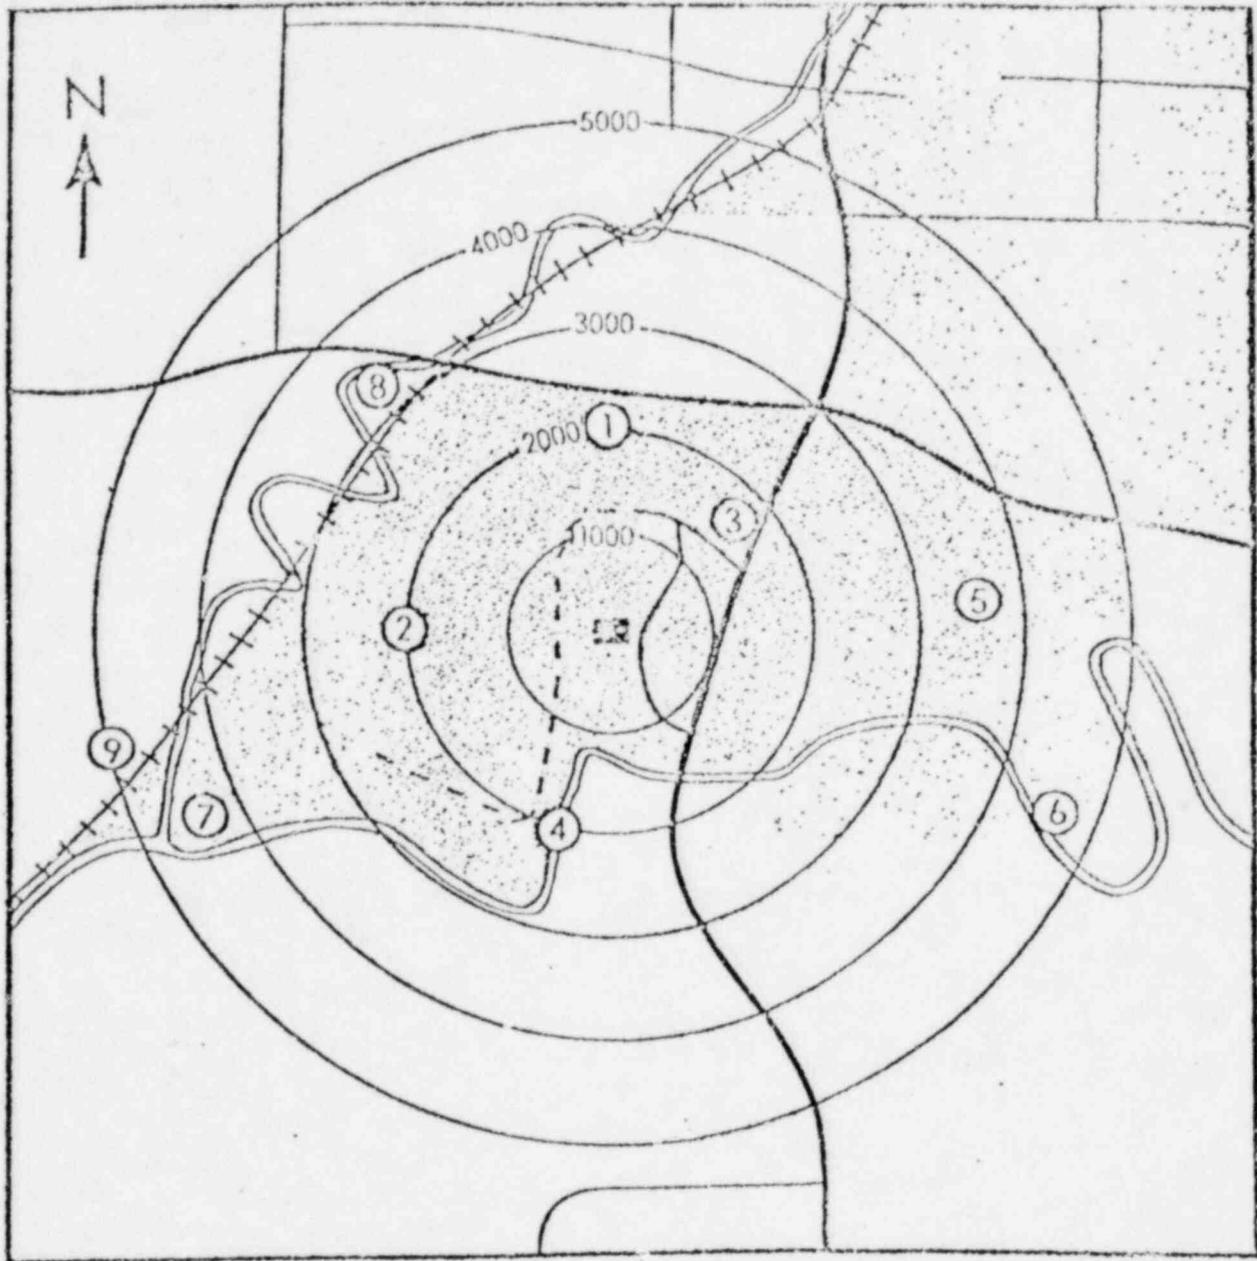
Figure 1

LOCATION OF SAMPLE STATIONS
RESEARCH REACTOR FACILITY
UNIVERSITY OF MISSOURI

Environmental samples are collected twice yearly at nine locations and analyzed for radioactivity. These locations are shown in Figure 1. Soil and vegetation samples are taken at each location. Water samples are taken at four of the nine locations. The results are given in the following tables.
