Public Service Company of Colorado

January 30, 1979
Fort St. Vrain
Unit No. 1
P-79026

Subject: Region 35 Inspection

FORT ST. VRAIN NUCLEAR GENERATING STATION
INSPECTION PLAN OUTLINE, REGION 35

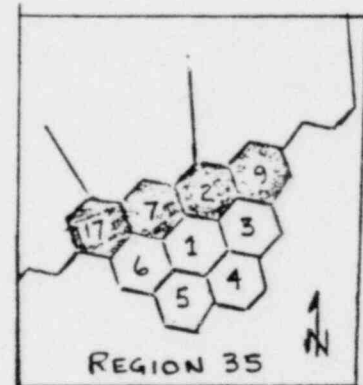
Sequence No. for
block removal of
Region 35.

Indicates blocks
to be inspected
in H.S.F.

1. Ten (10) blocks have been selected for visual inspection in Hot Service Facility (HSF). The location of these blocks is shown in Figure 1.
2. The ten (10) blocks will be stored in the FHM during the sequenced removal of Region 35. Upon completion of the removal of Region 35, the FHM will be positioned on the HSF for removal and inspection of the selected blocks.
3. Blocks will be inspected utilizing the general inspection plan outlined in Table B. Blocks will be observed at four (4) different positions as follows:
 - A. Bottom of block as it leaves the guide tube
 - B. Rotation of the block through 360°
 - C. Top of the block (in two separate positions 180° apart) after release by the FHM.
 - D. Observation will be compared with initial inspection records established for these blocks during initial fuel loading.
