ENCLOSURE 1
SALP BOARD REPORT

U.S. NUCLEAR REGULATORY COMMISSION
REGION I

SYSTEMATIC ASSESSMENT OF LICENSEE PERFORMANCE
INSPECTION REPORT 50-277/85-98 and 50-278/85-98
PHILADELPHIA ELECTRIC COMPANY
PEACH BOTTOM ATOMIC POWER STATION
ASSESSMENT PERIOD - APRIL 1, 1985 TO JANUARY 31, 1986
BOARD MEETING DATES MARCH 24 AND APRIL 22, 1986

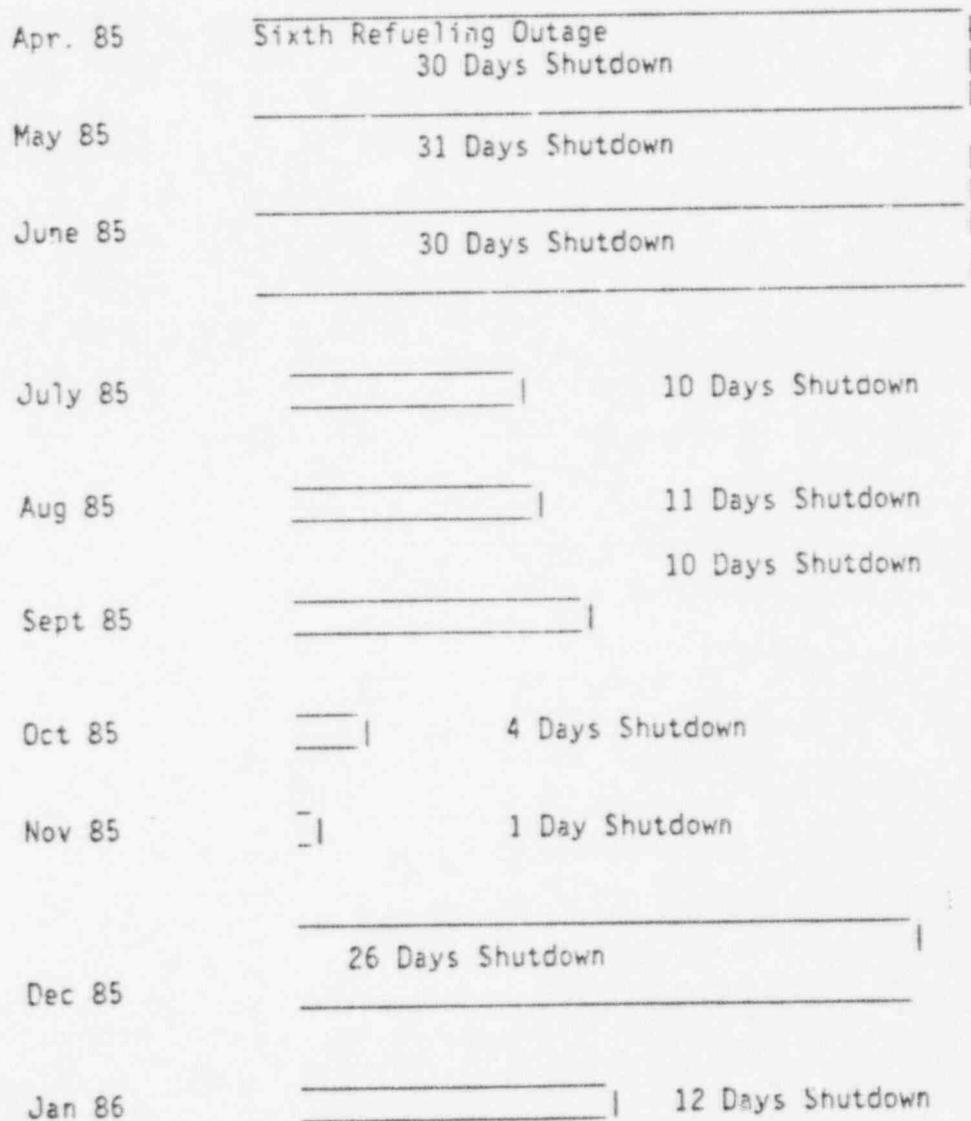
Unit 2 - Number of Days Shutdown

PEACH BOTTOM ATOMIC POWER STATION

Figure 1	Unit 2 Number of Days Shutdown.....	66
Figure 2	Unit 3 Number of Days Shutdown.....	67
