WCAP-8183
Rev. 9

OPERATIONAL EXPERIENCE WITH
WESTINGHOUSE CORES
(Up to December 31, 1979)

April 1980

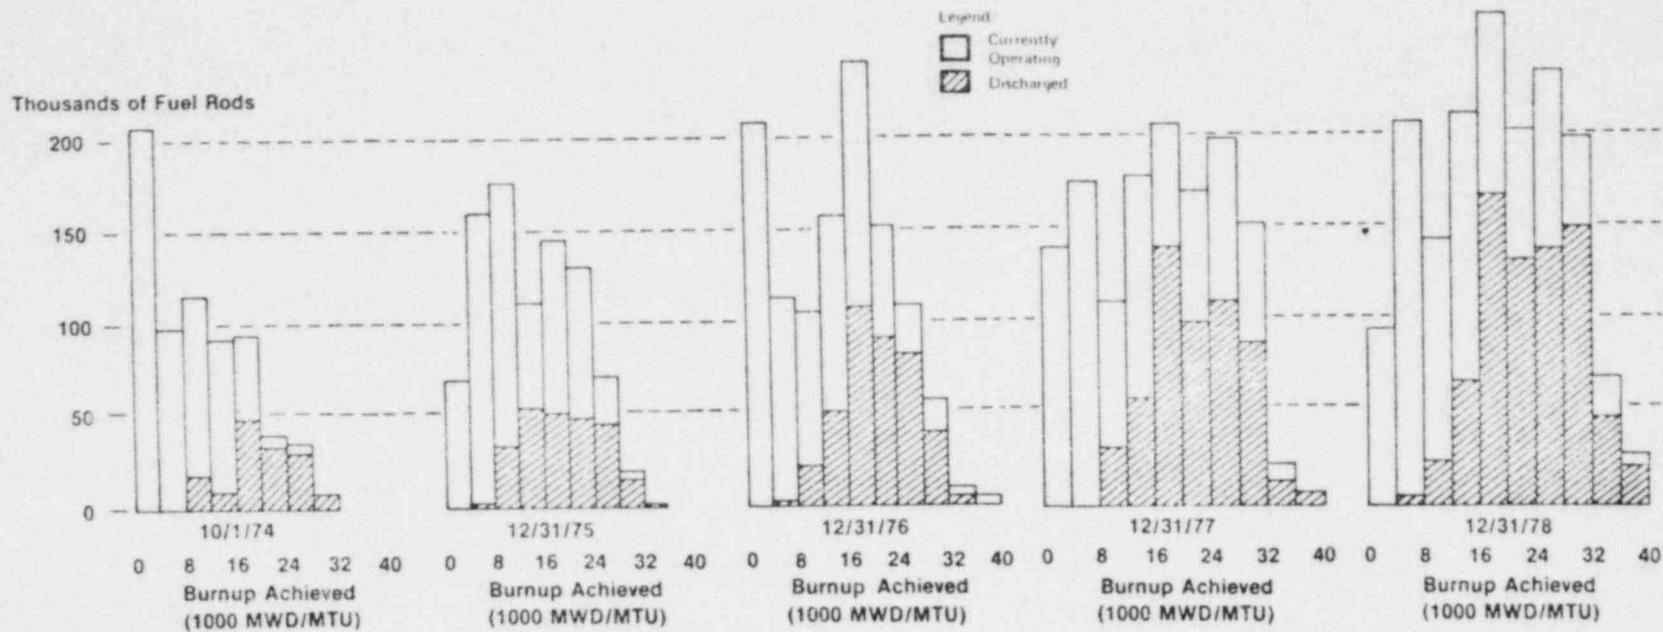
FIGURE 5-1

BURNUP PERFORMANCE OF WESTINGHOUSE ZIRCALOY-CLAD FUEL

Average Burnups	10/1/74	12/31/75	12/31/76	12/31/77	12/31/78
All Fuel	10,200	14,300	15,100	17,300	18,800
Discharged Fuel	19,900	19,600	20,700	22,200	23,700

Figure 5-1 contains a graphic representation of the data in Table 5-1 (also includes burnup performance figures from several previous years). The upper portion of the figure represents the fuel assemblies in service and the lower portion of the graph represents discharged assemblies.

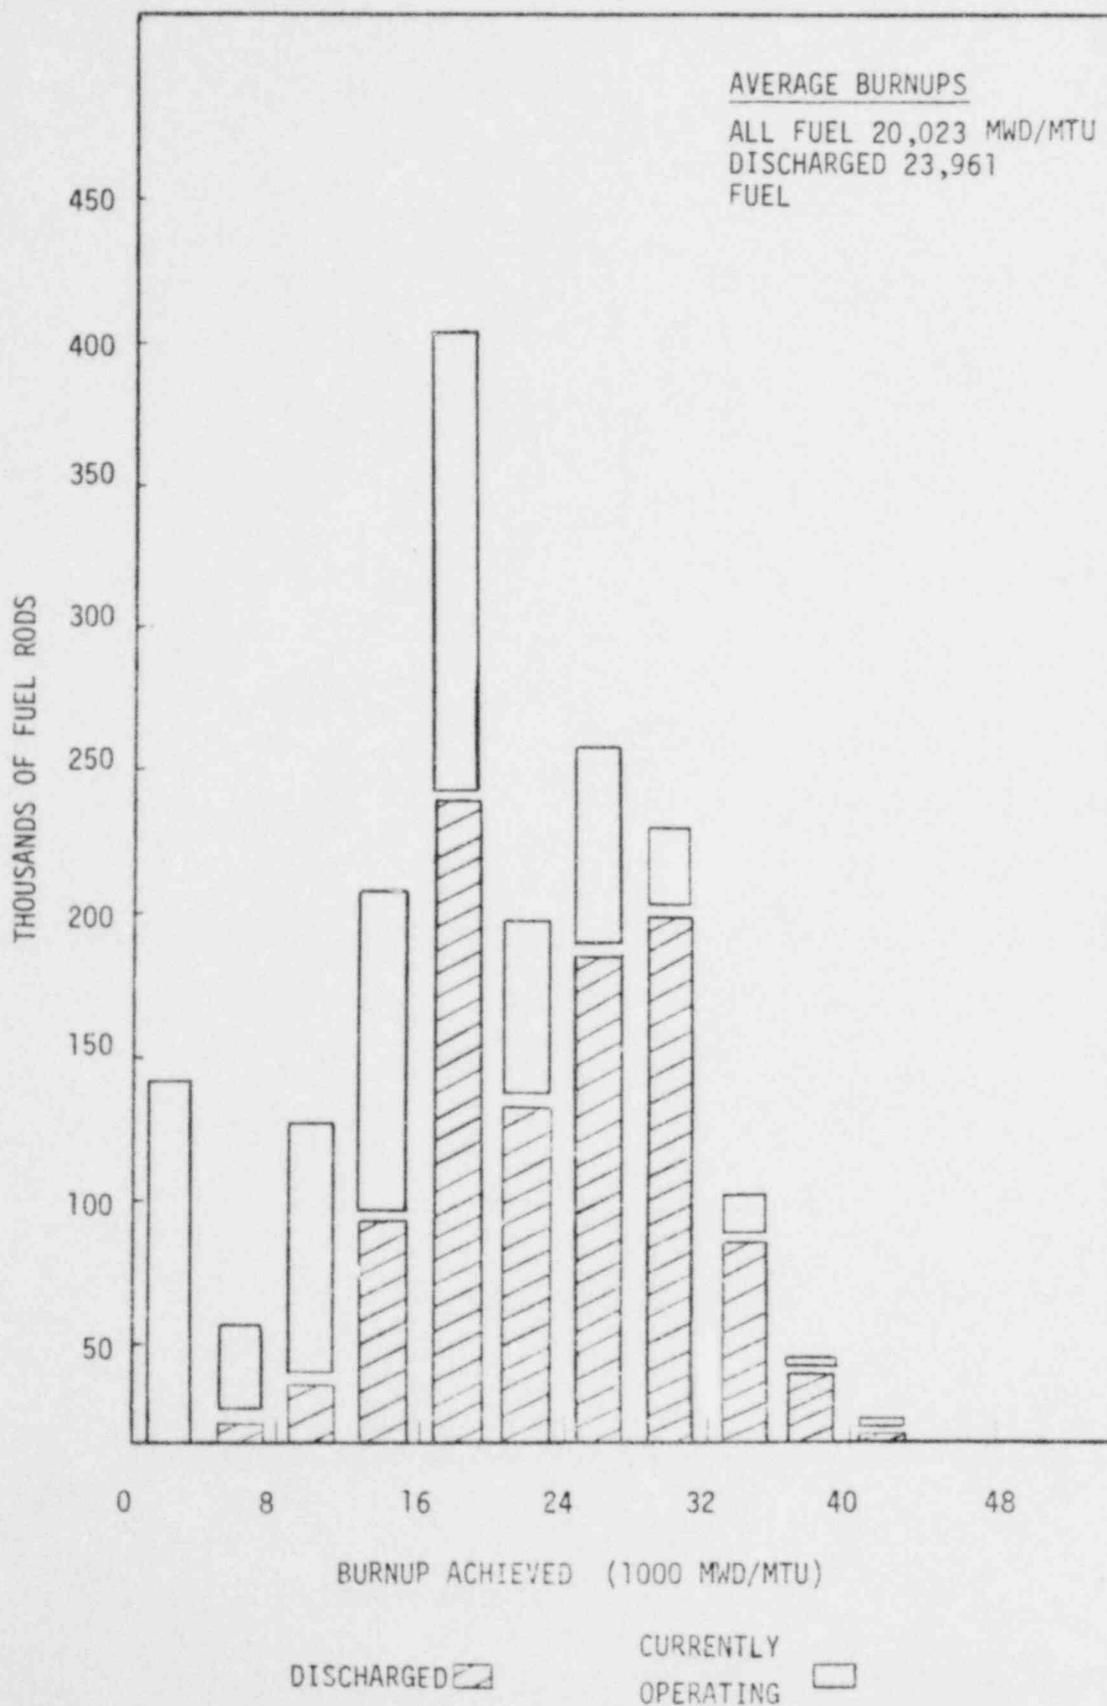
FIGURE 5-1 (Continued)

BURNUP PERFORMANCE OF WESTINGHOUSE
ZIRCALOY-CLAD FUEL

(As of 12/31/79)

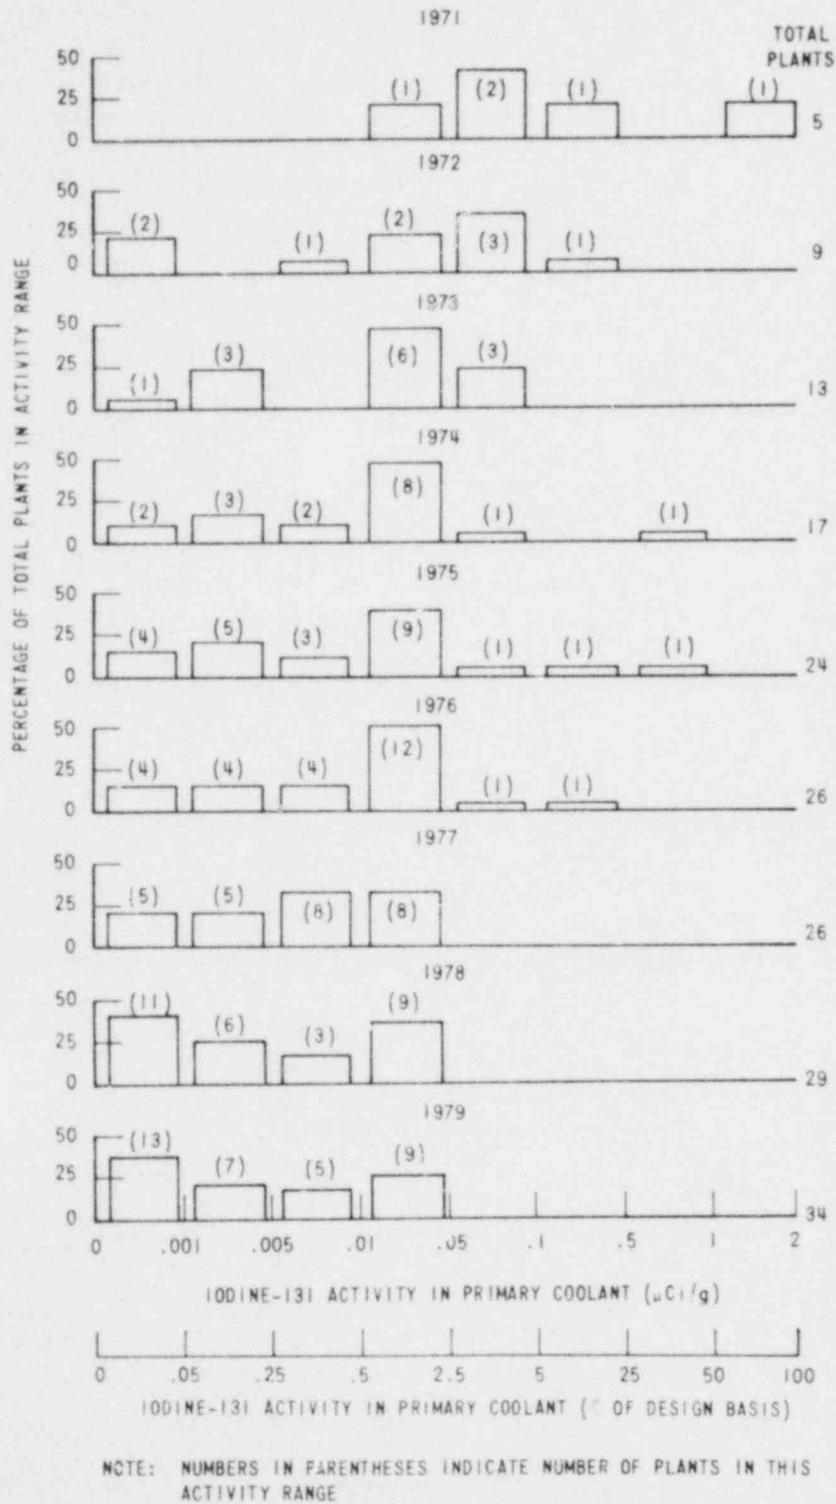
Figure 5-2. Westinghouse Fuel Performance — Iodine 131 Activity in Primary Coolant as of December 31, 1979

Figures 5-2 and 5-3 show the yearly change of coolant activity distributions for Westinghouse-fueled plants. The trend toward lower coolant activities over the periods reported is apparent. Figure 5-2, which employs a logarithmic scale, emphasizes the trend toward lower activities as the number of plants and amount of operating experience increases. Again, these data, combined with burnup experience of Table 5-1 and Figure 5-1, provide substantial proof of the reliability and performance of Westinghouse Zircaloy-clad fuel.

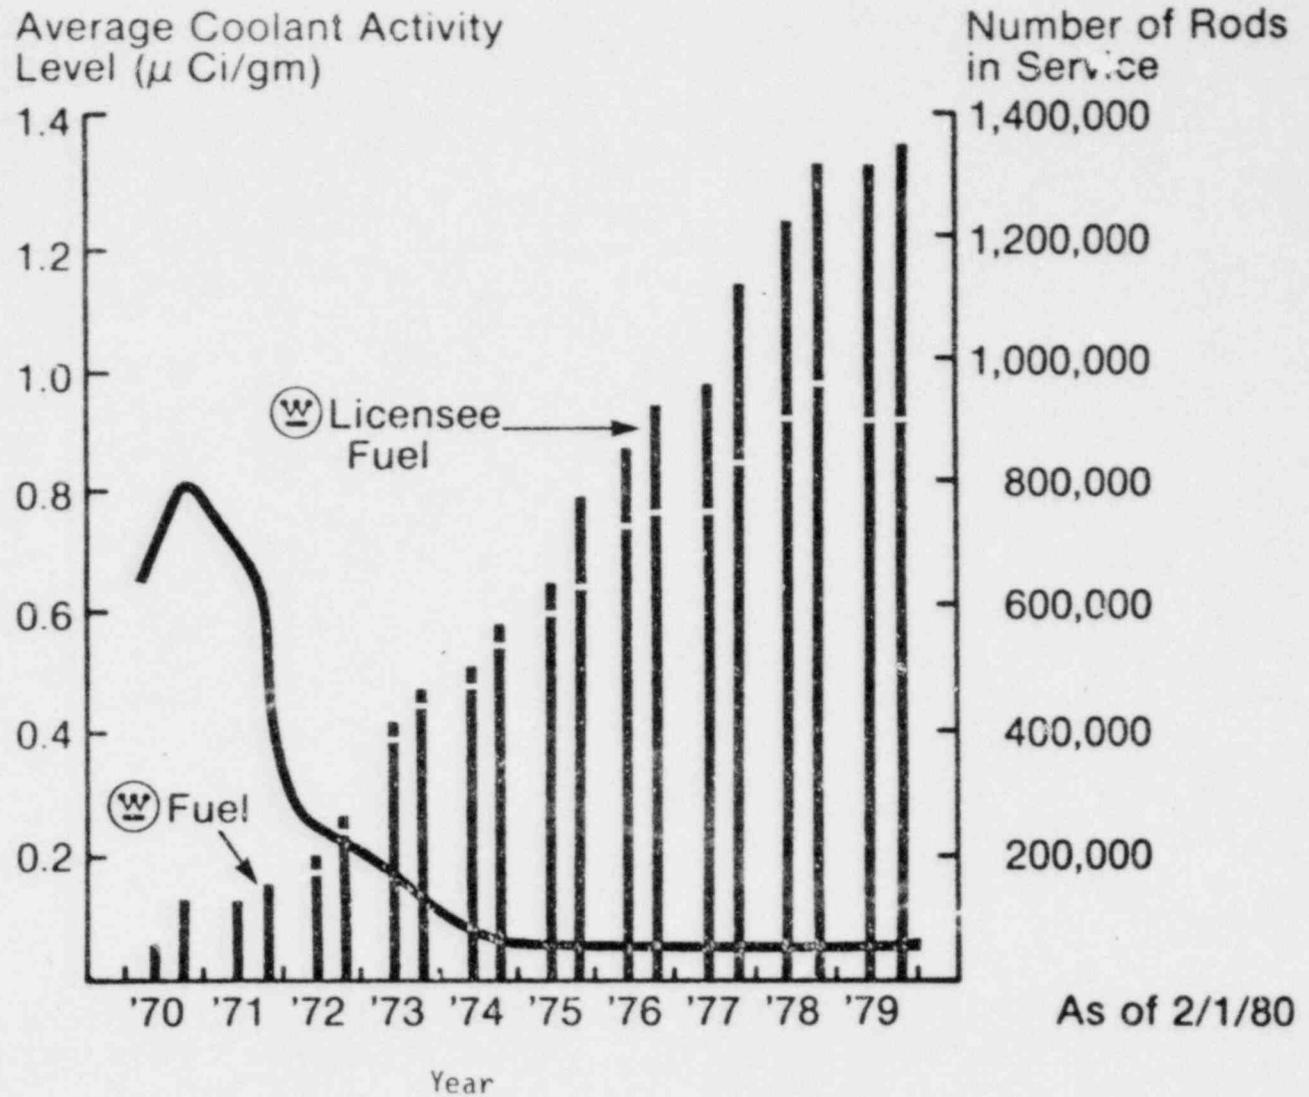
Zircaloy – Clad Fuel Performance and Experience

Figure 5-3. Performance Record - Average Coolant Activity Level/Number of Rods in Service
