NUREG/CR-1464  
ORNL/NUREG/TM-384

## **Review of Nuclear Power Plant Offsite Power Source Reliability and Related Recommended Changes to the NRC Rules and Regulations**

Review of Nuclear Power Plant Offsite Power Source  
Reliability and Related Recommended Changes to  
the NRC Rules and Regulations

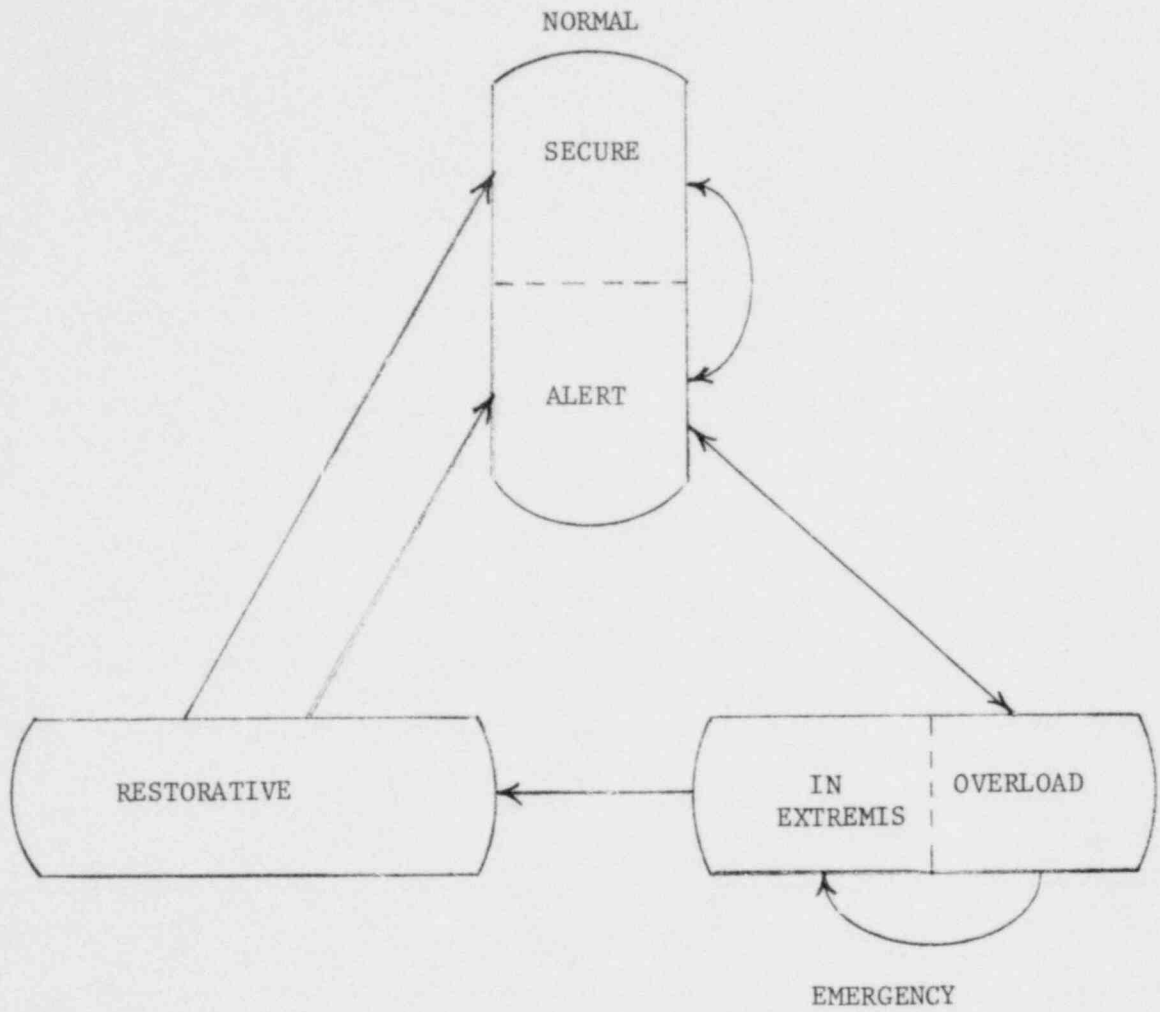
Fig. 1. Operating state diagram.

System operating conditions are usually separated into three states, with substates as indicated below (see also Fig. 1):

The states are governed by two constraints: equality and inequality. Equality constraints refer to the balance between total system generation and load, including the effects of dynamics. Inequality constraints refer to allowable maximum and minimum limits, including system variables such as voltage, current, and frequency.

In the *secure, normal* state, the equality and inequality constraints are not violated. Furthermore, in this state no single contingency, alone, will cause violation of these two constraints. Sufficient reserve margin in generation and transmission of power and a balanced load-generation distribution are measures that help establish the *secure, normal* state.

A system is in an *alert, normal* state if a single failure would cause the system to change to the *emergency* state. In the *alert, normal* state, neither the equality nor the inequality constraints are violated. However, there is at least one component that can fail and cause one or both of these constraints to be violated. The particular component that can cause the violation is usually identified by on-line load flow analysis. When a system is in the *alert, normal* state, it is likely a response to an accumulation of small disturbances. After each disturbance, the state of the system must be determined; when the state is no longer *secure, normal*, special action must begin to assure the security of the grid and return it to the *secure, normal* state.

The *emergency* state can be characterized by two levels of seriousness: (1) violation of inequality constraints, or *overload* substate, and (2) violation of equality and inequality constraints, or *in extremis* substate. It is unlikely that a condition would prevail where only the equality constraints would be violated, since the *in extremis* substate is a severe shock to the system. System instabilities are associated with the *in extremis, emergency* state, and equipment limit violation defines the *overload, emergency* state.

The *restorative* state occurs after a partial or total system collapse. Control actions are taken to restore the system to the *normal* state following transition from the *in extremis, emergency* state. The system may be forced to operate temporarily with some system elements overloaded, that is, violation of inequality constraints may be acceptable for a while to establish a more desirable operating condition. In other situations, violation of the equality constraints (load shedding) may be acceptable for a part of the system to restore normality to the remainder of the system.
