# DUKE POWER COMPANY

April 20, 1977

Re: Oconee Nuclear Station  
License Numbers DPR-38, DPR-47 and DPR-55  
Docket Numbers 50-269, 50-270 and 50-287

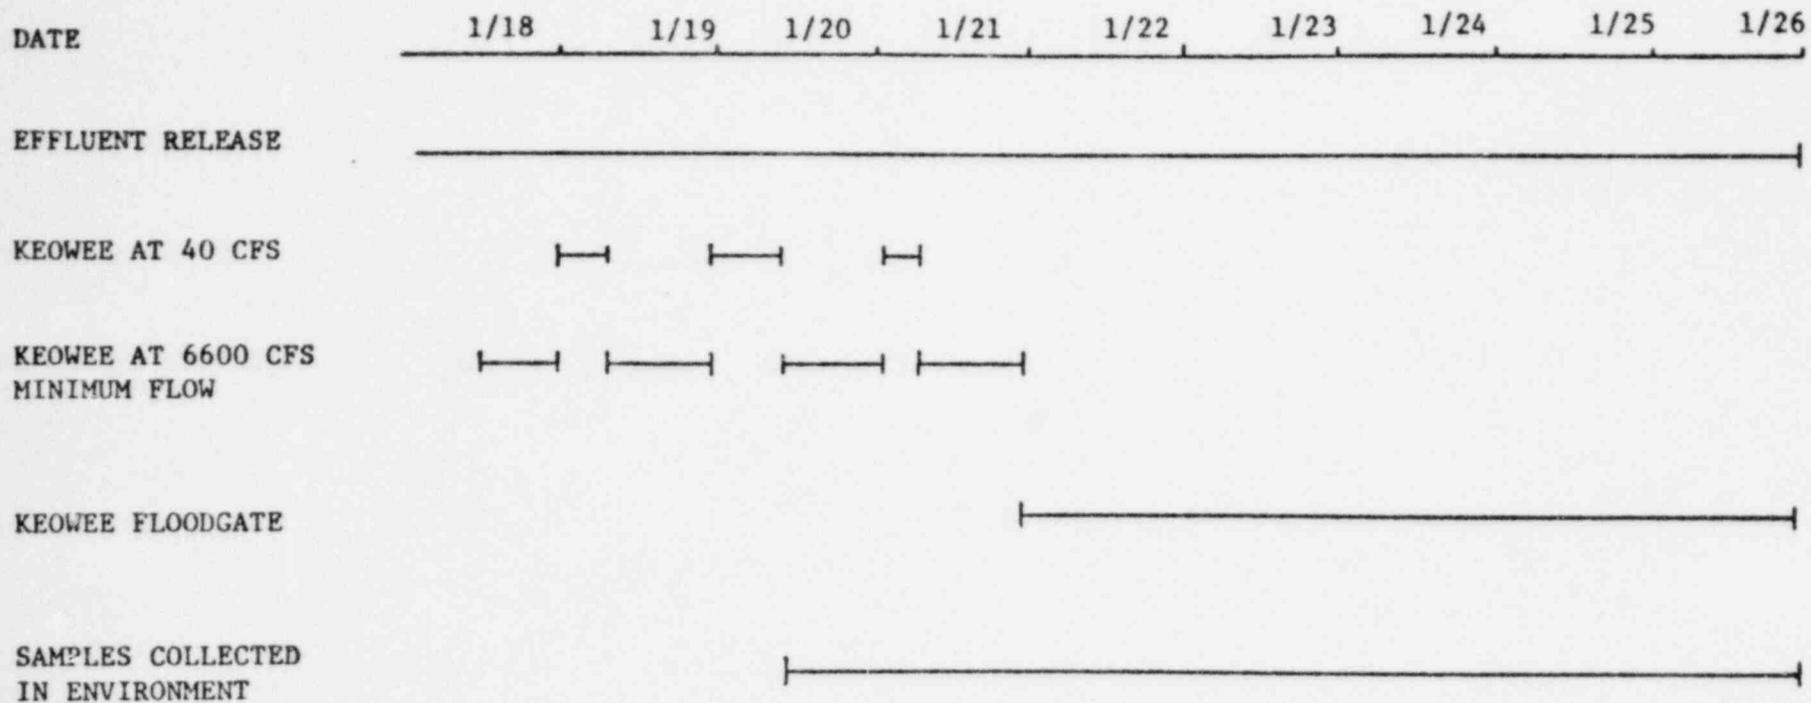
TIME LINE INDICATING RELEASE PERIOD,  
DILUTION FLOW SOURCES, AND SAMPLING PERIOD  
JANUARY 18-26, 1977

Doses From Release	Annual Regulatory Limits
Adult 0.13 mrem	
Child 0.77 mrem	
	10 CFR20 - 500 mrem
	10 CFR50 - 30 mrem Appendix I
	EPA Drinking - 4 mrem Water Standards
	Tech Spec - 5 mrem Bases
