MEMORANDUM FOR: B. Grimes, Chief, Environmental Evaluation Branch, DOR
THRU: J. Collins, Chief, Effluent Treatment Systems Branch, DSE
FROM: P. Stoddart, Effluent Treatment Systems Branch, DSE
SUBJECT: TAR-6406, TRIP REPORT, VISIT TO OCOHEE STATION,
MARCH 16, 1977

VISIT TO OCONEE NUCLEAR PLANT
MARCH 16, 1977, BY P. G. STODDART
EFFLUENT TREATMENT SYSTEMS BRANCH, DSE
(TAR-6406)

PROCEDURE FOR TESTING SCINTILLATION COUNTER CRYSTALS TO DETERMINE CRYSTAL FRACTURE OR DEGRADATION

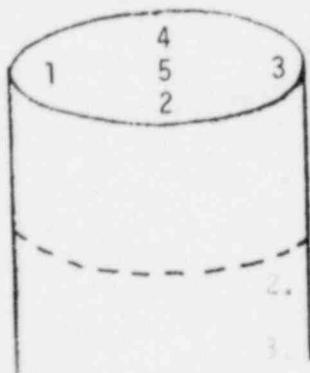
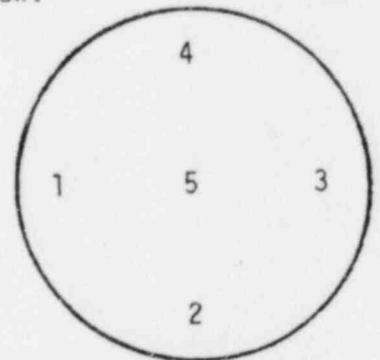
CRYSTAL END
OF DETECTOR
ASSEMBLY

1. Remove detector assembly from monitor well. Detector cable assembly should remain connected to monitor.
2. Place source in first position as in diagrams, below:

3. Make count determination, i.e., count rate, for position #1. Record count rate.
4. Repeat step 3 for positions 2, 3, 4, and 5.

If count rate at any point varies substantially, this is indicative of either crystal internal fracture or separation of crystal from glass face plate. To verify, disconnect detector assembly from monitor cable and disassemble components. Inspect crystal visually for defects. Any visible crack in the crystal, any separation of crystal from glass face plate as evidenced by bubbles under glass, or apparent discoloration (yellowing of crystal) indicates a defective crystal and that crystal should be replaced.
