**Summary of the NUMARC Initiative  
To Address Substandard Non-Safety-Related  
Molded Case Circuit Breakers**

November 1990

**Nuclear Management and  
Resources Council, Inc.  
1776 Eye Street, N.W.  
Washington, DC 20006-2496**

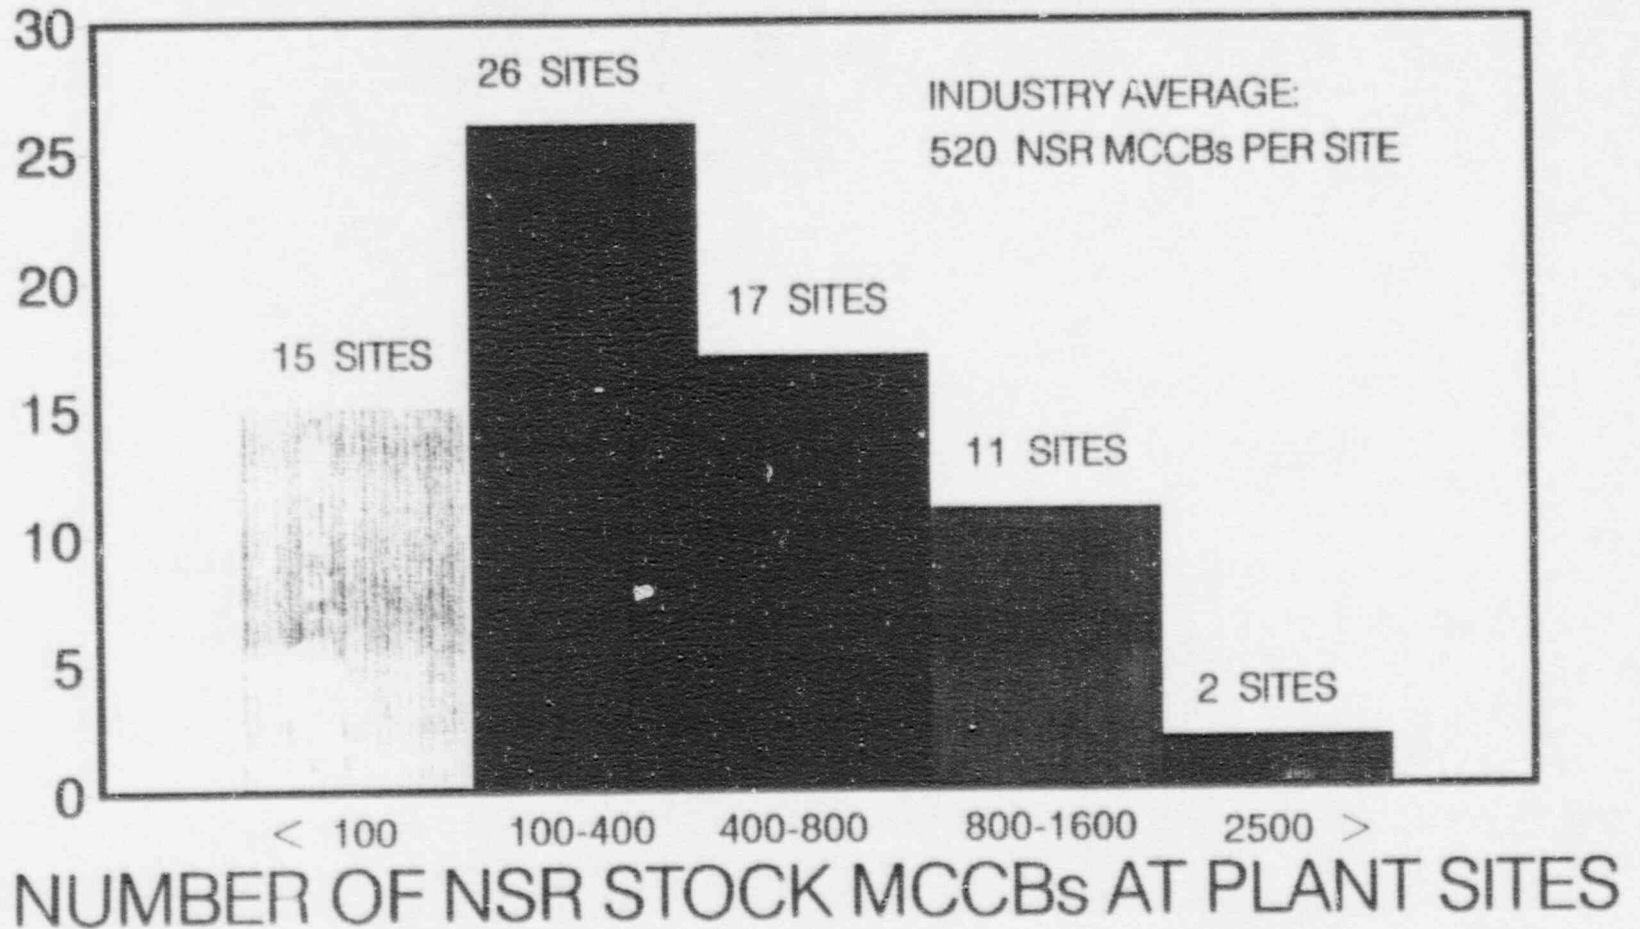
FIGURE 1

# NUMARC MCCB INITIATIVE NSR MCCB INVENTORIES

Figure 1 illustrates the distribution of NSR MCCB inventories among nuclear plant sites at the outset of the initiative. Figure 2 illustrates the findings of the warehouse inspection activity (Element 2) performed at all but one site. (At this one site, all stock MCCBs were treated within the scope of Bulletin 88-10 and so were not visually inspected.) The higher percentage findings indicated on Figure 2 for a small number of sites reflects either the small size of MCCB inventories, overly conservative warehouse inspections and/or the capture by the inspections of MCCBs previously used in the plant.

- o Of 36,597 individual MCCBs examined, 1,194 or 3.2 percent were judged suspect. These are in addition to MCCBs identified by Element 1. All suspect MCCBs are on hold. The number of MCCBs considered suspect has trended downward as minor discrepancies are resolved through follow-up inspections and manufacturer consultations. See also Figures 1 and 2.

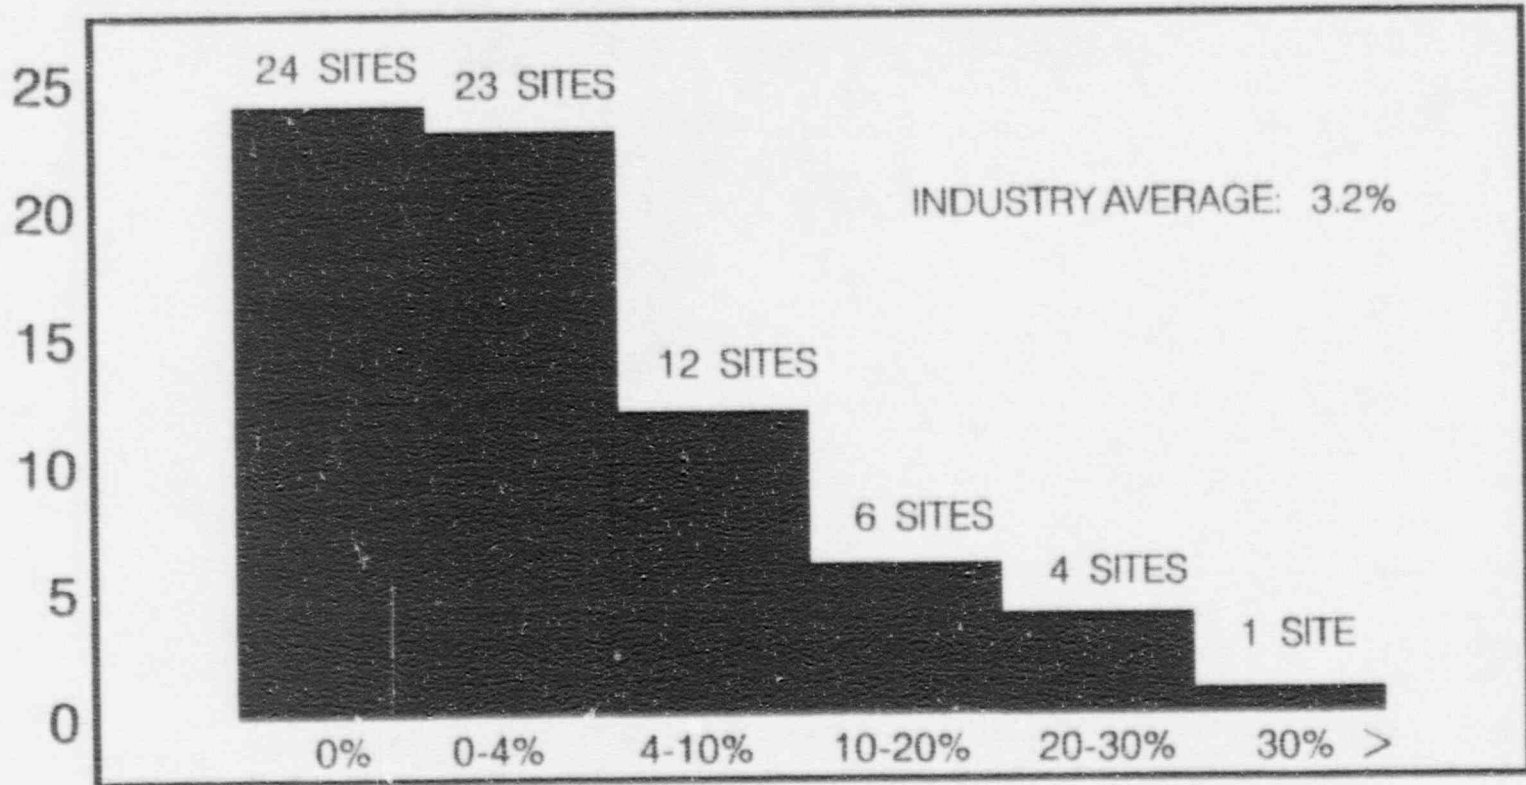
FIGURE 2

# NSR MARC NSR MCCB INITIATIVE WAREHOUSE INSPECTION FINDINGS

SUSPECT PERCENTAGE OF NSR MCCB STOCK

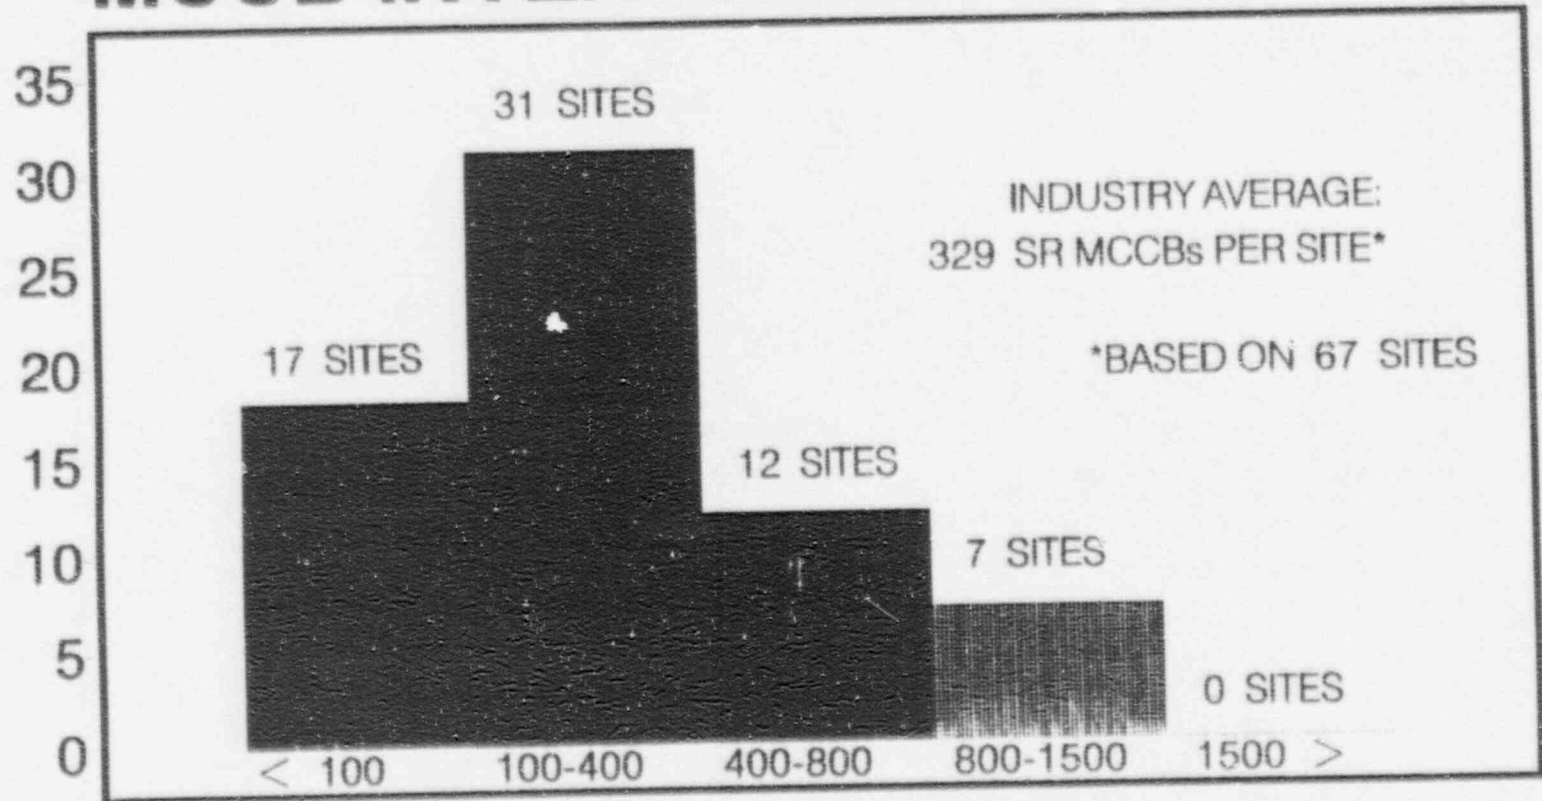
C-6

# NUCLEAR INDUSTRY SR MCCB INVENTORIES - NRCB 88-10

NUMBER OF SR STOCK MCCBs AT PLANT SITES
