U. S. NUCLEAR REGULATORY COMMISSION
OFFICE OF NUCLEAR REACTOR REGULATION

Facility Name: Haddam Neck Nuclear Power Plant
Audit At: Haddam Neck, Connecticut
Audit Conducted: July 24 - August 4, 1989

ISLOCA AUDIT REPORT

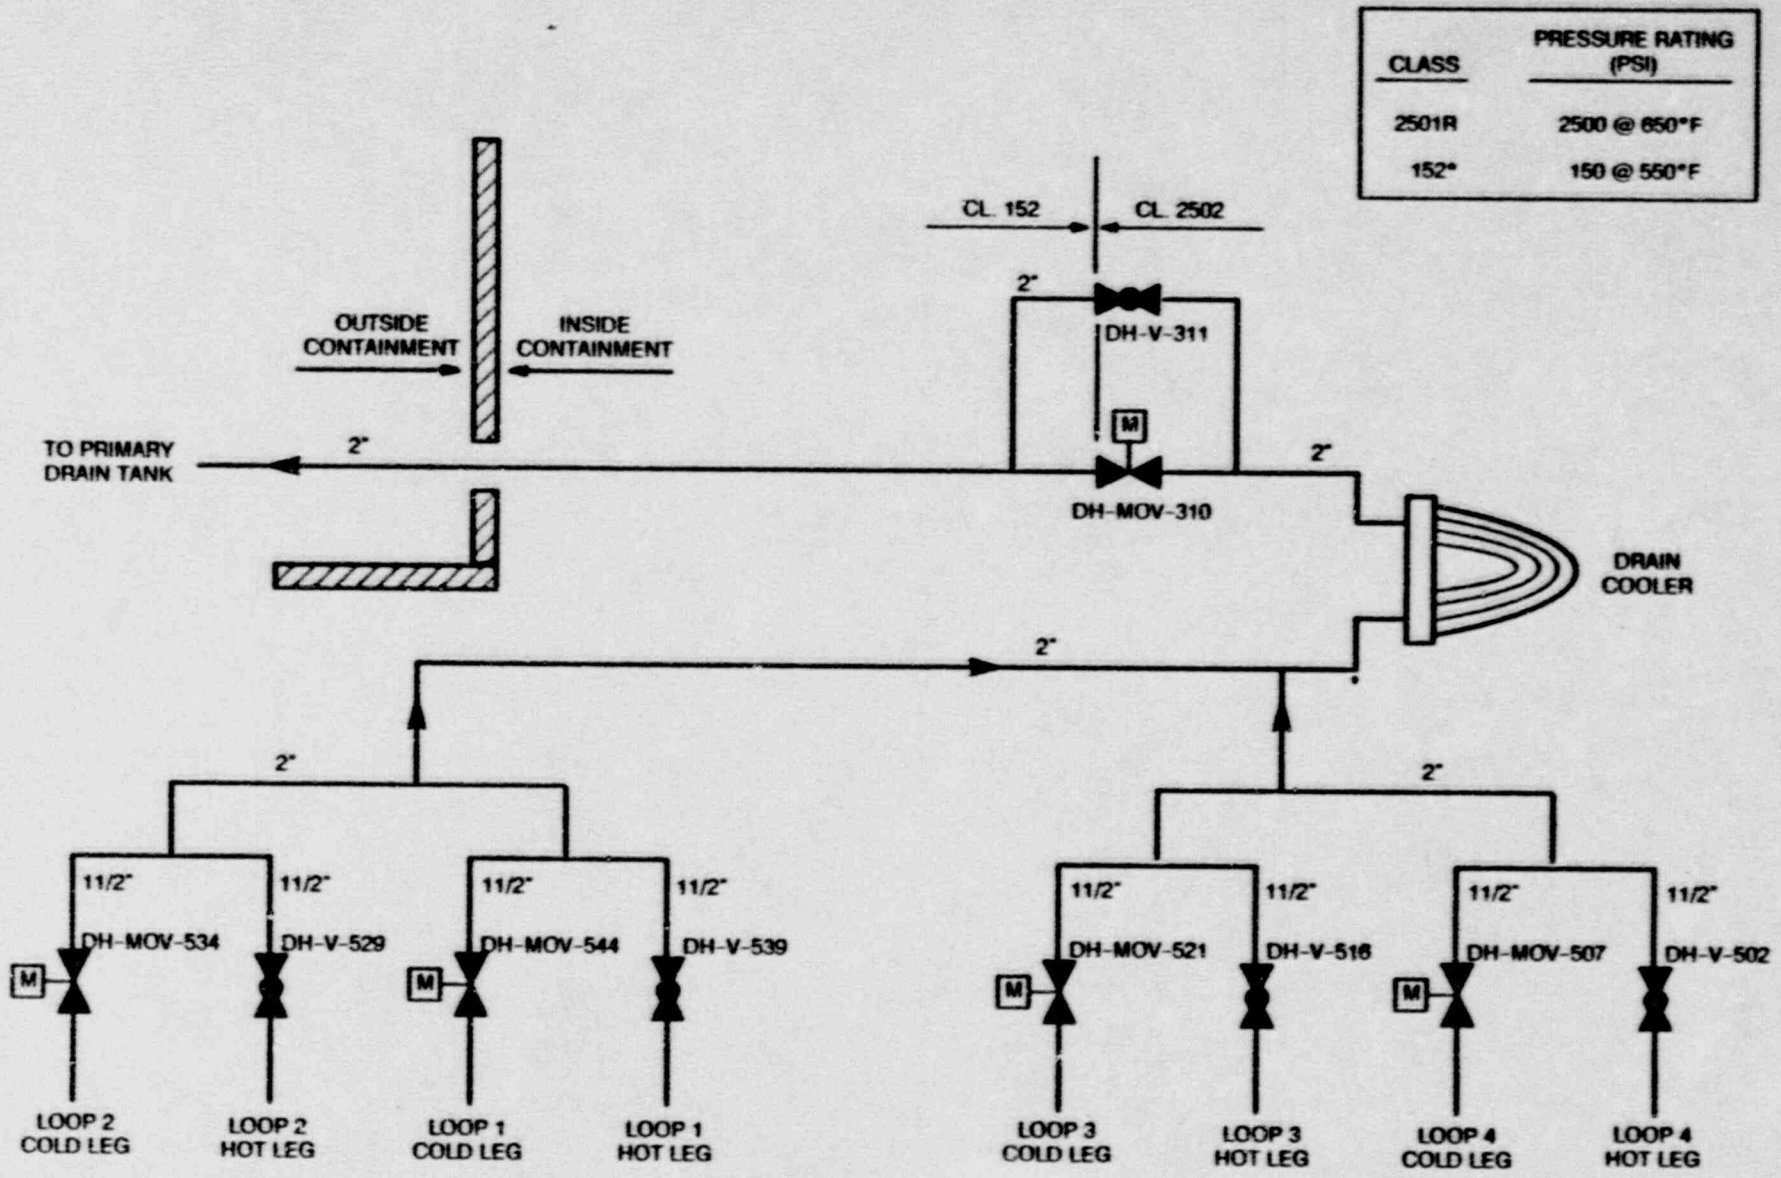
Figure 4.8 - HIGH/LOW PRESSURE INTERFACE - ALTERNATE LETDOWN LINE

CLASS	PRESSURE RATING (PSI)
2501R	2500 @ 650°F
152"	150 @ 550°F

The alternate letdown flowpath is used when the normal letdown flowpath is not available and the reactor is shutdown. Each RC loop has two drain flowpaths, one attached to the cold leg and isolated by an MOV (DH-MOV-507,521,534,544). The other pathway may allow the draining of the RCS through the hot leg utilizing two manual valves on each line (DH-V-502,502A,516,516A,529,529A and 539,539A respectively). The drain flow from each loop is combined into a header and is directed to either the Primary Drain Tank (PDT) or VCT. The drain header flow is controlled by a motor operated valve, DH-MOV-310. The valve is not qualified for post accident conditions and as such the line is not used during normal operations. The system layout is shown schematically on Figure 4.8.
