DRESDEN NUCLEAR POWER STATION

Commonwealth Edison Company

ANNUAL REPORT OF STATION OPERATION
FOR THE YEAR 1967

January 23, 1968

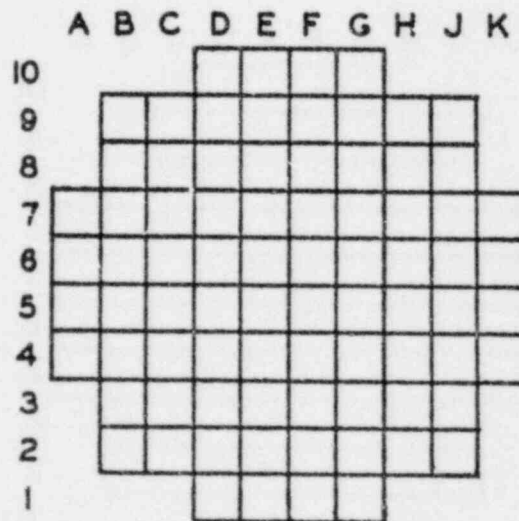
FIGURE 1

TURBINE TRIP AND REACTOR SHUTDOWN AT END OF CYCLE IV
JANUARY 13, 1967

Conditions prior to trip
 Time - 9:33 P.M.
 MWe - 70
 PSF - $.74 \times 10^6$ lb/hr.
 SSF - $.10 \times 10^6$ lb/hr.

1/13/67 Time - 10:30 P.M.
 Residual - 10 rods - 1 notch

1/14/67 Time: 1:30 A.M.
 Rt - 450° F
 Residual - 14 rods - 4 notches

In preparation for a turbine trip, the load was adjusted to 68 MWe by the insertion of 14 notches and an increase in secondary steam flow to accomplish the initial conditions exhibited in Figure 1. The rod patterns and critical conditions subsequent to the turbine trip and in use during the training of operators are also indicated in Figure 1.

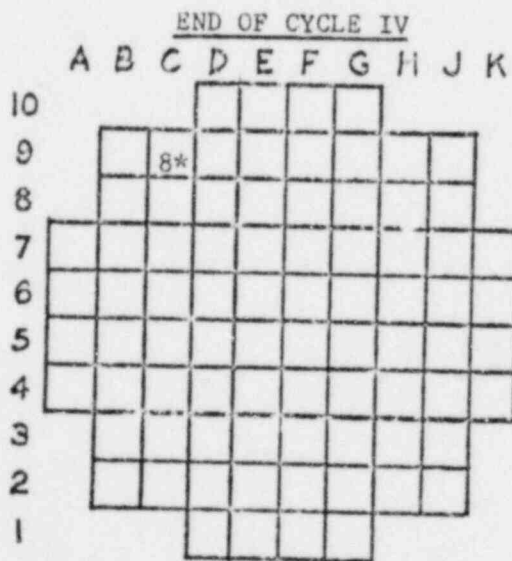
FIGURE 13

ROD PATTERNS DURING JANUARY

1/1/67
MWe - 160
MWt - 517
PWF - $.97 \times 10^6$ lb/hr.
SWF - 1.14×10^6 lb/hr.
Residual - 1 rod

1/13/67
MWe - 140
MWt - 453
PWF - $.94 \times 10^6$ lb/hr.
SWF - $.87 \times 10^6$ lb/hr.
Residual - 4 notches

The rod pattern in use at power and the variations within it as experienced during the month are exhibited in Figure 13.

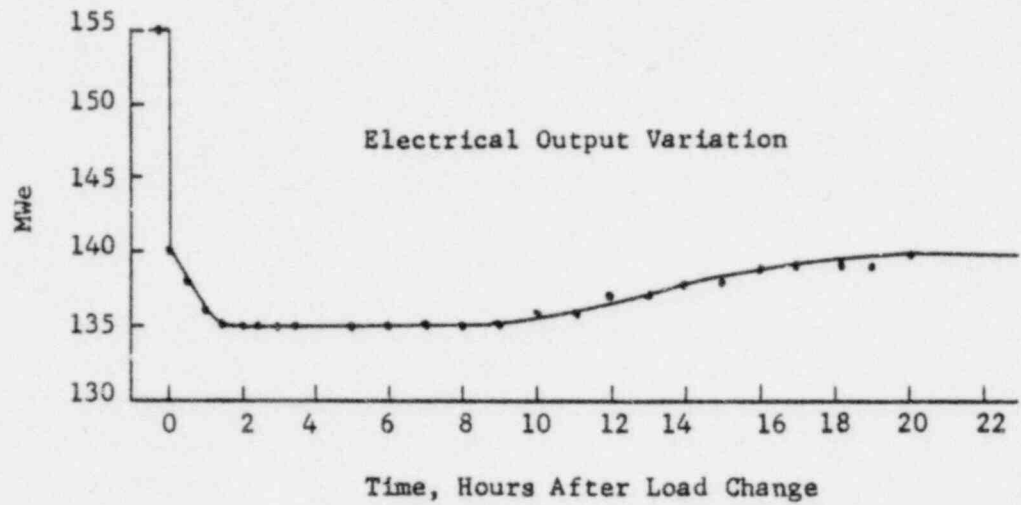
FIGURE 15

REACTOR STABILITY
LOAD STABILITY AND INCORE VARIATIONS RESULTING
FROM A STEP CHANGE ON POWER LEVEL AND XENON OSCILLATIONS

The secondary steam flow and rod pattern were kept constant over the next 24 hours. The power level and primary steam flow decreased, during the first two hours, remained essentially constant over the next seven and slowly returned toward the initiating load level in ten hours, as exhibited in Figure 15. The axial distribution in the meantime shifted toward the top of the core and reversed itself. The maximum average incore swing was experienced on "A" level approaching 12 percent of the level set by the load reduction. The maximum power level drop approached 33 percent of its initiating power step.
