YANKEE NUCLEAR POWER STATION

OPERATION REPORT NO. 64

APRIL 1966

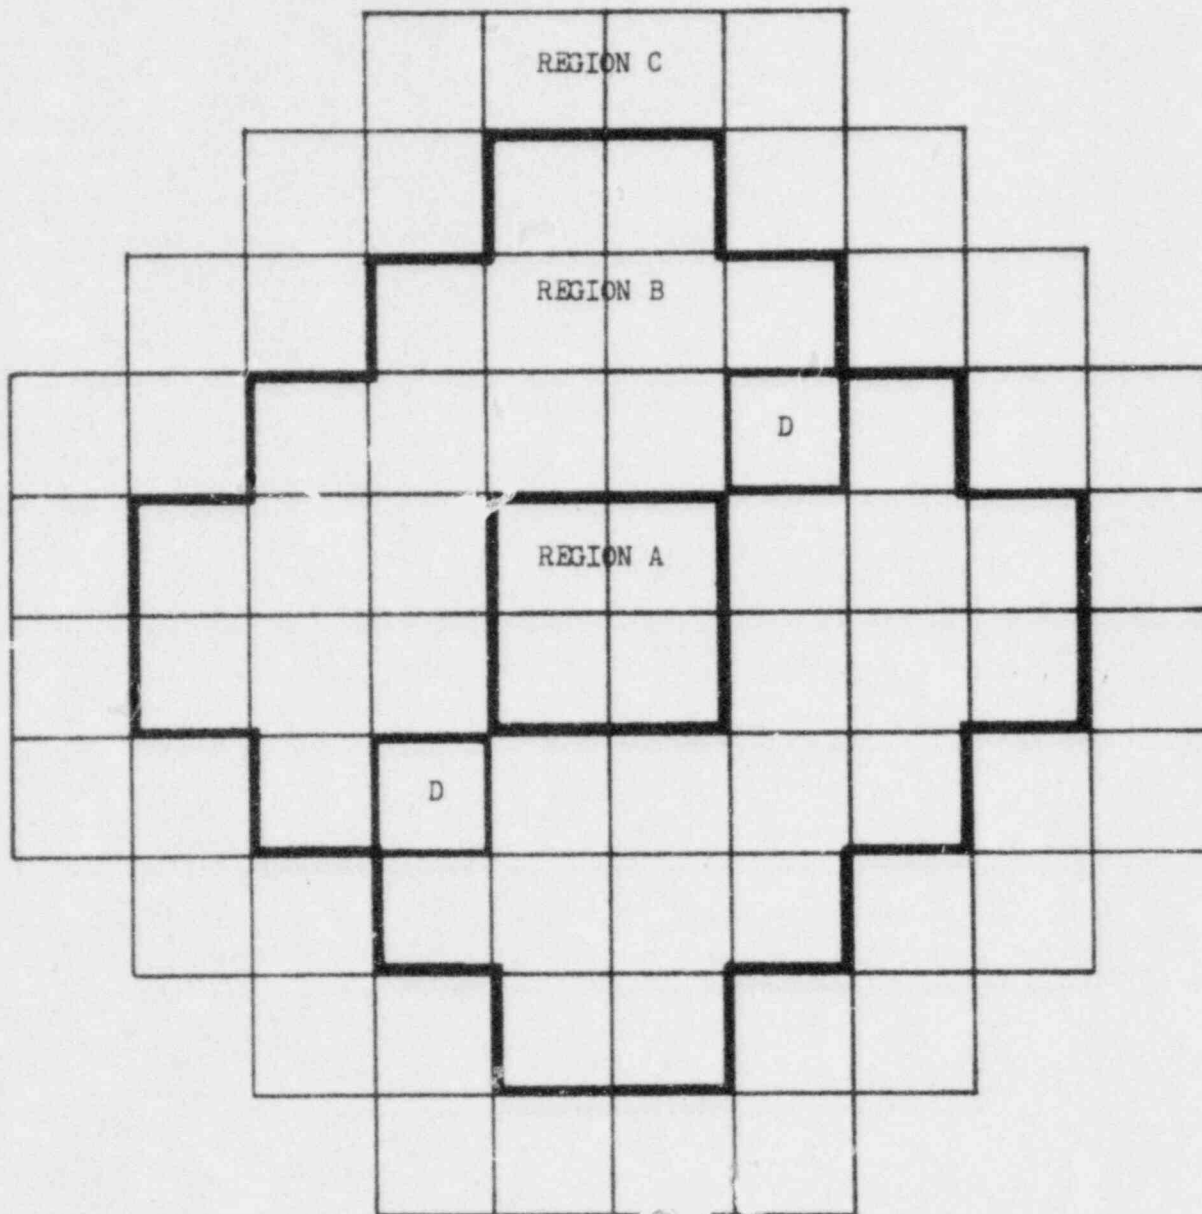
CORE V REGION LOCATIONS

D - ZIRCALOY TEST ASSEMBLIES
