WCAP-8183  
Rev. 10

OPERATIONAL EXPERIENCE WITH  
WESTINGHOUSE CORES  
(Up to December 31, 1980)

May 1981

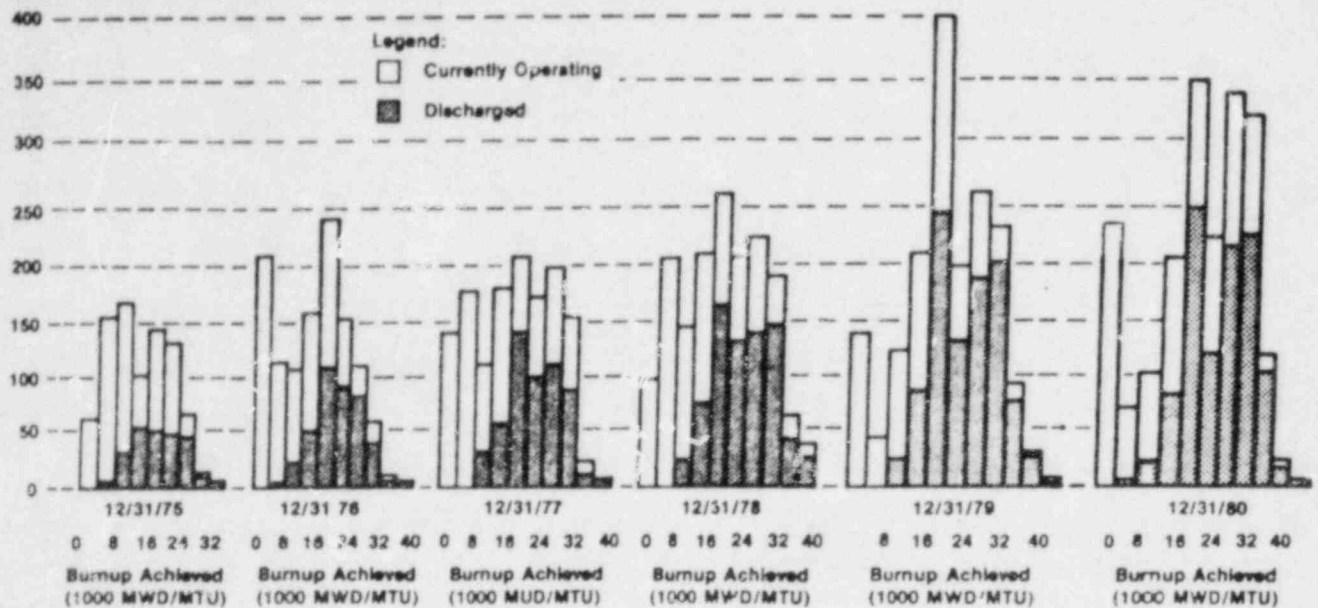
Figure 5-1 Burnup Performance of Westinghouse Zircaloy-Clad Fuel

Thousands of Fuel Rods

Average Burnups

All Fuel	14,300	15,100	17,300	18,800	20,000	20,600
Discharged Fuel	19,800	20,700	22,200	23,700	24,000	24,500

Figure 5-1 contains a graphic representation of the fuel burnup data through 1980 (also includes burnup performance figures from several previous years). The unshaded portion of the figure represents the fuel assemblies in service and the shaded portion of the graph represents discharged assemblies.

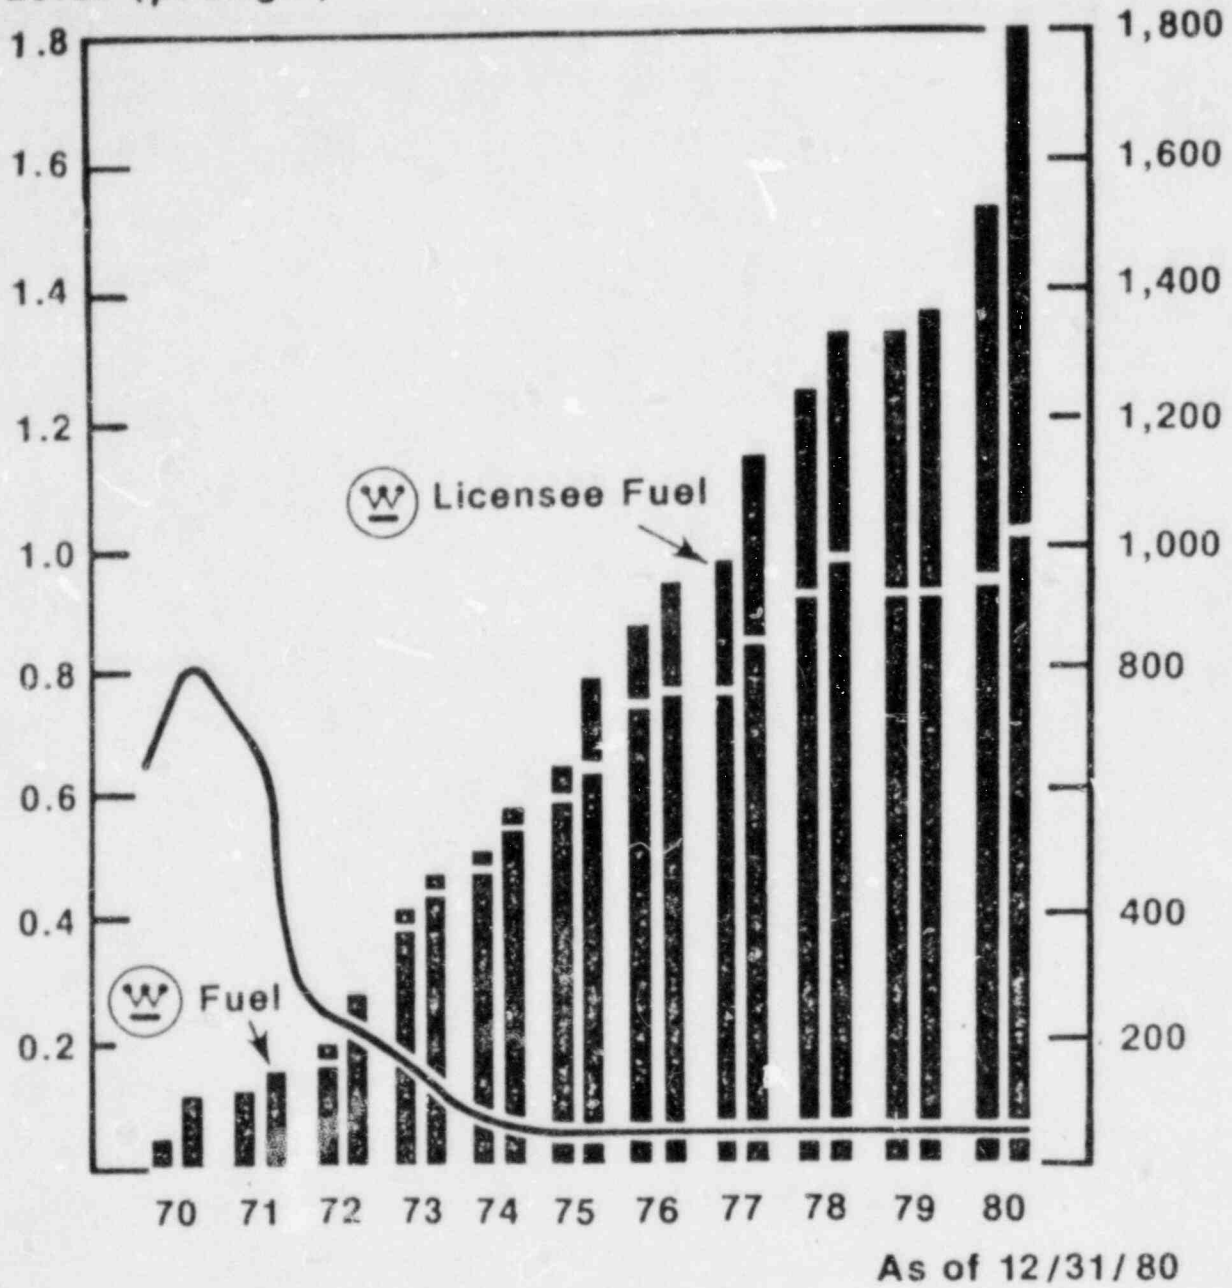
Figure 5-3 Performance Record - Average Coolant Activity Level/Number of Rods in Service

Average Coolant Activity Level ( $\mu\text{Ci/gm}$ )

Number of Rods in Service (000's)

Figures 5-2 and 5-3 show the yearly change of coolant activity distributions for Westinghouse-fueled plants. The trend toward lower coolant activities over the periods reported is apparent. Figure 5-2, which employs a logarithmic scale, emphasizes the trend toward lower activities as the number of plants and amount of operating experience increases. The reported coolant activity levels, combined with the burnup experience of Figure 5-1, provide substantial proof of the reliability and good performance of Westinghouse Zircaloy-clad fuel.
