Docket Nos. 50-266
and 50-301

SAFETY EVALUATION REPORT
INSTRUMENT BUS MODIFICATIONS
POINT BEACH NUCLEAR PLANT, UNITS 1 AND 2

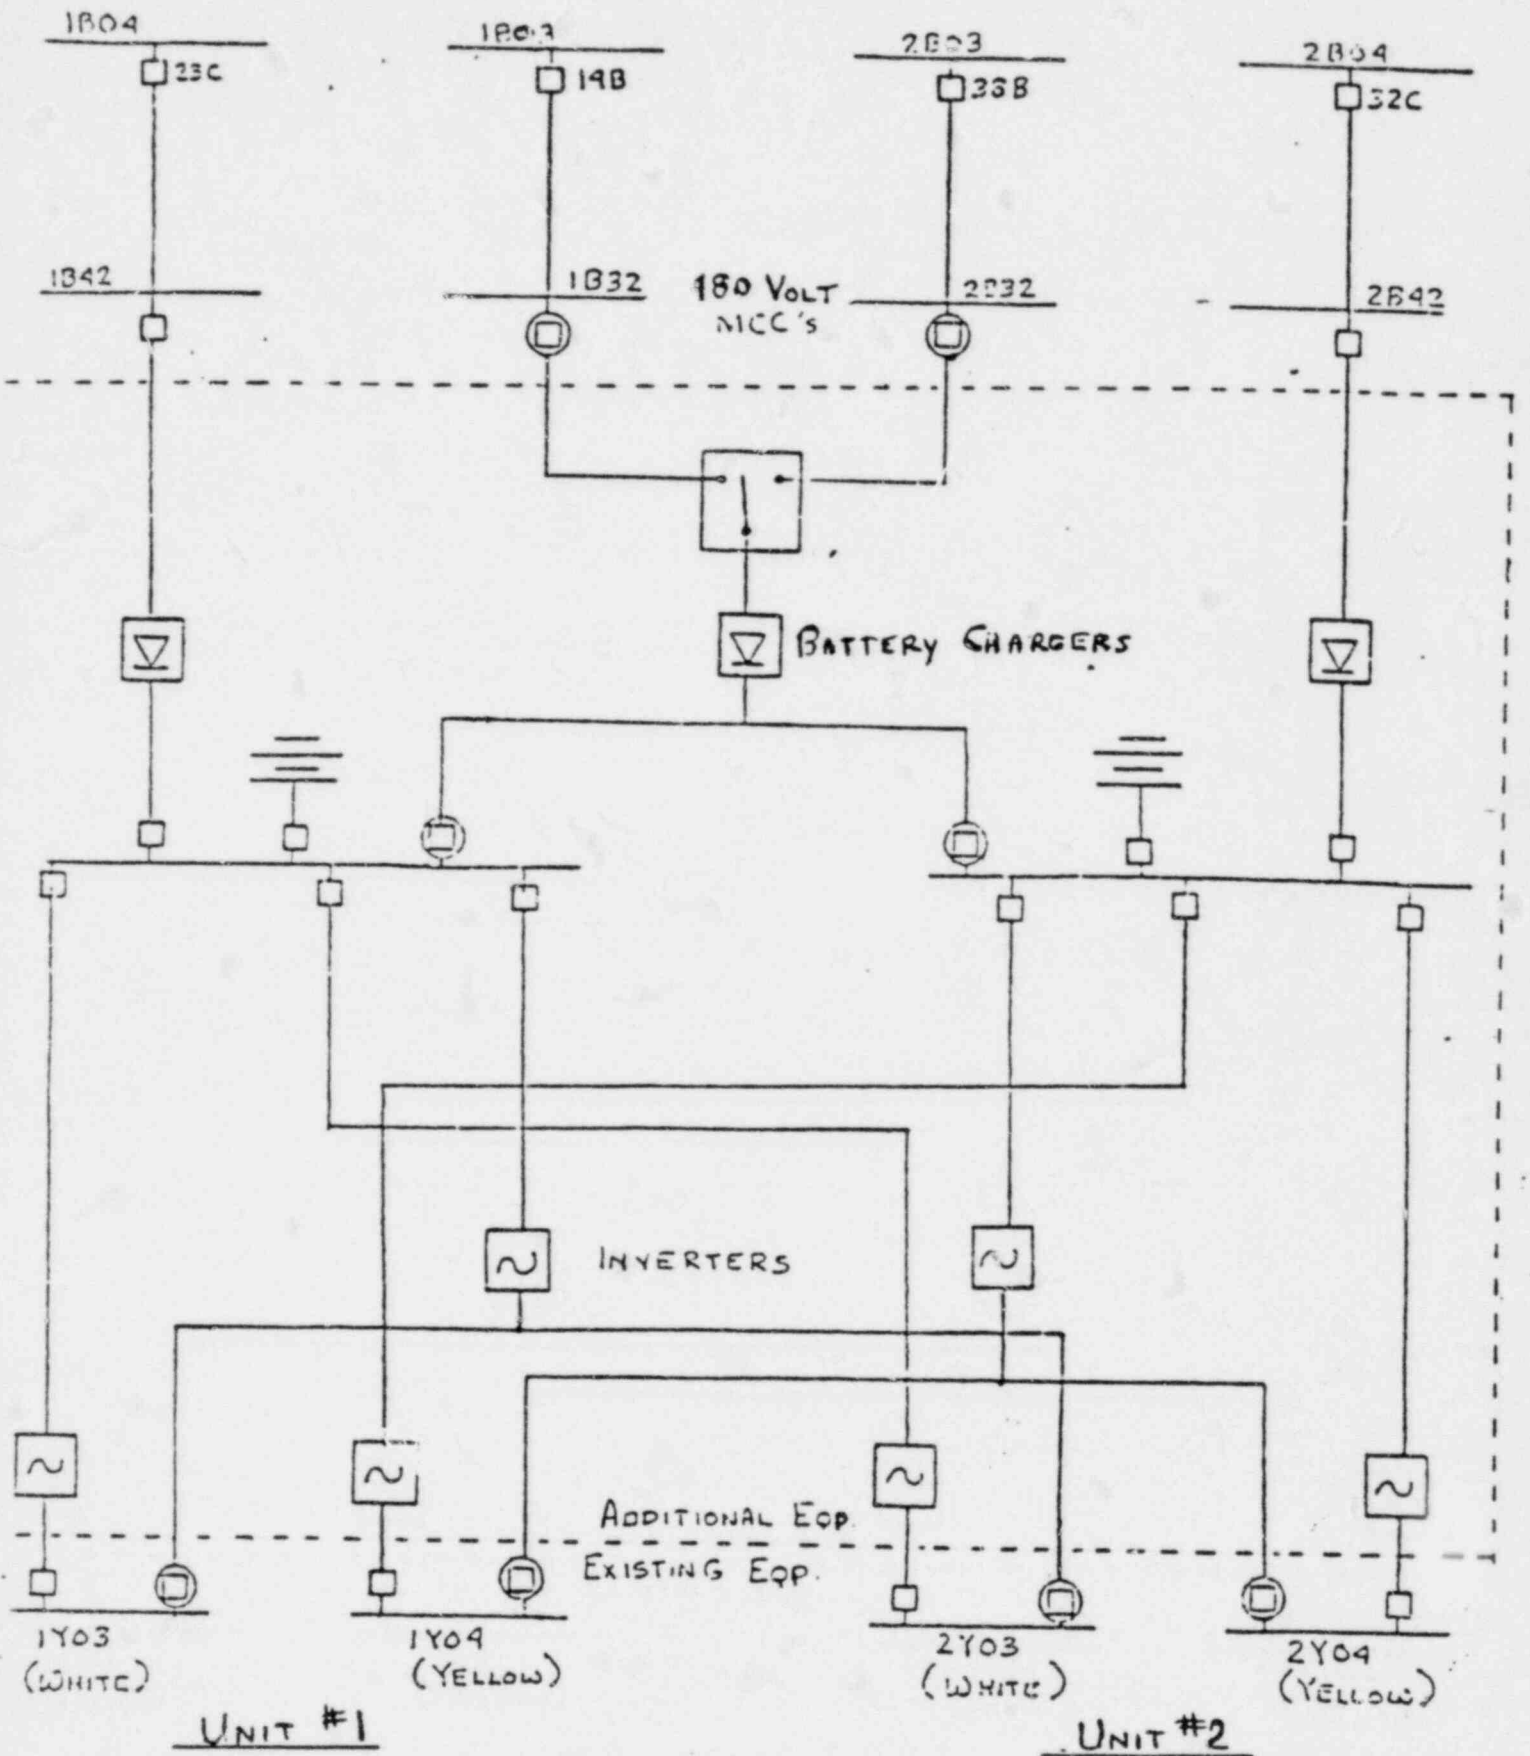
Figure 1

The modification to the instrument bus power supplies consists of the addition of two batteries, three battery chargers, six static inverters, and associated distribution buses and wiring to supply power to the white (1Y03 and 2Y03) and yellow (1Y04 and 2Y04) instrument buses of both units (see Figure 1). These modifications essentially duplicate the existing power supply arrangement for the red (1Y01 and 2Y02) and blue (1Y02 and 2Y02) instrument buses.

The proposed modification in combination with the existing power supply design for the red and blue instrument buses results in an instrument bus system which can be operated without offsite power. The design is such that the worst case single failure in conjunction with a loss of offsite power and a LOCA in one unit, would result in the failure of only one instrument bus per unit. Such failure could not result in a spurious starting of all emergency loads in both units.
