UNION CARBIDE CORPORATION

URAVAN, COLORADO

SOLID WASTE DISPOSAL

REPORT

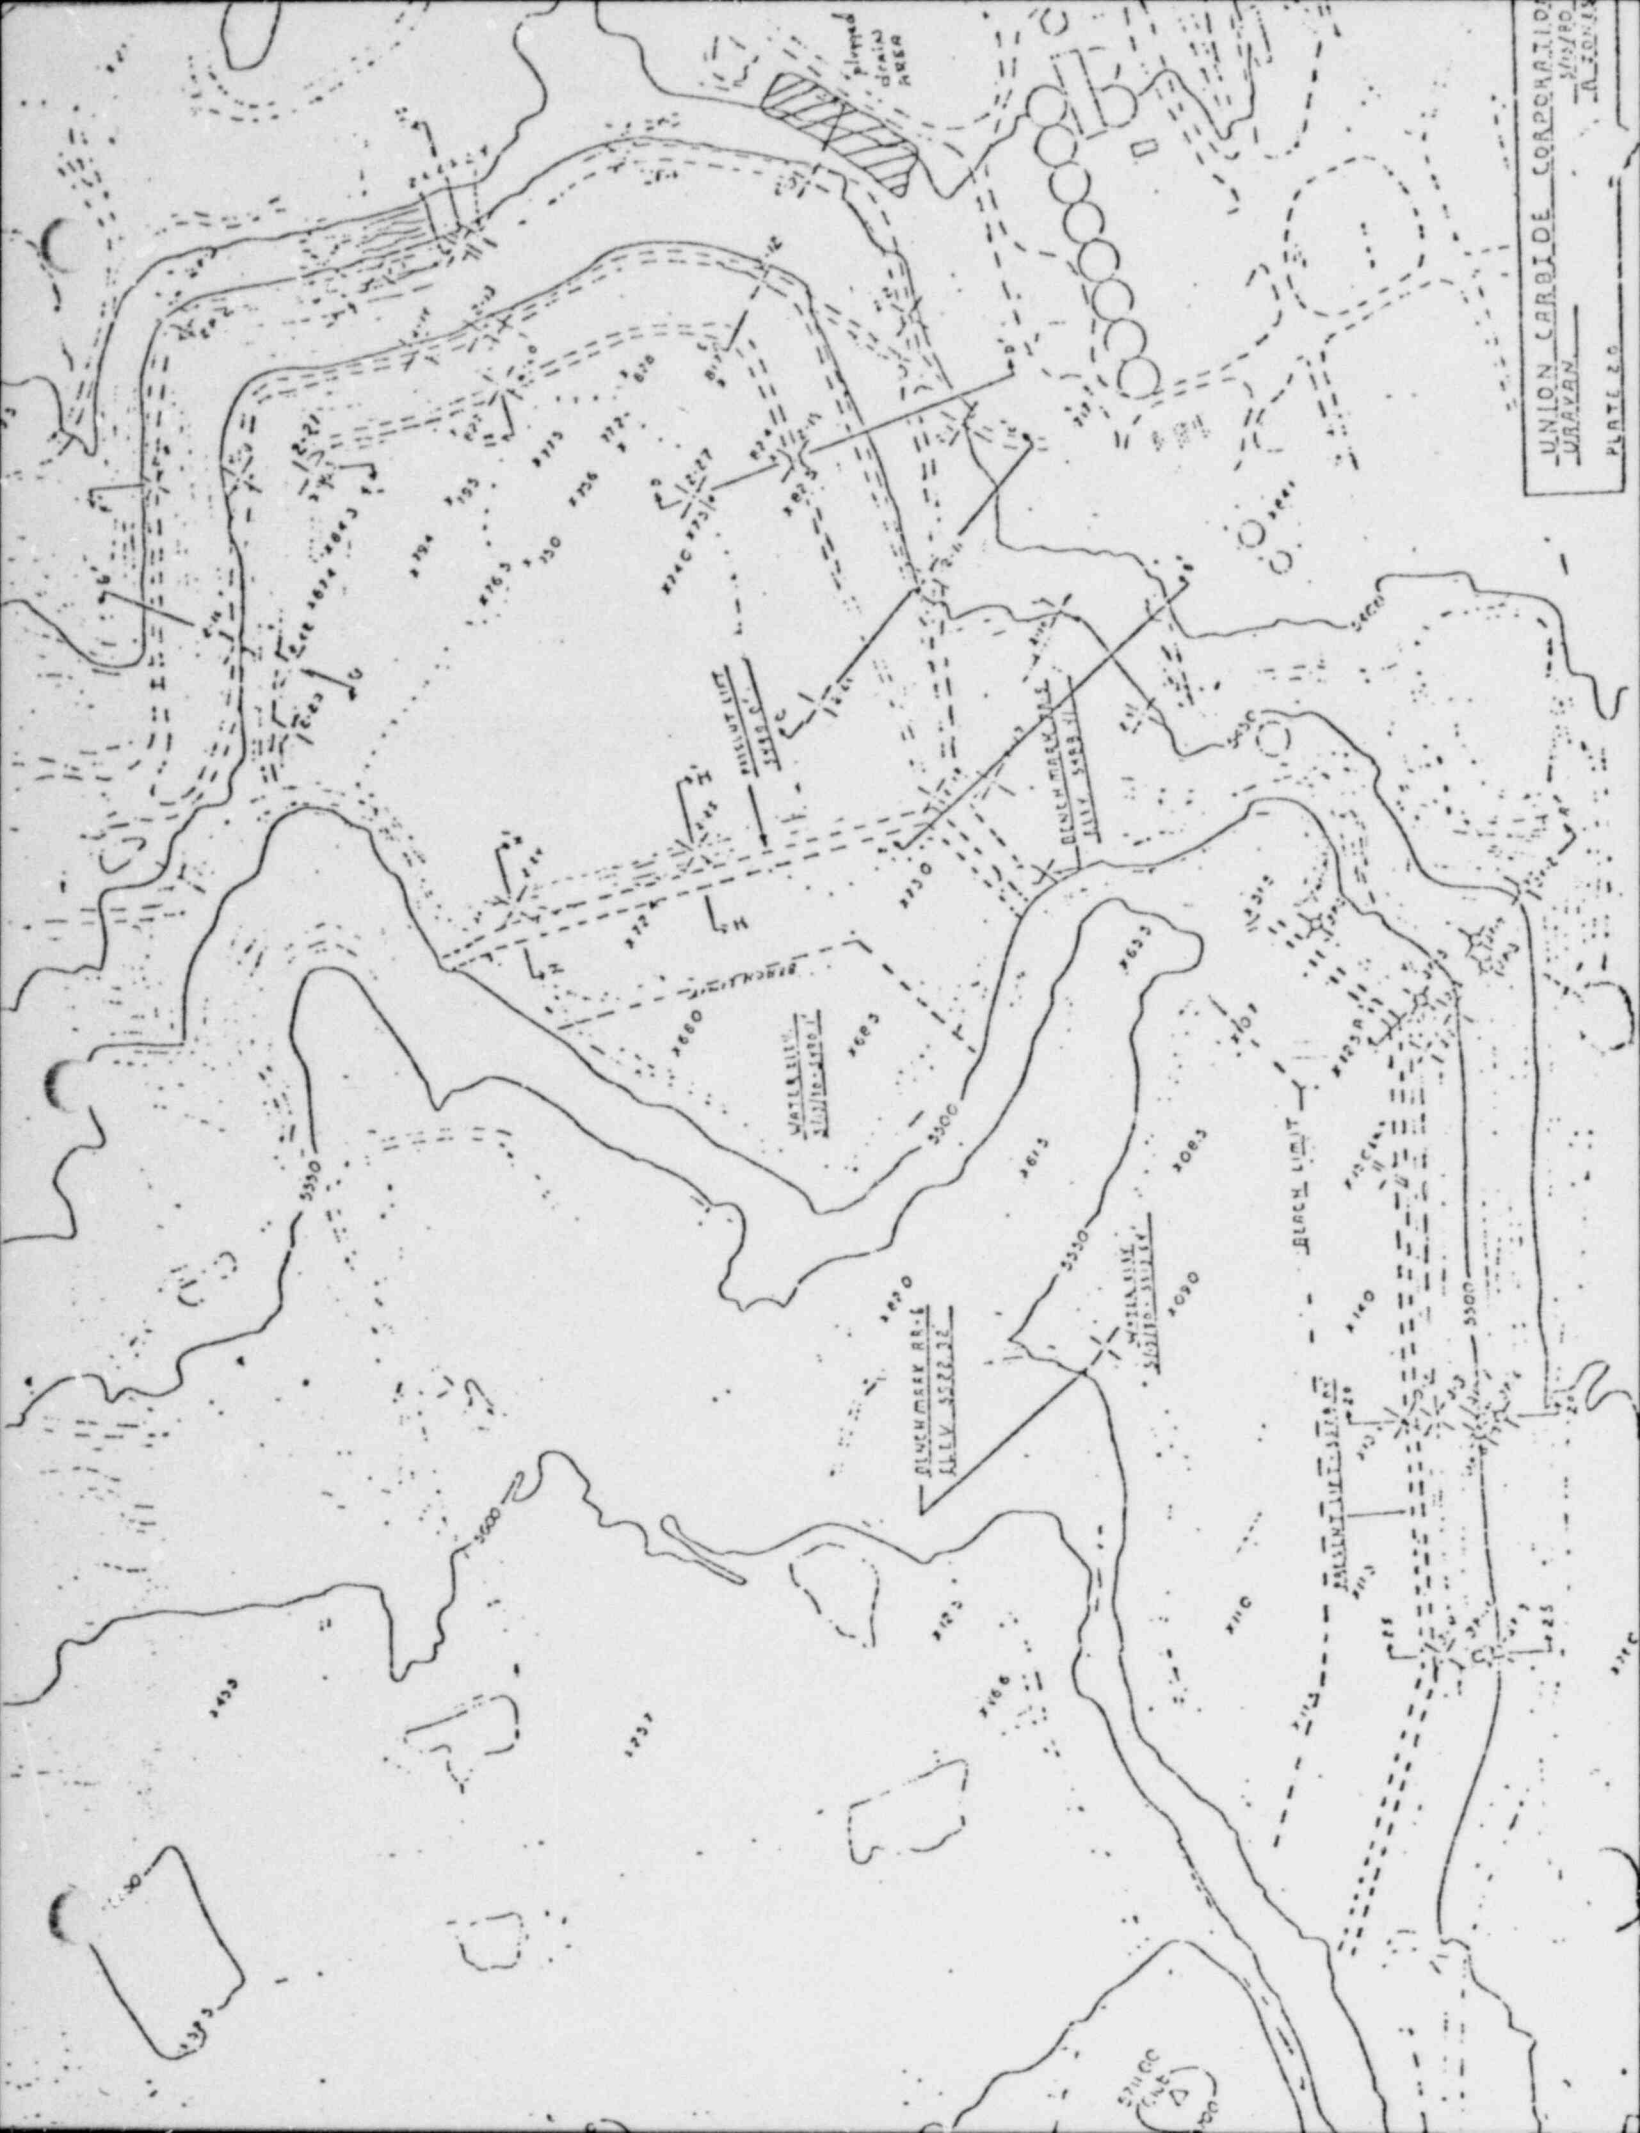
PIEZOMETRIC MEASUREMENTS

UNION CARBIDE CORPORATION  
 URAVAN ENVIRONMENTAL DEPARTMENT  
 MONITOR WELL PHREATIC MEASUREMENTS

Monitor Well	Casing Elevation	Surface Elevation	Date
2-6	5418.81	5418.81	4/1/81
2-7	5418.81	DAMAGED	4/8/81
2-8	5410.93	DAMAGED	4/16/81
2-9	5422.43	DAMAGED	4/23/81
2-10	5454.7	DAMAGED	4/28/81
			5/1/81
			5/18/81
			5/27/81
			6/4/81
2-6	5363.77	5363.69	5/13
2-7	5418.81	5363.62	5/18/81
2-8	5410.93	5363.81	5/27/81
2-9	5422.43	5363.89	6/4/81
2-10	5454.7	5363.64

Location of the piezometers is illustrated on Plate 2.0. Total precipitation for May was 0.91 inches.
