Dames & Moore Report No. 05467-028-06
Salt Lake City, Utan
June 4, 1981

REPORT OF STABILITY ANALYSES
18-FOOT RAISE OF TAILINGS EMBANKMENT
TC ELEVATION 4076 FEET
MOAB, UTAH
FOP
ATLAS MINERALS

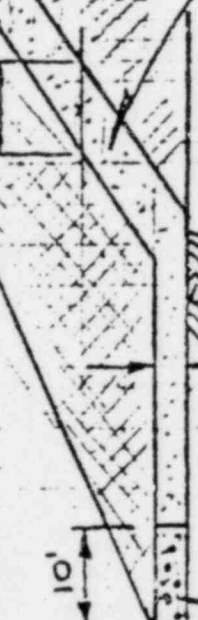
6' MIN. MINIMUM COVER OF

WELL-GRADED RIVER RUN GRAVEL - MAXIMUM SIZE

NATURAL OVERBURDEN SOILS PLACED IN 12" LIFTS COMPACTED TO DENSITY OF 98% OF AASHTO T-99 $\frac{1}{2.5}$

BEACH SAND TAILINGS MATERIAL (NO GREATER THAN 7% BY WEIGHT PASSING THE #200 SIEVE)

FILTER DRAIN RIVER RUN GRAVEL/SAND MIX DESIGNED IN ACCORDANCE WITH U.S. CORP OF ENGS. CRITERIA

6. Overburden material will be placed over the beach sand with minimum cover of 8 feet. The overburden will be of natural near-site sand and silt and will be placed to the dimensions shown on Figure 1. The fill should be placed in 12 inch lifts (loose state) and compacted to a dry density of at least 90% of the maximum density as determined by the AASHTO T-99 method of compaction.
