UNITED STATES  
NUCLEAR REGULATORY COMMISSION  
WASHINGTON, D. C. 20555

RESPONSES TO CHAIRMAN KOSTMAYER'S QUESTIONS

- I. Seabrook IR 90-80 (p.92) states that "... as documented in CAT IR 84-07 and discussed in IR 85-31; the licensee conducted an independent third party review of all RT film stored onsite, whether provided by vendors or shot by site contractors."

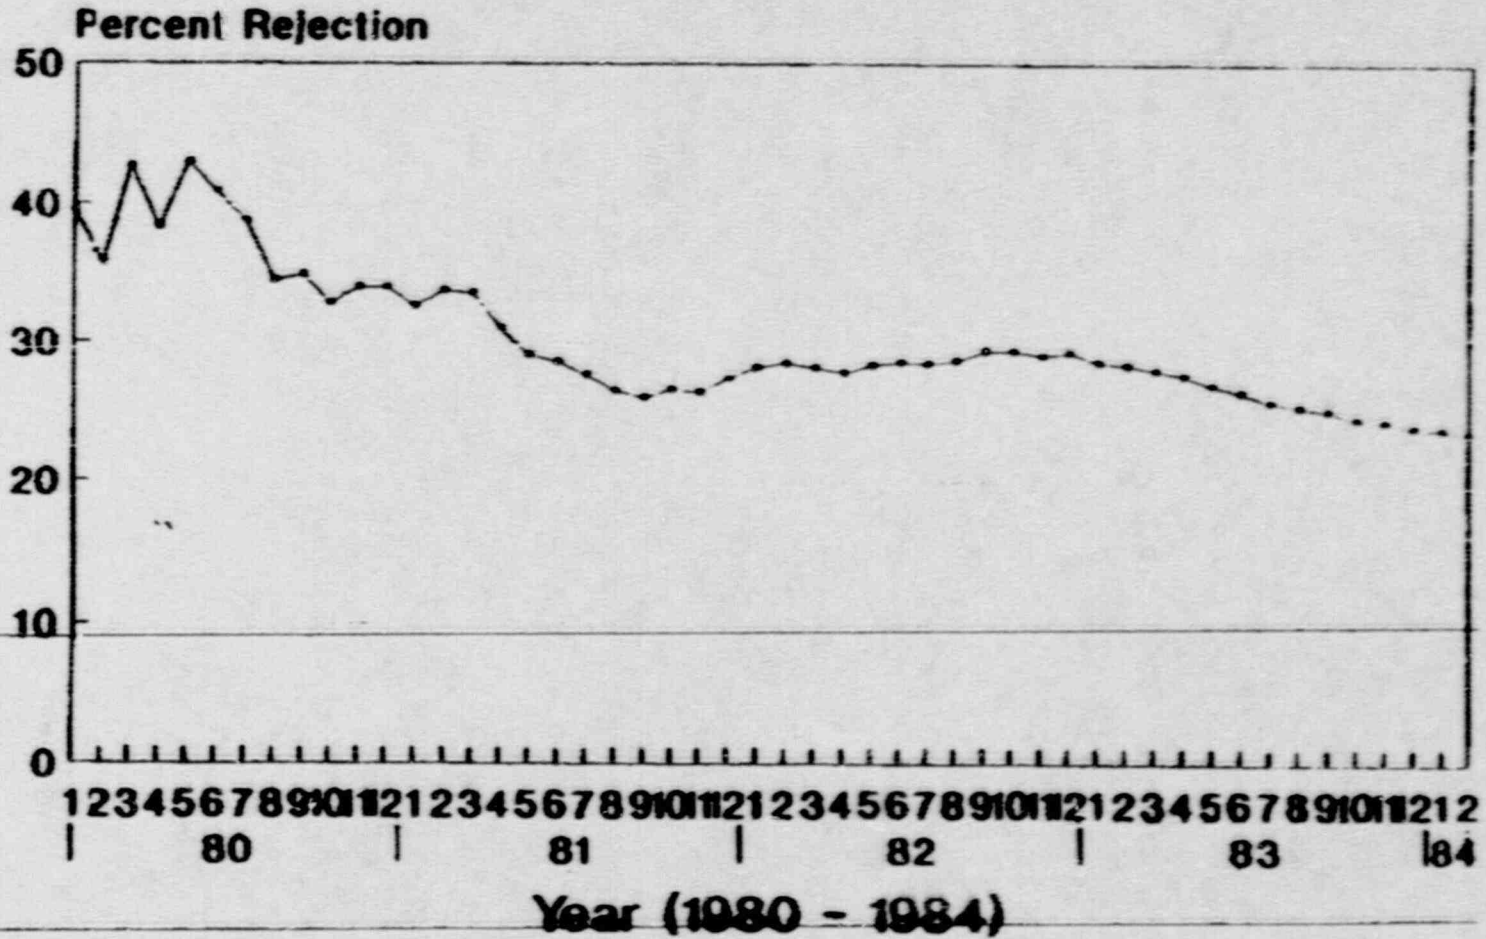
# Seabrook Station Radiograph Reject Rate

"The NRC inspector reviewed the methods currently being employed by P-H and UE&C to evaluate and minimize welding defects. Records are currently kept and continuously updated of X-ray reject rate percentages and totals for each welder. Specific welder defect trends are recorded (where applicable) to indicate what types of defects are being produced by specific welders. This information is used to assist welding foremen and welding engineers in providing on-the-job additional instruction and to point out specific techniques which need more training. Both paid and unpaid additional training for welder upgrading is available at the site. Monthly Welder Training Upgrade Summary Sheets were reviewed by the inspector.

NRC inspections throughout this period verified that, although the weld radiograph reject rate was high, the quality of the final and installed components was good. This was noted in the NRC SALP, dated February 19, 1985: "It is noted, however, that with regard to completed and finally inspected hardware, very few problems were identified. In fact, in the welding and NDE areas, independent examinations by NRC inspectors revealed generally high quality work and effective licensee overview of the final radiographic film packages."
