NORTHEAST UTILITIES

LICENSEE EVENT REPORT (LER)

FACILITY NAME (1) **Millstone Nuclear Power Station Unit 1** DOCKET NUMBER (2) **050002451** PAGE (3) **1 OF 06**

TITLE (4) **LLRT Failure**

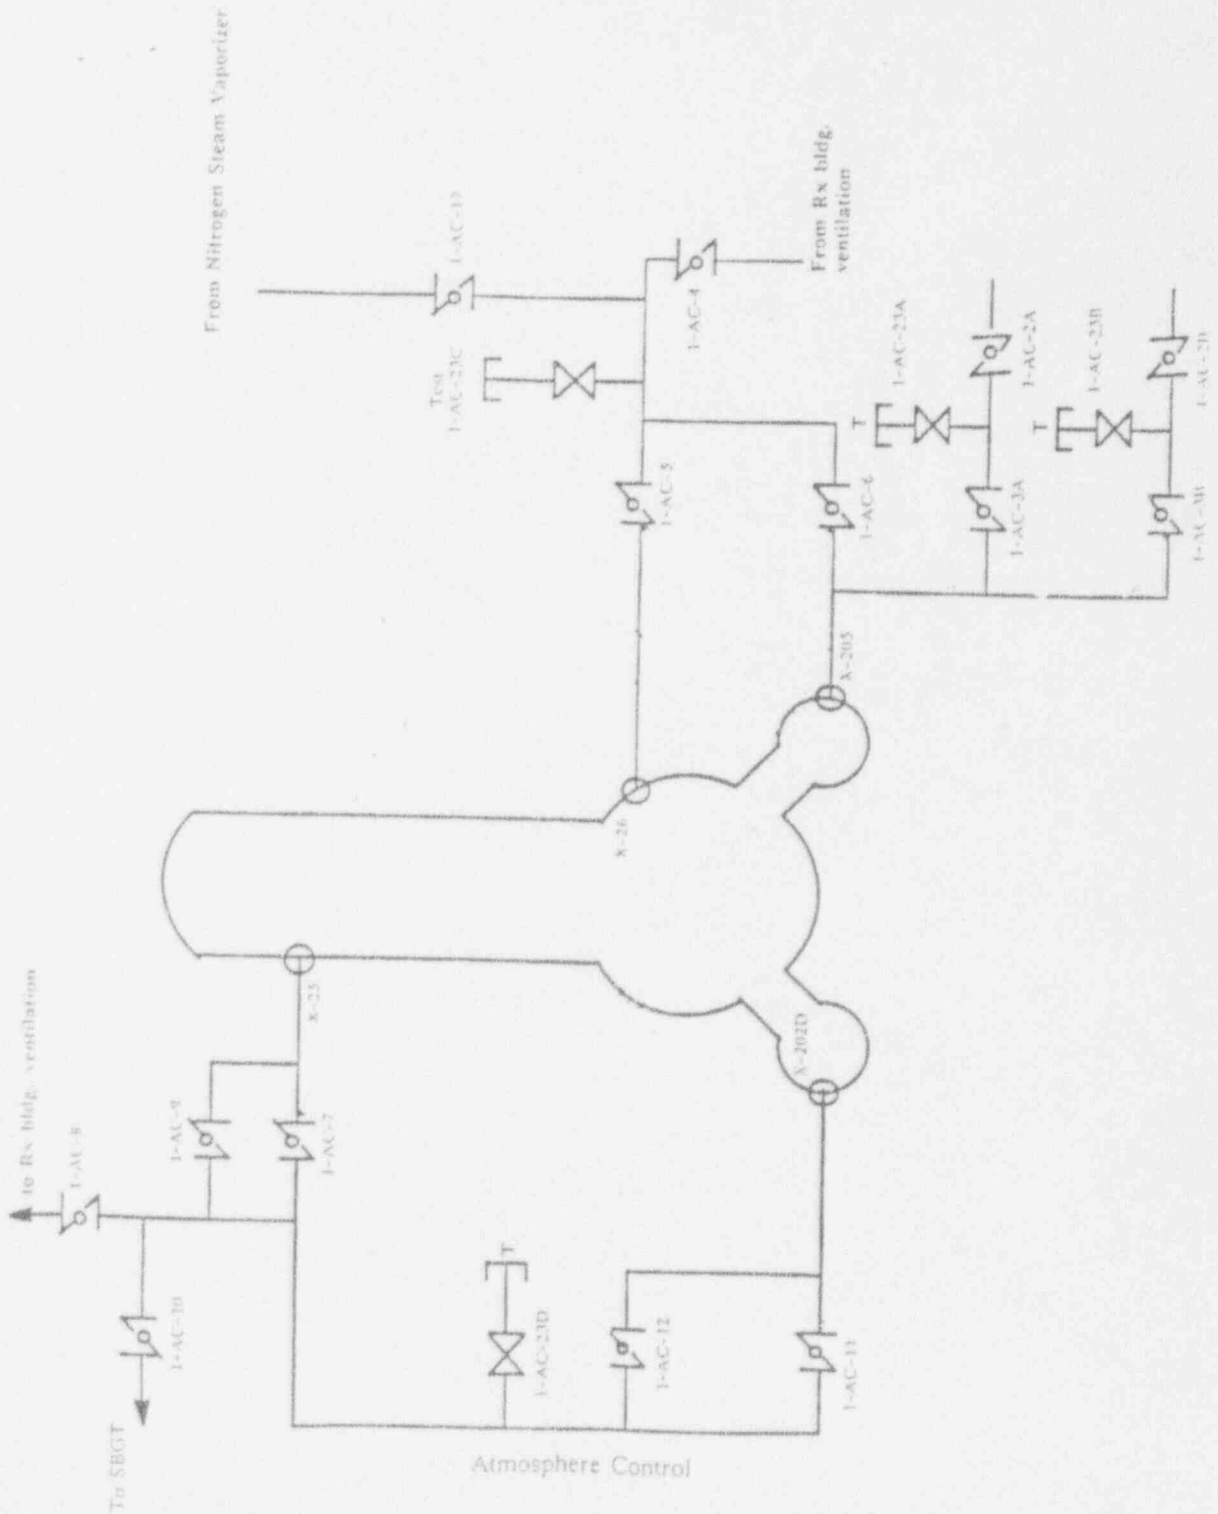
Subsequent LLRT of Penetration X-25/202D yielded a total valve leakage rate of 5.645 SCFH. This demonstrated that the corrective action taken for valves 1-AC-11 and 1-AC-12 was effective.

Valve 1-AC-12 is a two inch eccentric plug valve which operates on air to open and spring return on loss of air to close. The design of this valve utilizes a rack and pinion arrangement for rotating the soft seat plug into the steel seat in the valve body. The packing on the plug shaft is preloaded by adjusting a valve packing nut on the plug shaft which compresses the valve packing spring to obtain the proper preload on the packing to effect a leak tight fit. Over time, a slight increase in valve friction coupled with a high preload on the valve stem packing which was a result of an improper factory adjustment, the higher force required to completely rotate the plug into the seat was slightly above the preload of the return spring and resulted in the valve not attaining its full closure position. The valve packing nut was adjusted to the proper preload setting and the valve was retested several times to ensure the full closure would be obtained consistently. This valve was leak tested on the bench at accident pressure in both directions to ensure that both the valve packing was air tight as well as the plug being fully seated. The valve leakage prior to installing this valve back into the system was 0.65 SCFH. Since the two plug valves in this penetration were installed new during the 1991 refueling outage, the other valve (1-AC-9) was also checked visually to ensure that the valve stem packing was properly adjusted. The valve packing for valve 1-AC-9 was found to be properly adjusted by the factory. Additionally, the In Service Test (IST) records for valve stroke time on valves 1-AC-9 and 1-AC-12 were reviewed which indicated that valve 1-AC-12 was originally stroking approximately 0.5 seconds slower than valve 1-AC-9. This can be attributed to the higher packing preload on valve 1-AC-12. Following adjustment of the packing preload on valve 1-AC-12, both valves are stroking at approximately 1.5 seconds.
