APPENDIX A

Significant Appraisal Findings

Power Authority of the State of New York  
James A. FitzPatrick Nuclear Power Plant

Docket No. 50-333  
License No. DPR-59

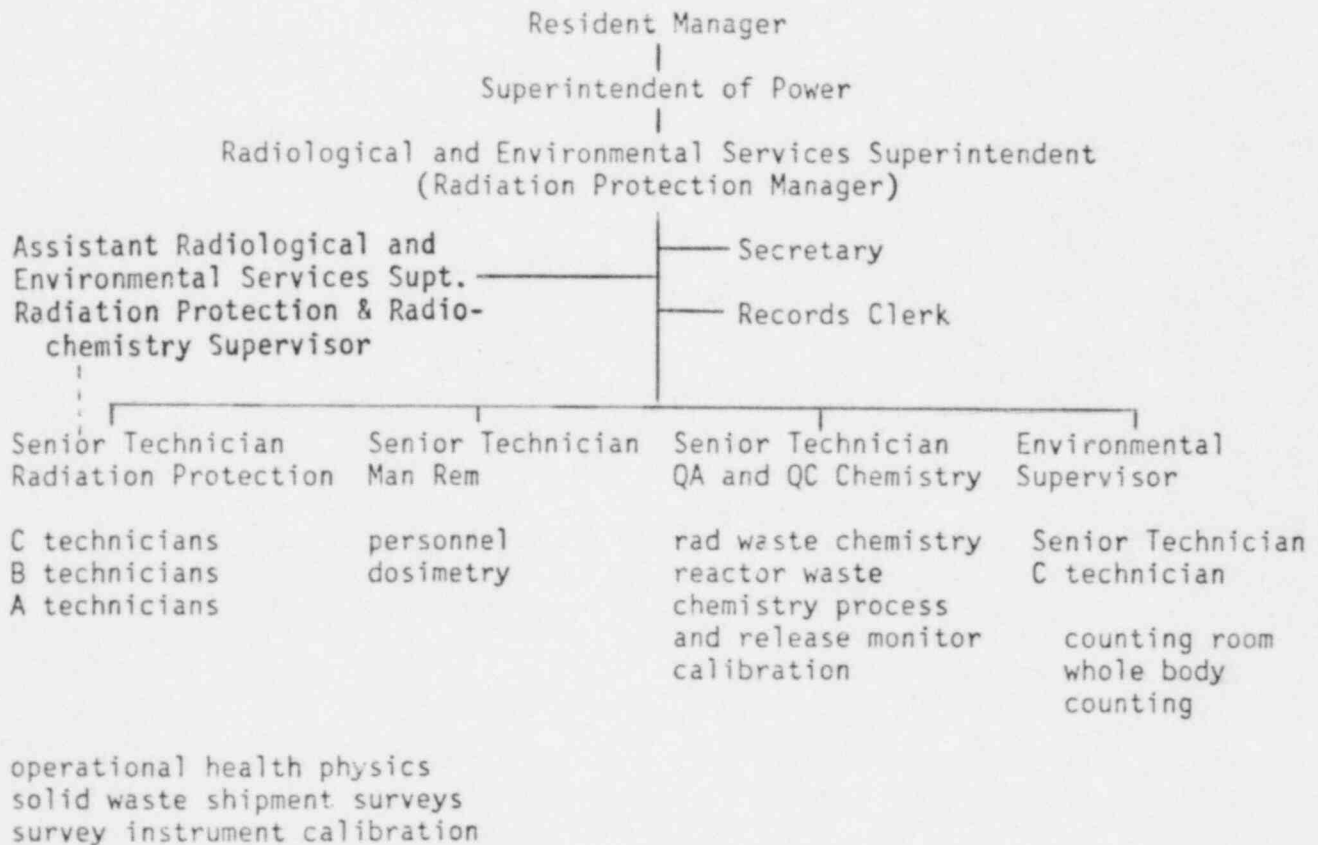
The organization of the RES Department as specified in RES Department Standing Order No. 3, Revision 1, is shown below.
