**VOGTLE ELECTRIC GENERATING PLANT
1989 ANNUAL REPORT - PART 2**

PLANT VOGTLE UNITS 1 & 2

ANNUAL REPORT

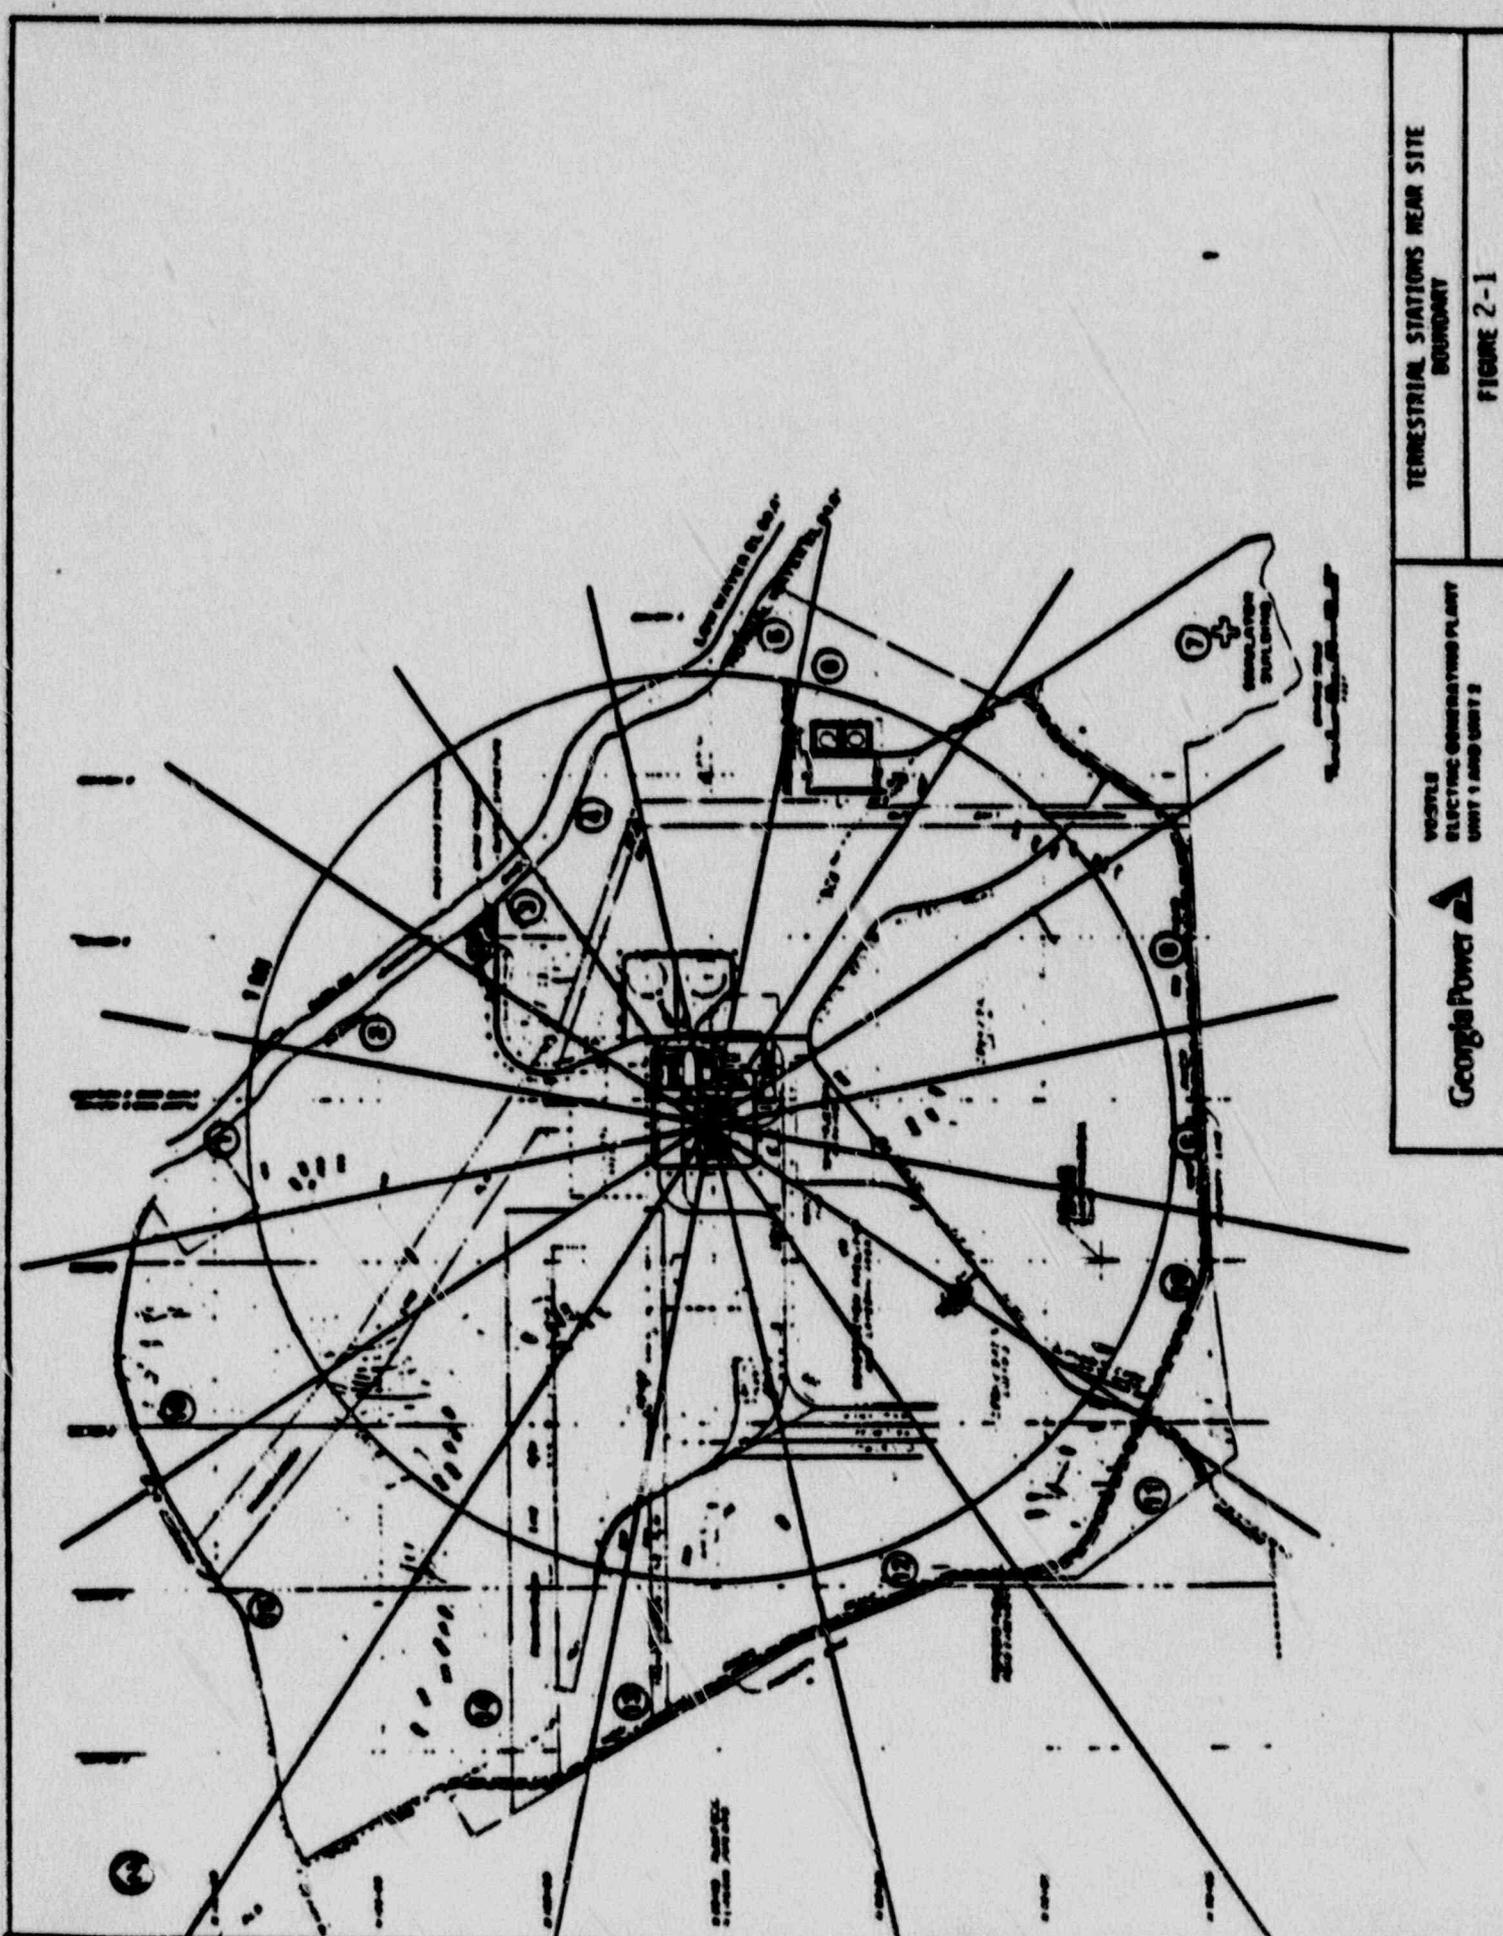
TERRESTRIAL STATIONS NEAR SITE
BOUNDARY
FIGURE 2-1

A summary description of the REMP is provided in Table 2-1. This table portrays the program in the manner by which it is being regularly carried out; it is essentially a copy of Table 3.12-1 of the TS which delineates the program's requirements. Sampling locations specified by Table 2-1 are described in Table 2-2 and are shown on maps in Figures 2-1 through 2-4. This description of the sample locations closely follows that found in the table and figures of Section 3.0 of the Offsite Dose Calculation Manual (ODCM).

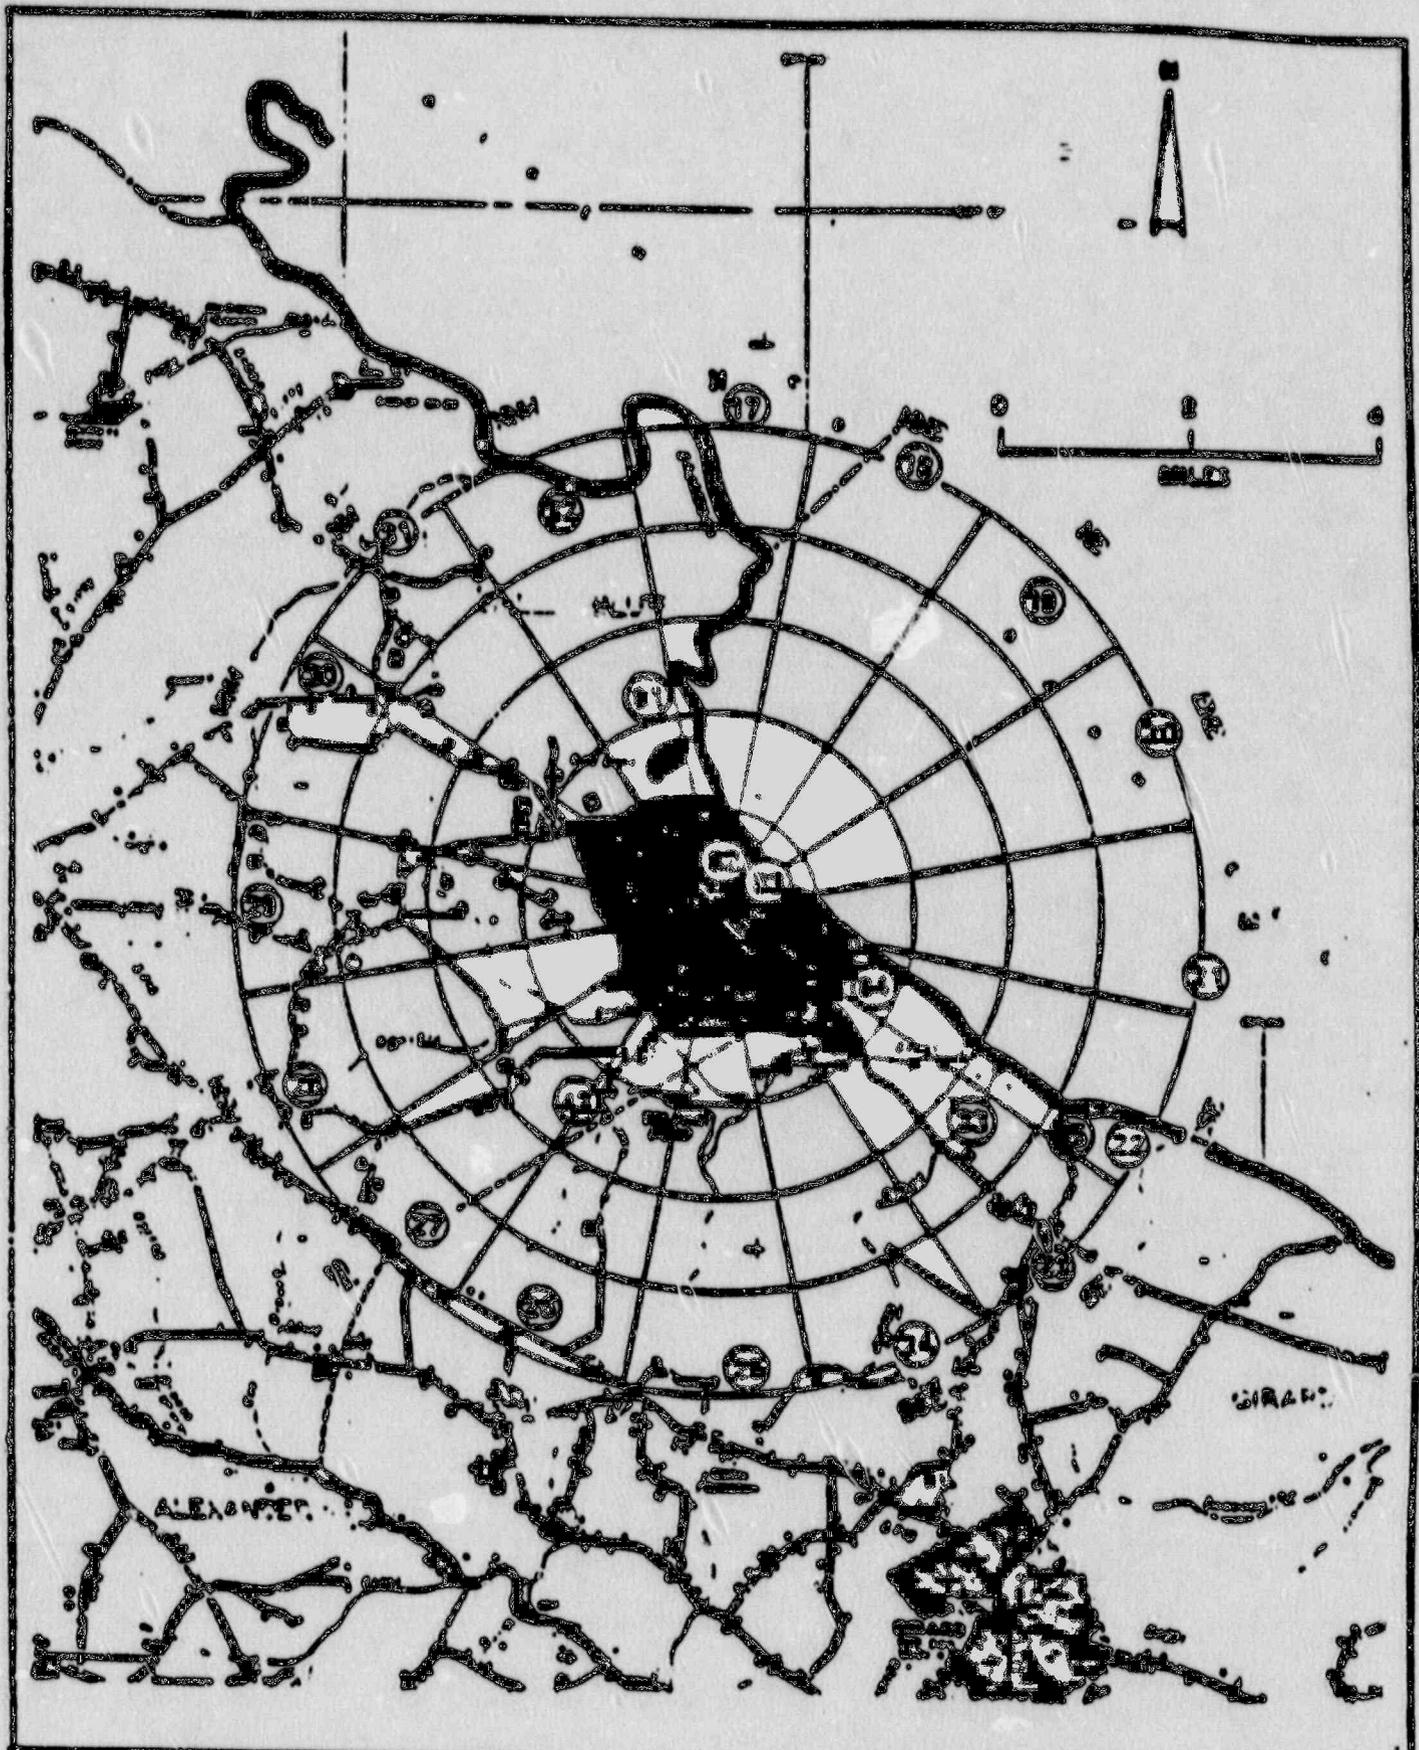
FIGURE 2-2

TERRESTRIAL STATIONS BEYOND SITE
BOUNDARY OUT TO APPROXIMATELY SIX
MILES AND RIVER STATIONS

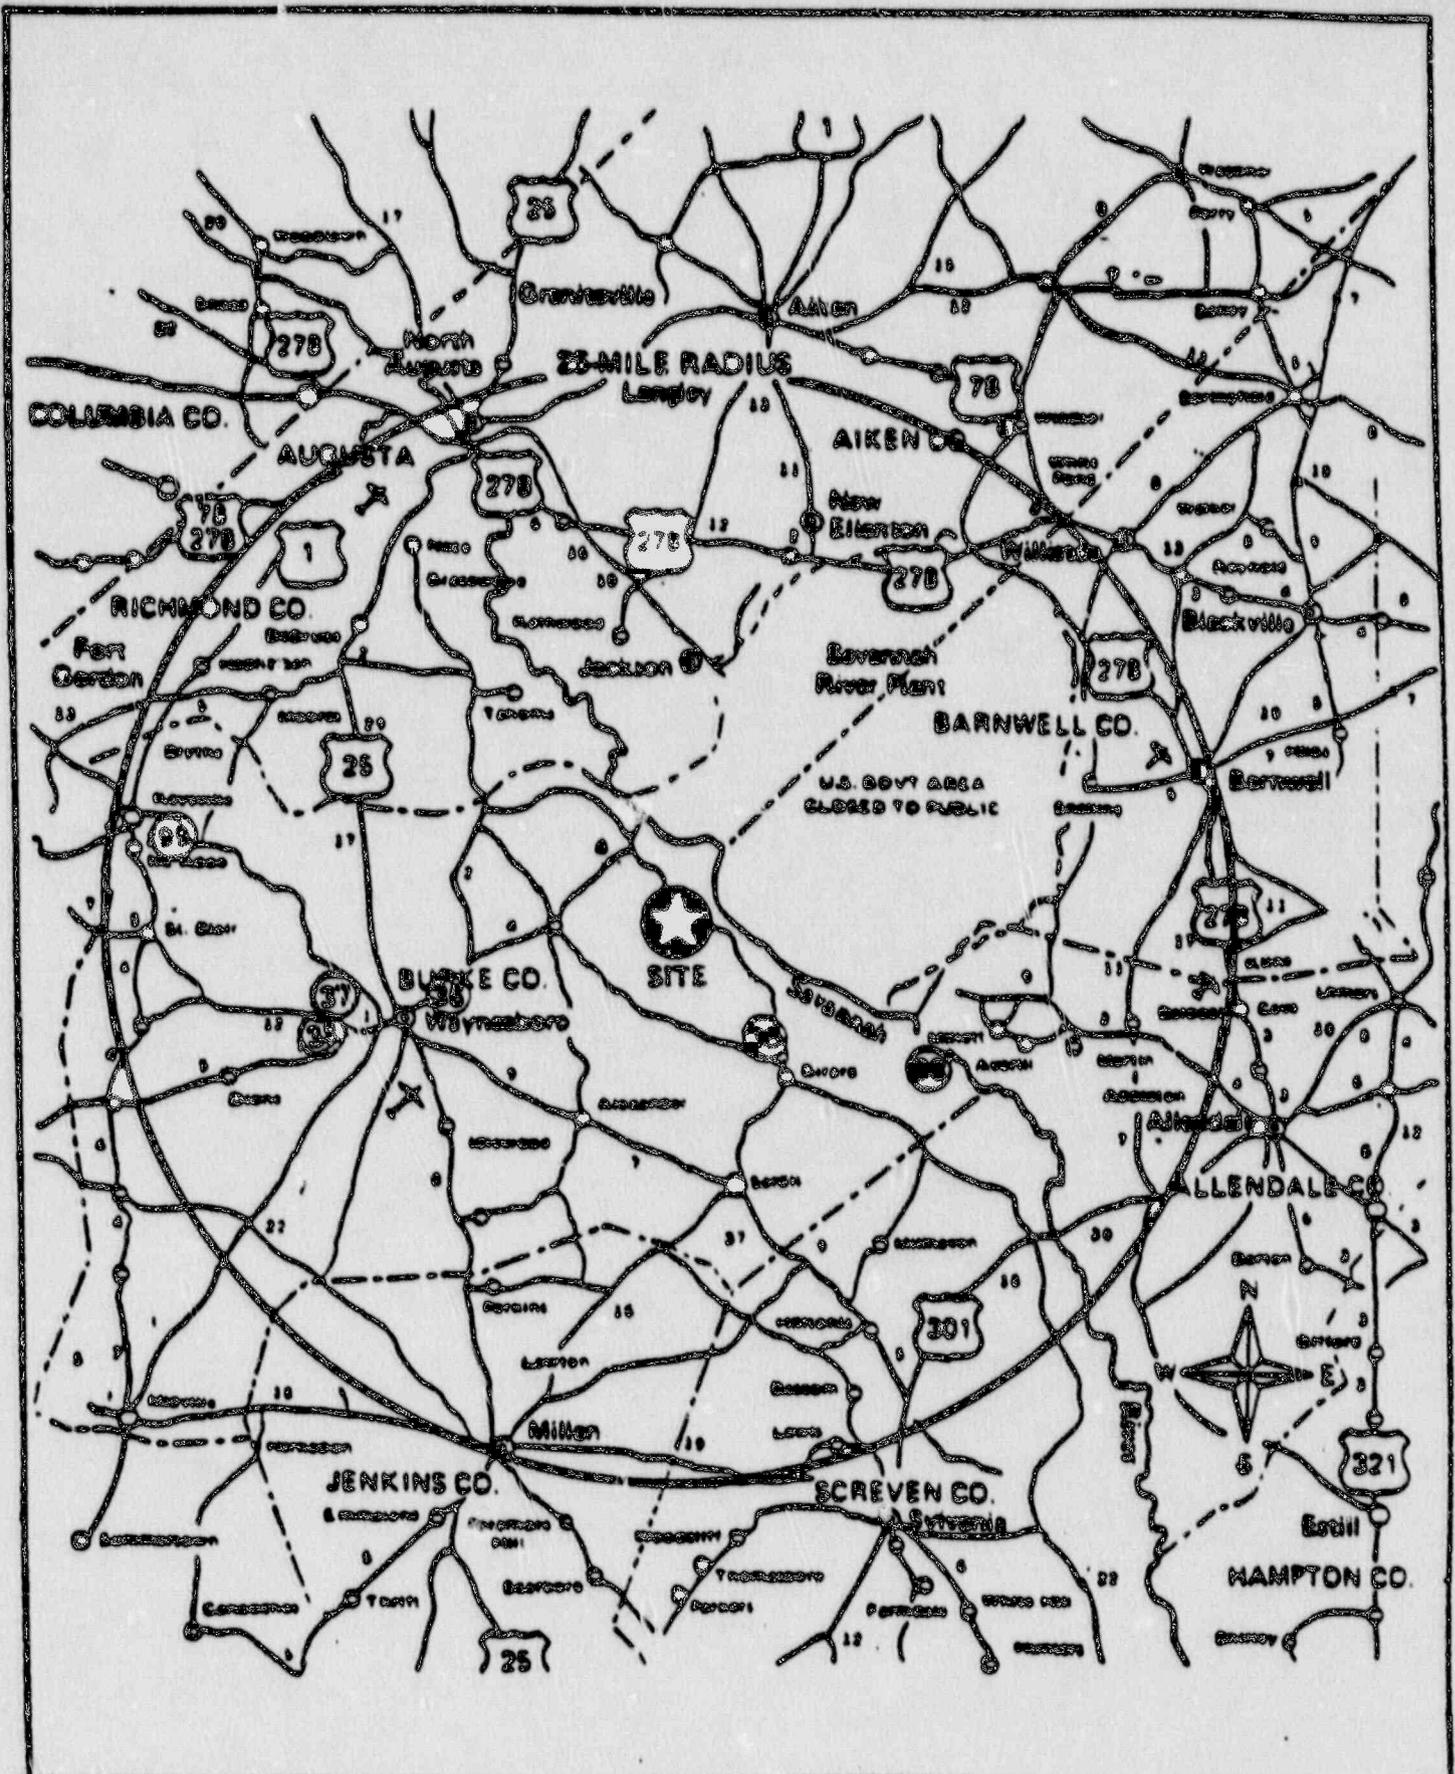
FIGURE 2-3

TERRESTRIAL STATIONS
BEYOND 6 MILES
