U.S. NUCLEAR REGULATORY COMMISSION

Report No. 90-13
90-12

Facility Name: Limerick Generating Station, Units 1 and 2

Inspection Period: March 6 - April 9, 1990

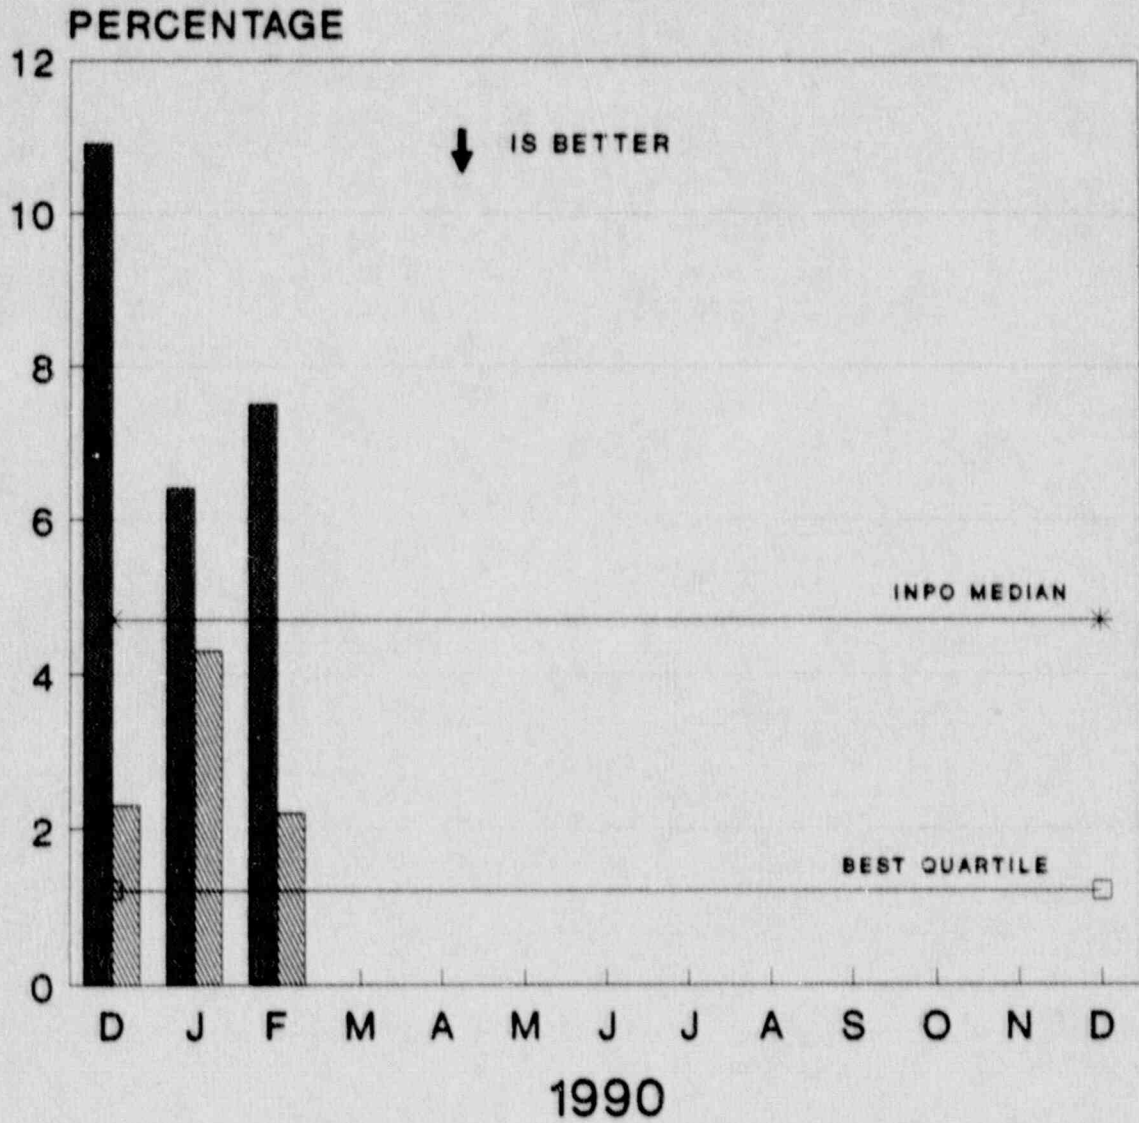
LIMERICK UNITS 1 & 2 PM OVERDUE INDICATOR

INDICATOR FOR UNIT 1
 INDICATOR FOR UNIT 2
 INPO MEDIAN
 INPO BEST QUARTILE
