NUREG/CR-6014
BNL-NUREG-52367

High Pressure Coolant Injection System Risk-Based Inspection Guide for Hatch Nuclear Power Station

Prepared by
A. M. DiBiasio

Brookhaven National Laboratory

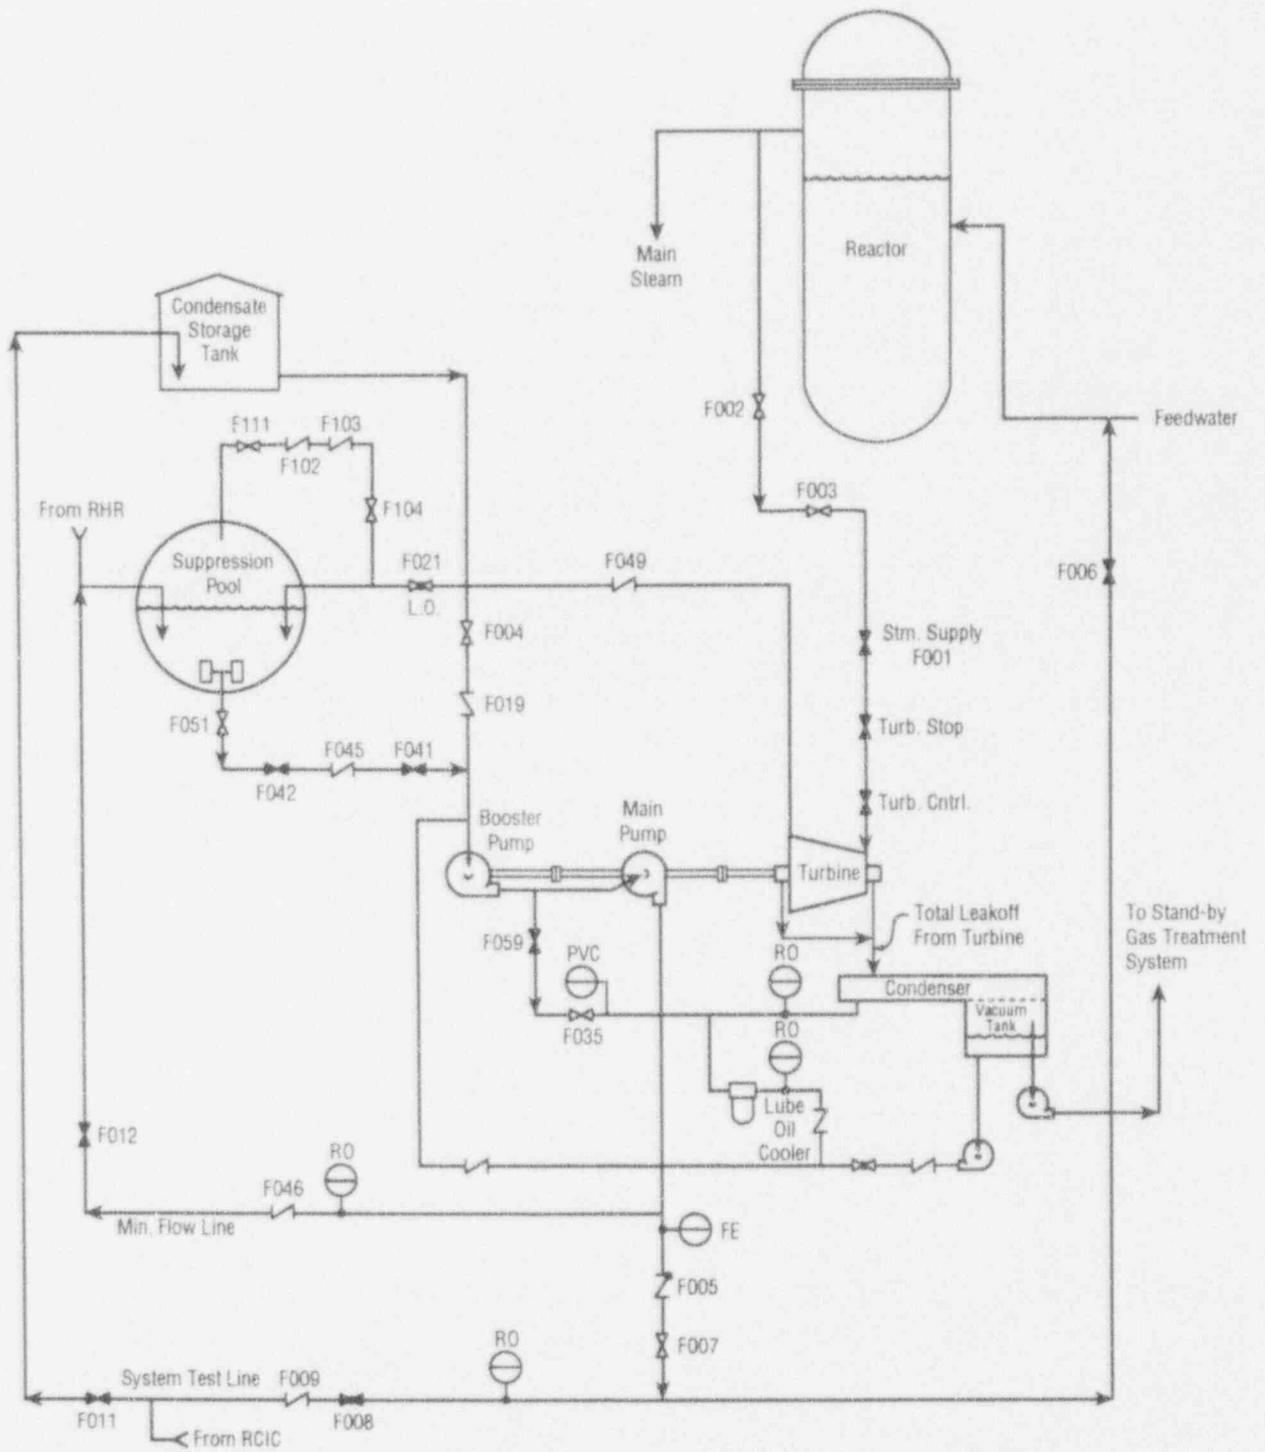
Figure 2-1 Simplified HPCI Flow Diagram

The HPCI turbine is driven by reactor steam. The inboard and outboard HPCI isolation valves in the steam line to the HPCI turbine (E41-F002 and F003) are normally open to keep the piping to the turbine at an elevated temperature, permitting rapid startup. Upon receiving a signal from the HPCI isolation logic, these valves will close and cannot be reopened until the isolation signal is cleared and the logic is reset. Inboard isolation valve E41-F002 is powered from 600/208 VAC R24-S011 and controlled by isolation logic system A; outboard isolation valve E41-F003 is powered from 125/250 VDC R24-S022 and controlled by isolation logic system B.

Steam is admitted to the HPCI turbine through supply valve E41-F001, a turbine stop valve, and a turbine control valve, all of which are normally closed and are opened by an HPCI initiation signal. Exhaust steam from the turbine is discharged to the torus, while condensed steam from the steam lines and leakage from the turbine gland seals are routed to a barometric condenser.

The Hatch High Pressure Coolant Injection (HPCI) system is a single train system consisting of steam turbine-driven injection and booster pumps, a barometric condenser, piping, supports, valves, controls, and instrumentation. A simplified flow diagram is shown in Figure 2-1. The system is designed to pump a minimum of 4250 gpm into the reactor vessel over a range of reactor pressures from 150 to 1120 psig when automatically activated on a reactor water level low (-47 inches) or drywell high pressure (1.9 psig) signal, or manually initiated from the control room. Each automatic initiation signal is "one-out-of-two-twice" logic. Two sources of injection water are available. Initially, the HPCI pump takes suction from the condensate storage tank (CST) through a normally open motor-operated valve E41-F004. The pump suction automatically transfers to the torus on low CST level or high torus level. This transfer is accomplished by a signal that opens the torus suction valves E41-F041 and F042. Once these valves are fully open, valve-position-limit switch contacts automatically close the CST suction valve. Events that raise the torus temperature above the HPCI system design limit for suction source temperature may require a manual suction transfer back to the CST.
