TRIP REPORT:
ONSITE ANALYSIS OF
THE HUMAN FACTORS OF AN EVENT
AT NORTH ANNA 2
ON APRIL 16, 1993

DISABLING AUXILIARY FEEDWATER SYSTEM
DURING REACTOR TRIP RECOVERY

Published June 1993

Idaho National Engineering Laboratory
EG&G Idaho, Inc.
P. O. Box 1625
Idaho Falls, ID 83415

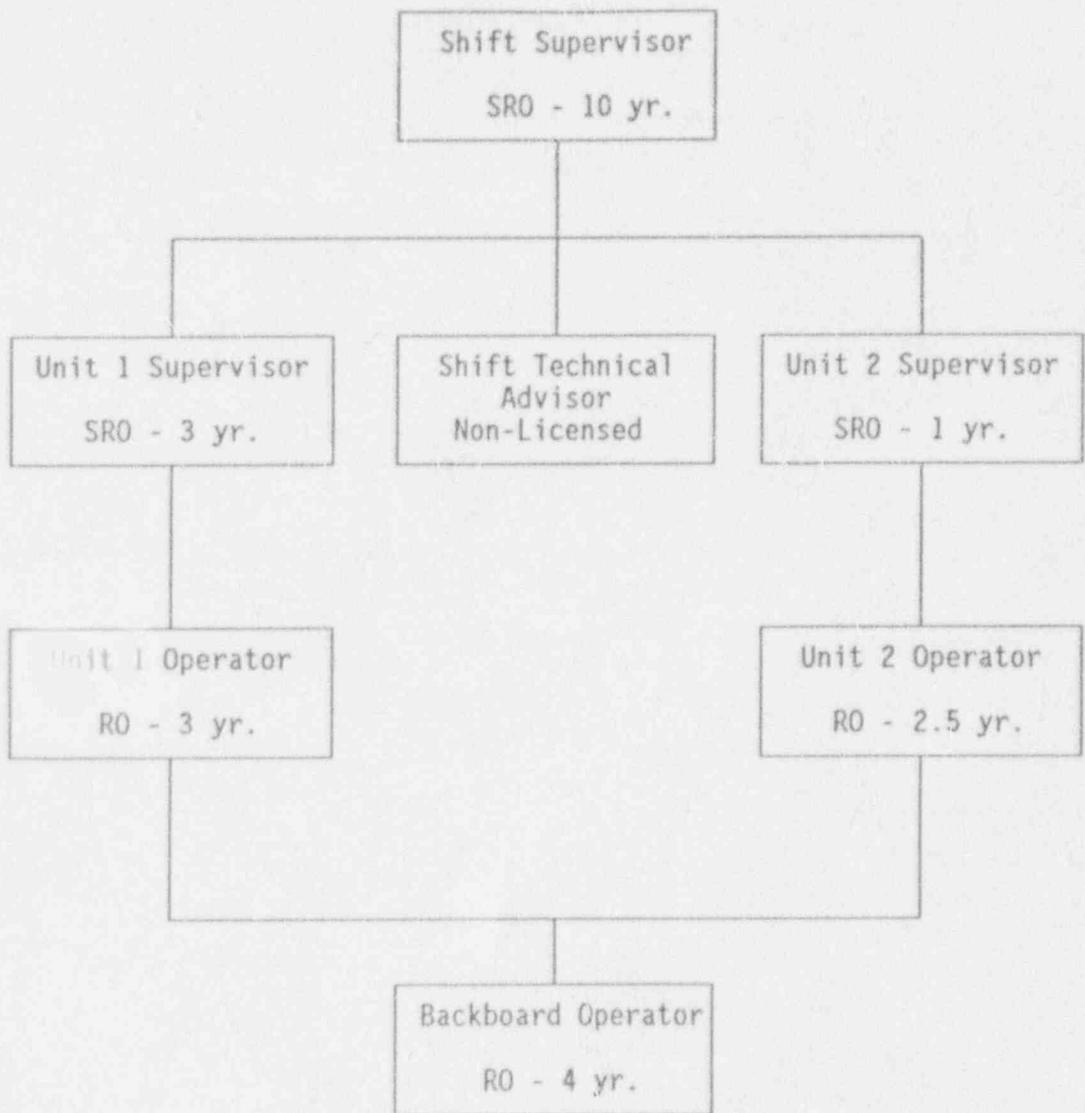
Note : The SRO and RO license periods are for North Anna and do not include any previous licensing or operating experience.

Figure 1. North Anna control room staffing (normal conditions).

On April 16, 1993, Unit 1 had reached 75% power returning from a refueling outage and Unit 2 was operating at 100% power. Crew A was on day two of their 12-hour shift schedule (7:00 am to 7:00 pm) following 6 days off. Shift manning included three senior licensed operators and three reactor operators. These personnel were assigned as shift supervisor (SS), Unit 1 supervisor, Unit 2 supervisor, Unit 1 reactor operator, Unit 2 reactor operator, and backboard operator (see Figure 1). A shift technical advisor (STA) was also assigned to the shift.

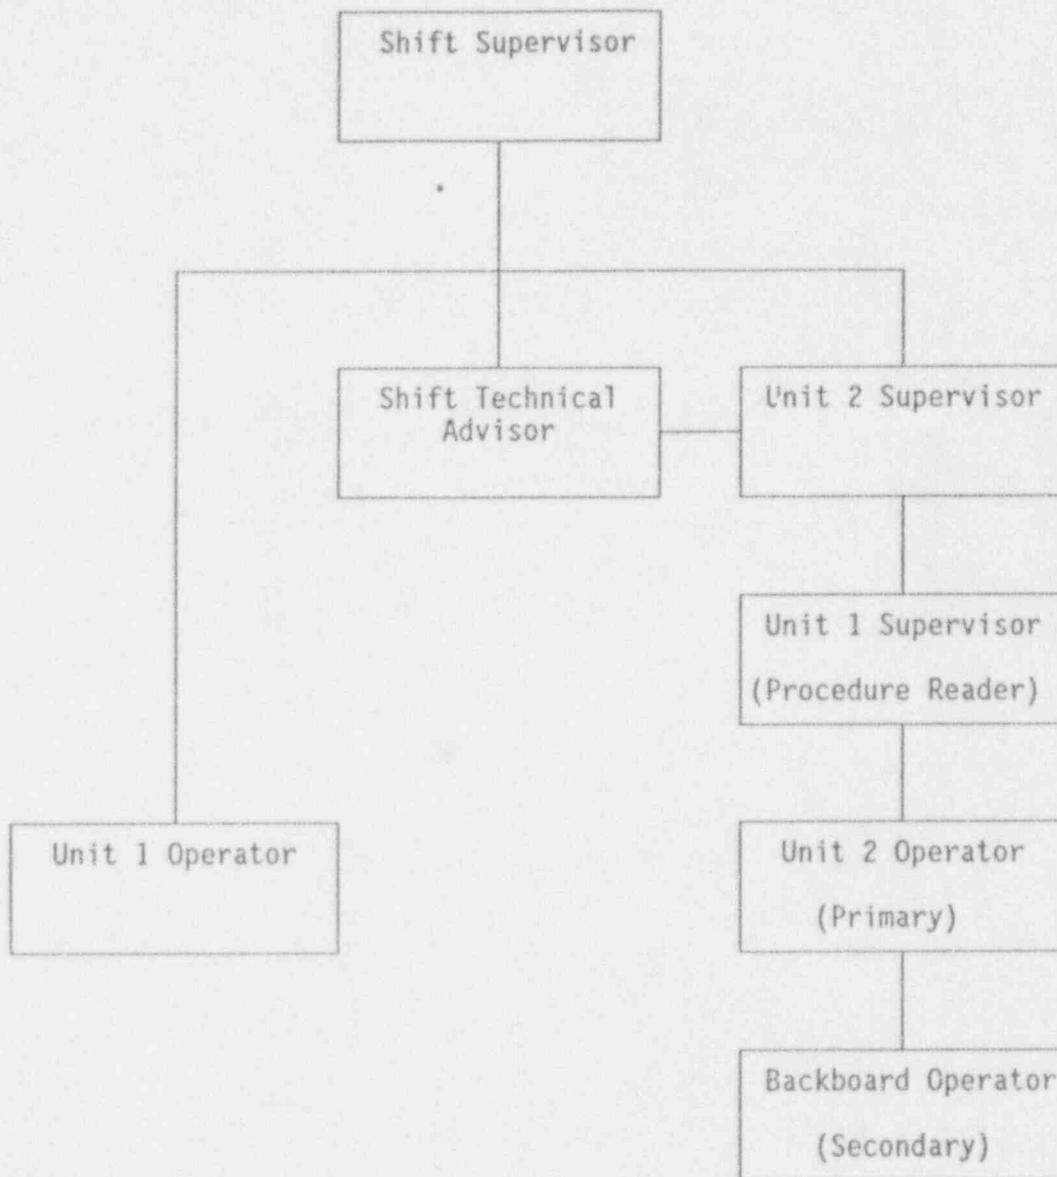
Note : Each crew has an additional qualified reactor operator assigned as a procedure writer and is available to the control room if needed.

Figure 2. North Anna control room organization (Unit 2 event).

room to assume procedure reader responsibilities (see Figure 2). The backboard operator was on the Unit 1 side of the control room in anticipation of assisting with feedwater control because of problems experienced with flow oscillations. He immediately went to the Unit 2 side to assume secondary plant responsibilities following the reactor trip. No safety injection had occurred, and the crew exited Procedure 2-E-0 at Step 4 and transitioned to Procedure 2-ES-0.1, Reactor Trip Response. It was at this point the SS, other crew members, and some dayshift personnel entered the control room to assist.

The control room crew had two recent additions. The Unit 2 operator had joined the crew just 2 months prior to the event and the Unit 1 supervisor had just returned from outage-related duties. The new group had trained together on startup activities before this event. Looking at Figure 2, the chain of command appears relatively clear. However, complications developed during the reactor trip recovery when the SS became involved in directing actions on the unit in the turbine building and the unit supervisor communicated directions directly to the primary and secondary operators. The position of procedure reader was bypassed during these instances, specifically when directions were given for AFW and main feedwater, providing no backup or check against written procedure requirements.
