# NORTHEAST UTILITIES

Reference: Facility Operating License No. DPR-65  
Docket No. 50-336  
Licensee Event Report 93-012-01

LICENSEE EVENT REPORT (LER)

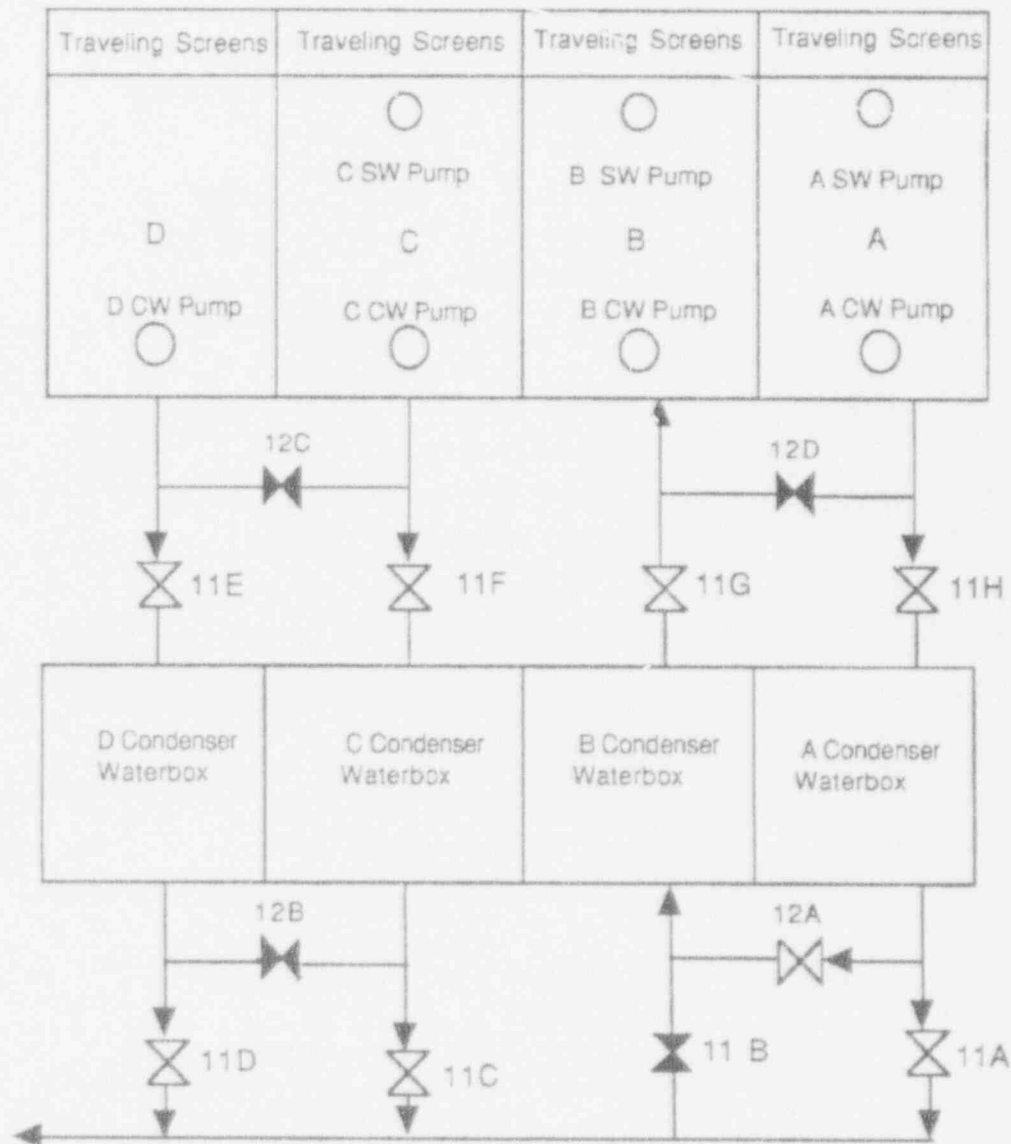
MUSSEL COOK (THERMAL BACKWASH) LINEUP

To Discharge Canal

\* Throttle 11A to maintain inlet temperature of 'B'  
Circulating waterbox between 110 - 120 F.

- The reactor trip was caused by a turbine trip. The root cause of the turbine trip was the lack of heat removal capabilities from the Main Generator Stator Water Cooling System. The warm water being discharged through the 'B' circulating water pump into the 'B' intake bay was being recirculated to the 'A' and 'C' intake bays, causing an increased service water temperatures. The tide was a significant factor in the high service water temperature. The low incoming tide allowed the 'B' intake bay's high temperature to cause an aggravated effect on the adjacent bays. Some temperature stratification in the adjacent bays has been observed on previous mussel cooks. The low tide placed the higher temperature water at the suction of the Service Water pumps.

On the 'B' feedwater regulating valve, a calibration of the positioner and the position indication circuit was performed. The valve was stroked from the Control Room to verify the stroke and the position indicator. The valve was verified satisfactory.
- Upon mussel cook restoration, the Service Water temperature decreased to its normal value. To prevent recurrence of this condition, procedure changes have been made to secure mussel cooking if RBCCW temperature reaches greater than 83 degrees Fahrenheit.
