U.S. Nuclear Regulatory Commission Accident Sequence Precursor Program 2019 Annual Report

February 2020

**Performance and Reliability Branch
Division of Risk Analysis
Office of Nuclear Regulatory Research
U.S. Nuclear Regulatory Commission
Washington, DC 20555-0001**

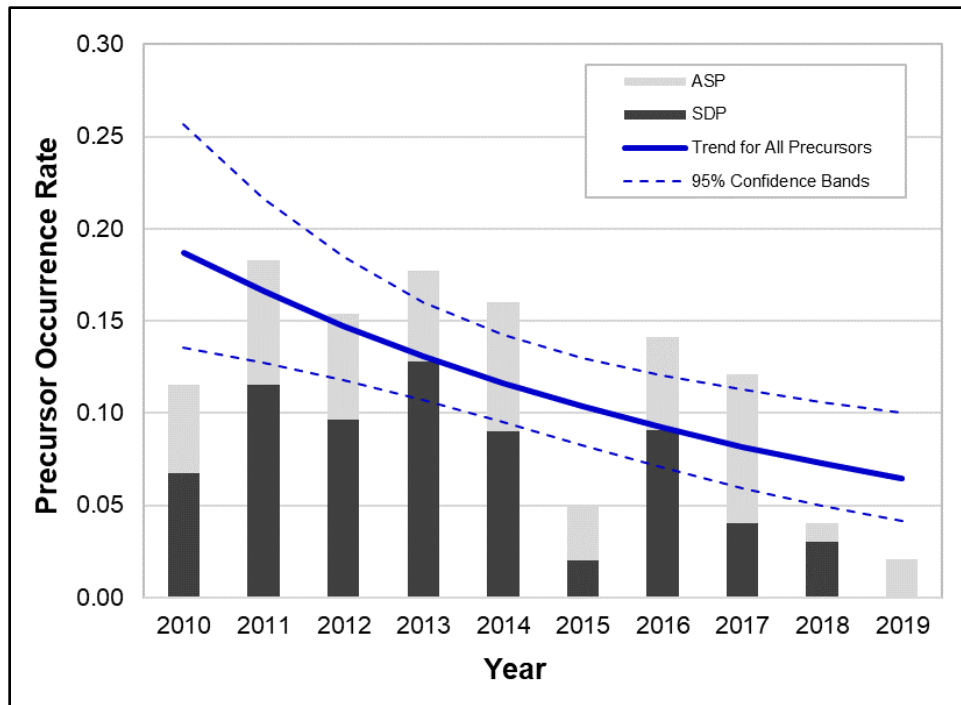
⁴ For figures with statistically significant trends, the solid line is the fitted occurrence rate of precursor using a Poisson process model. The dashed lines represent the 90-percent confidence band for the fitted occurrence rate.

Figure 1. Occurrence rate of all precursors

- *Trend.* Over the past decade (2010–2019), the mean occurrence rate of all precursors exhibits a statistically significant decreasing trend (*p-value* = 0.0003).⁵ See [Figure 1](#) for additional information. A figure containing the historical precursor occurrence rates is provided in Appendix B of the [ASP Program Summary Description](#) (ADAMS Accession No. ML20049G020).

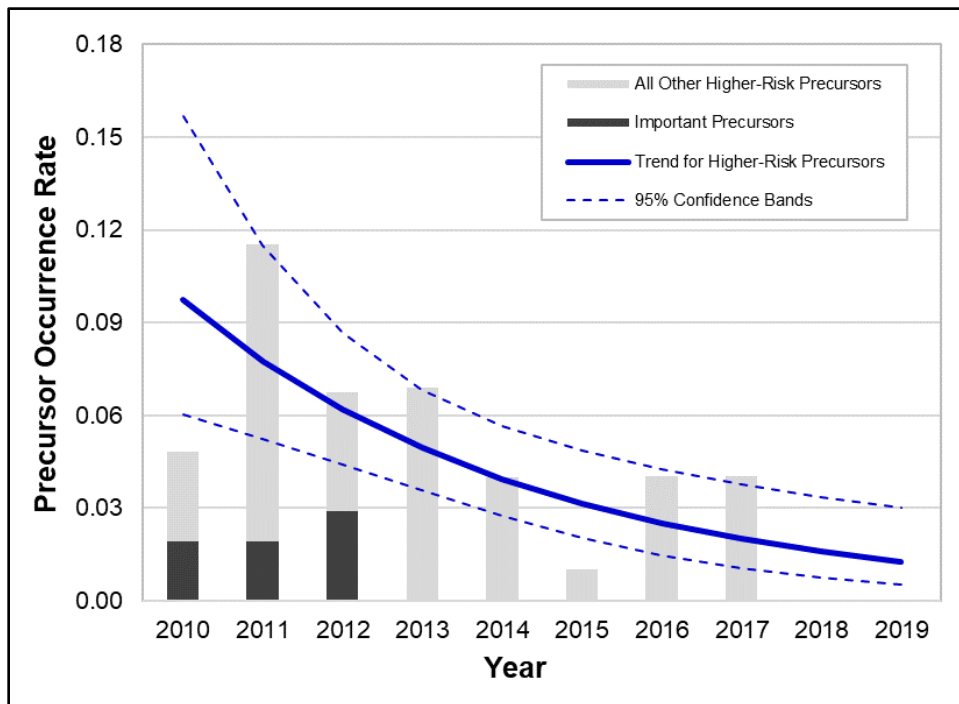
Figure 2. Occurrence rate of all higher-risk precursors

- *Trends.* Over the past decade (2010–2019), the mean occurrence rate of precursors with a CCDP or Δ CDP greater than or equal to 10^{-5} exhibits a statistically significant decreasing trend (p -value = 0.00006). See [Figure 2](#) for additional information. In addition, the mean occurrence rate of *important* precursors exhibits a statistically significant decreasing trend (p -value = 0.0008).

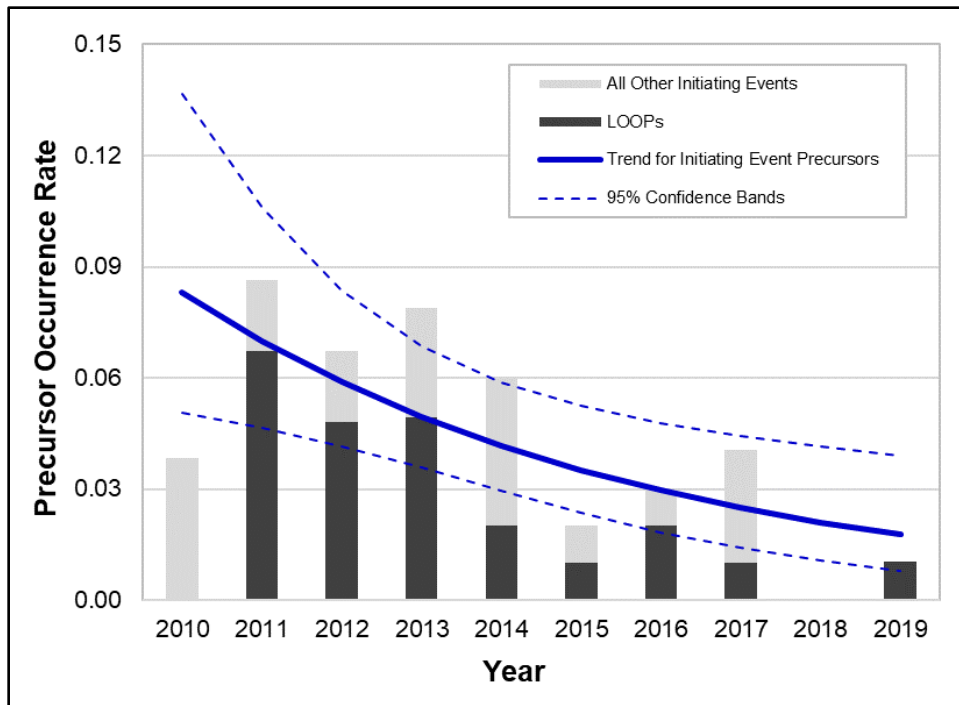
Figure 3. Occurrence rate of precursors involving an initiating event

- *Trend.* Over the past decade (2010–2019), the mean occurrence rates of precursors involving initiating events exhibits a statistically significant decreasing trend (p -value = 0.002). See [Figure 3](#) for additional information.

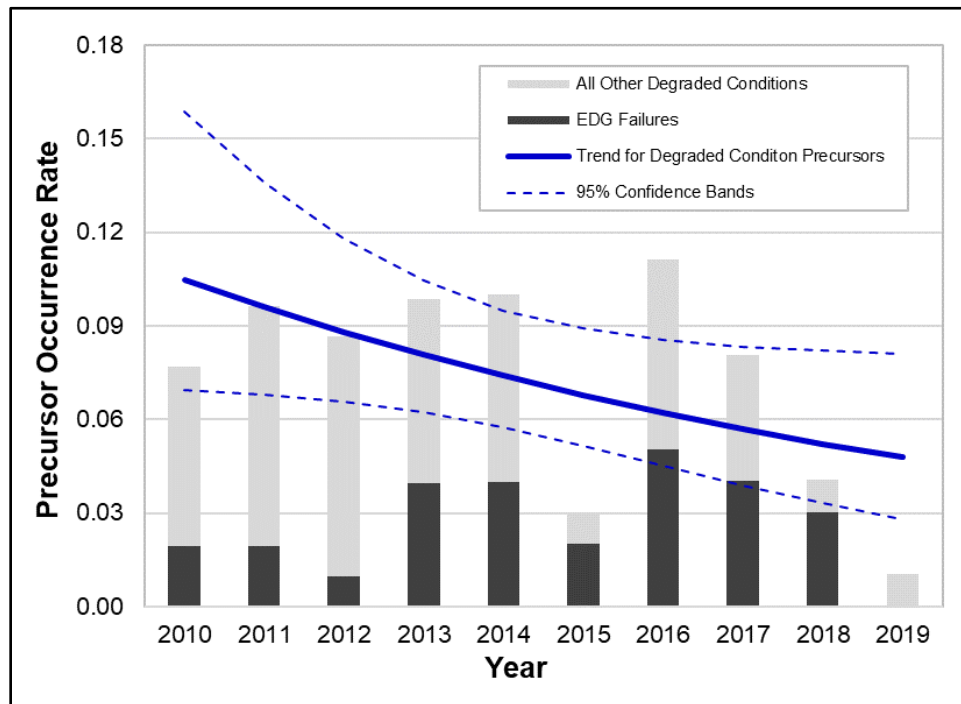
Figure 4. Occurrence rate of precursors involving degraded condition(s)

- *Trend.* The mean occurrence rates of precursors involving degraded condition(s) exhibits a statistically significant decreasing trend (p -value = 0.03). See [Figure 4](#) for additional information.

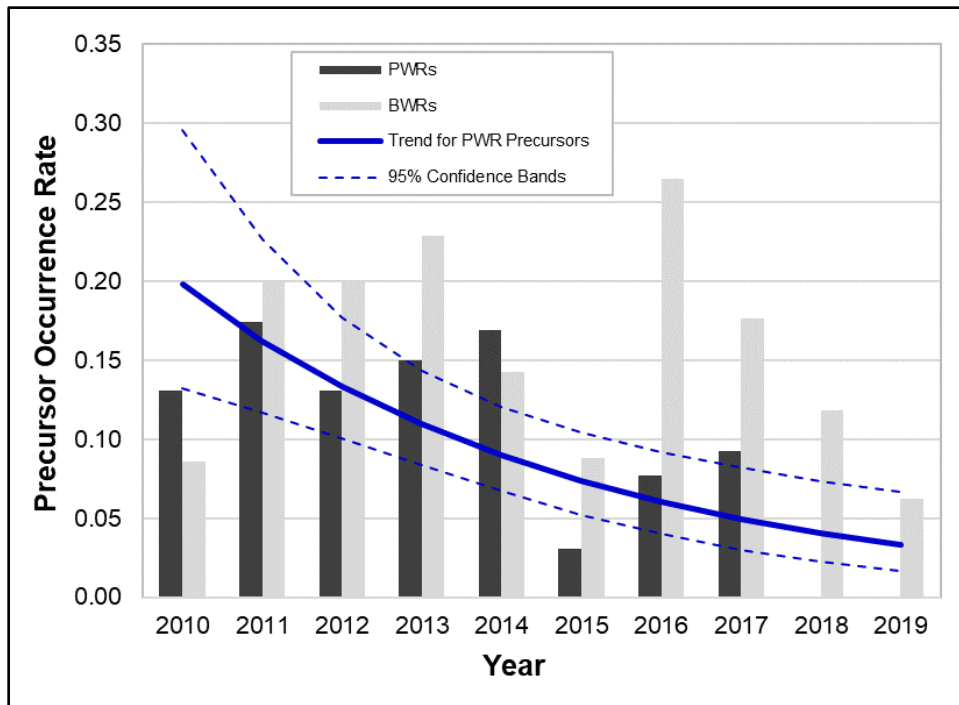
Figure 5. Occurrence rates of precursors at BWRs and PWRs

- *Trends.* The mean occurrence rates of precursors that occurred at BWRs does not exhibit a statistically significant trend (p -value = 0.5).¹² However, there is a statistically significant decreasing trend (p -value = 0.0002) for the mean occurrence rate of precursors that occurred at PWRs. See [Figure 5](#) for additional information. *LOOPS by Plant Type.* Of the 19 precursors involving initiating events at BWRs, 12 precursors (63 percent) were complete LOOP events. Of the 25 precursors involving initiating events at PWRs, 12 precursors (48 percent) were complete LOOP events.

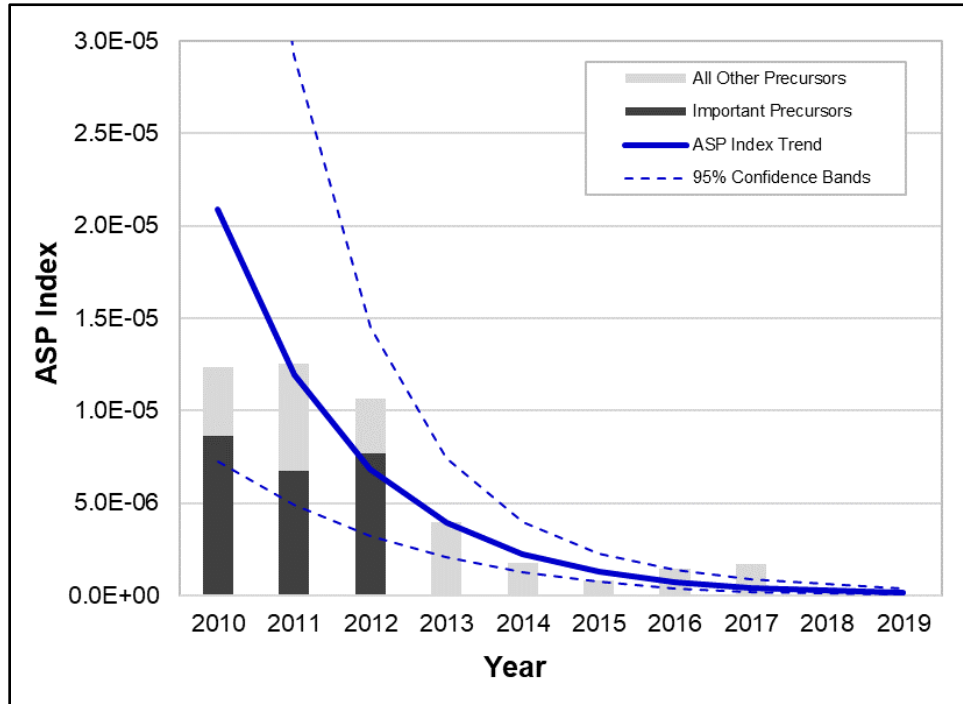
Figure 6. Integrated ASP index

- *Trends.* The integrated ASP index exhibits a statistically significant decreasing trend (p -value = 0.0001).¹³ This trend is largely influenced by the seven precursors with CCDP or Δ CDP greater than or equal to 10^{-4} that occurred in the 2010–2012 period. See [Figure 6](#) for

¹³ A log-linear regression was used for the trend analysis of the integrated ASP index.

- *Insights.* The total risk associated with precursors (118 total precursors) is dominated by 7 important precursors, which account for approximately 51 percent of the total risk due to all precursors. The other 111 precursors account for approximately 49 percent to the total risk due to all precursors.
- *Limitations.* Unlike the trend analyses performed on various precursor groups that are focused on the occurrence rate of precursors, the integrated ASP index is focused on the total risk due to all precursors. It is important to note that precursors evaluated by an independent ASP analysis or an SDP evaluation are limited to a 1-year exposure period. Therefore, the integrated ASP index provides a unique way to evaluate the total risk effect of longer-term degraded conditions that is not fully captured in the individual analyses.
