UNITED STATES OF AMERICA
NUCLEAR REGULATORY COMMISSION

(Shoreham Nuclear Power Station,)
Unit 1))

PREPARED DIRECT TESTIMONY OF
RICHARD B. HUBBARD
ON BEHALF OF SUFFOLK COUNTY

QUALITY ASSURANCE/QUALITY CONTROL

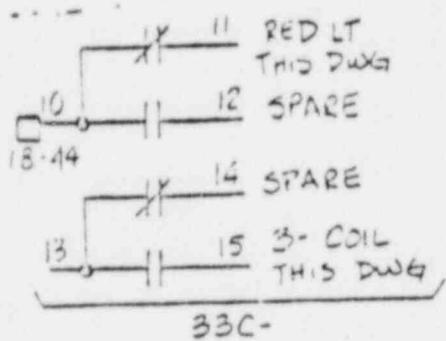
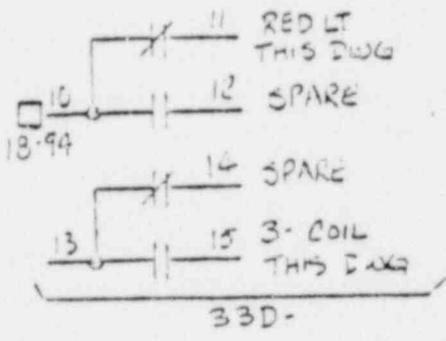
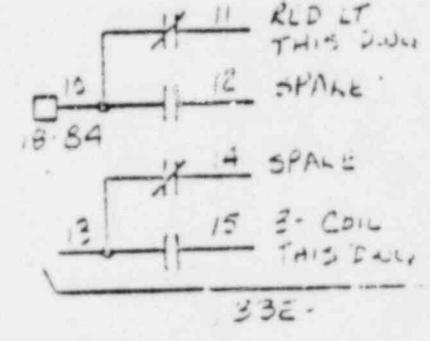
CCF 821/1

- NOTES:
1. APPLICABLE LOGIC: NONE
 2. # R B DENISON INC, PROXSWITCH, MODEL WE-77/E
 3. ## REFERENCE ANDERSON, GREENWOOD & CO. DRAWING 0A-3553 (J&W NO 6.53-B)
 4. LETTERS IN PARENTHESIS ARE ANDERSON, GREENWOOD & CO., IDENTIFICATION
