COMMONWEALTH EDISON COMPANY
QUAD-CITIES NUCLEAR POWER STATION
UNITS 1 and 2

SPECIAL REPORT

LOSS OF AUXILIARY ELECTRICAL POWER
EVENT OF JUNE 22, 1982

NRC DOCKET NOS. 50-254 and 50-265

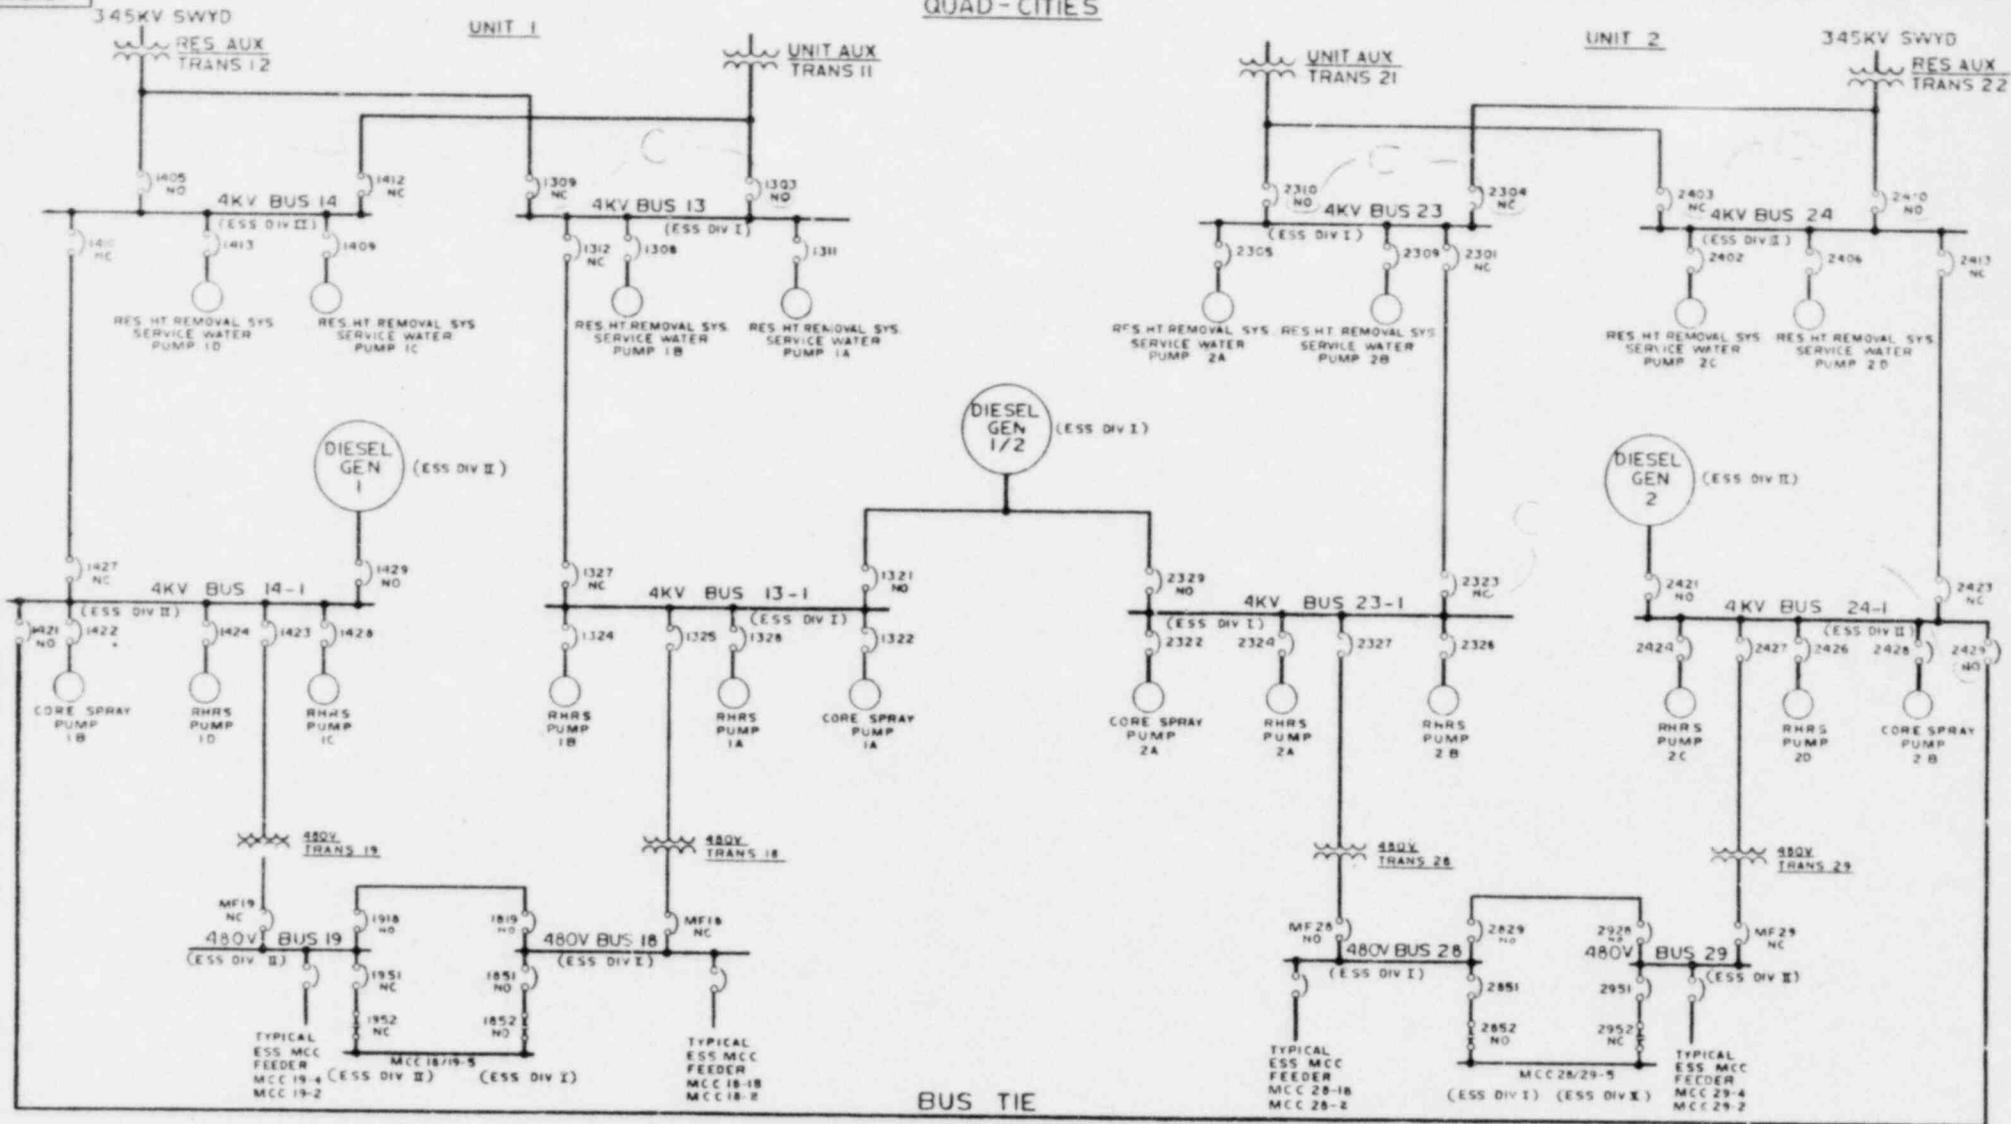
BUS TIE

NUCLEAR SAFETY RELATED EQUIPMENT IS SHOWN ON THIS DRAWING.

1. Single Line Diagram - Emergency Power System
2. LER/RO 82-12/OIT-0
3. Response to NRC I.E. Bulletin 79-27
4. Unit 2 Essential Service UPS Block Diagram and System Description

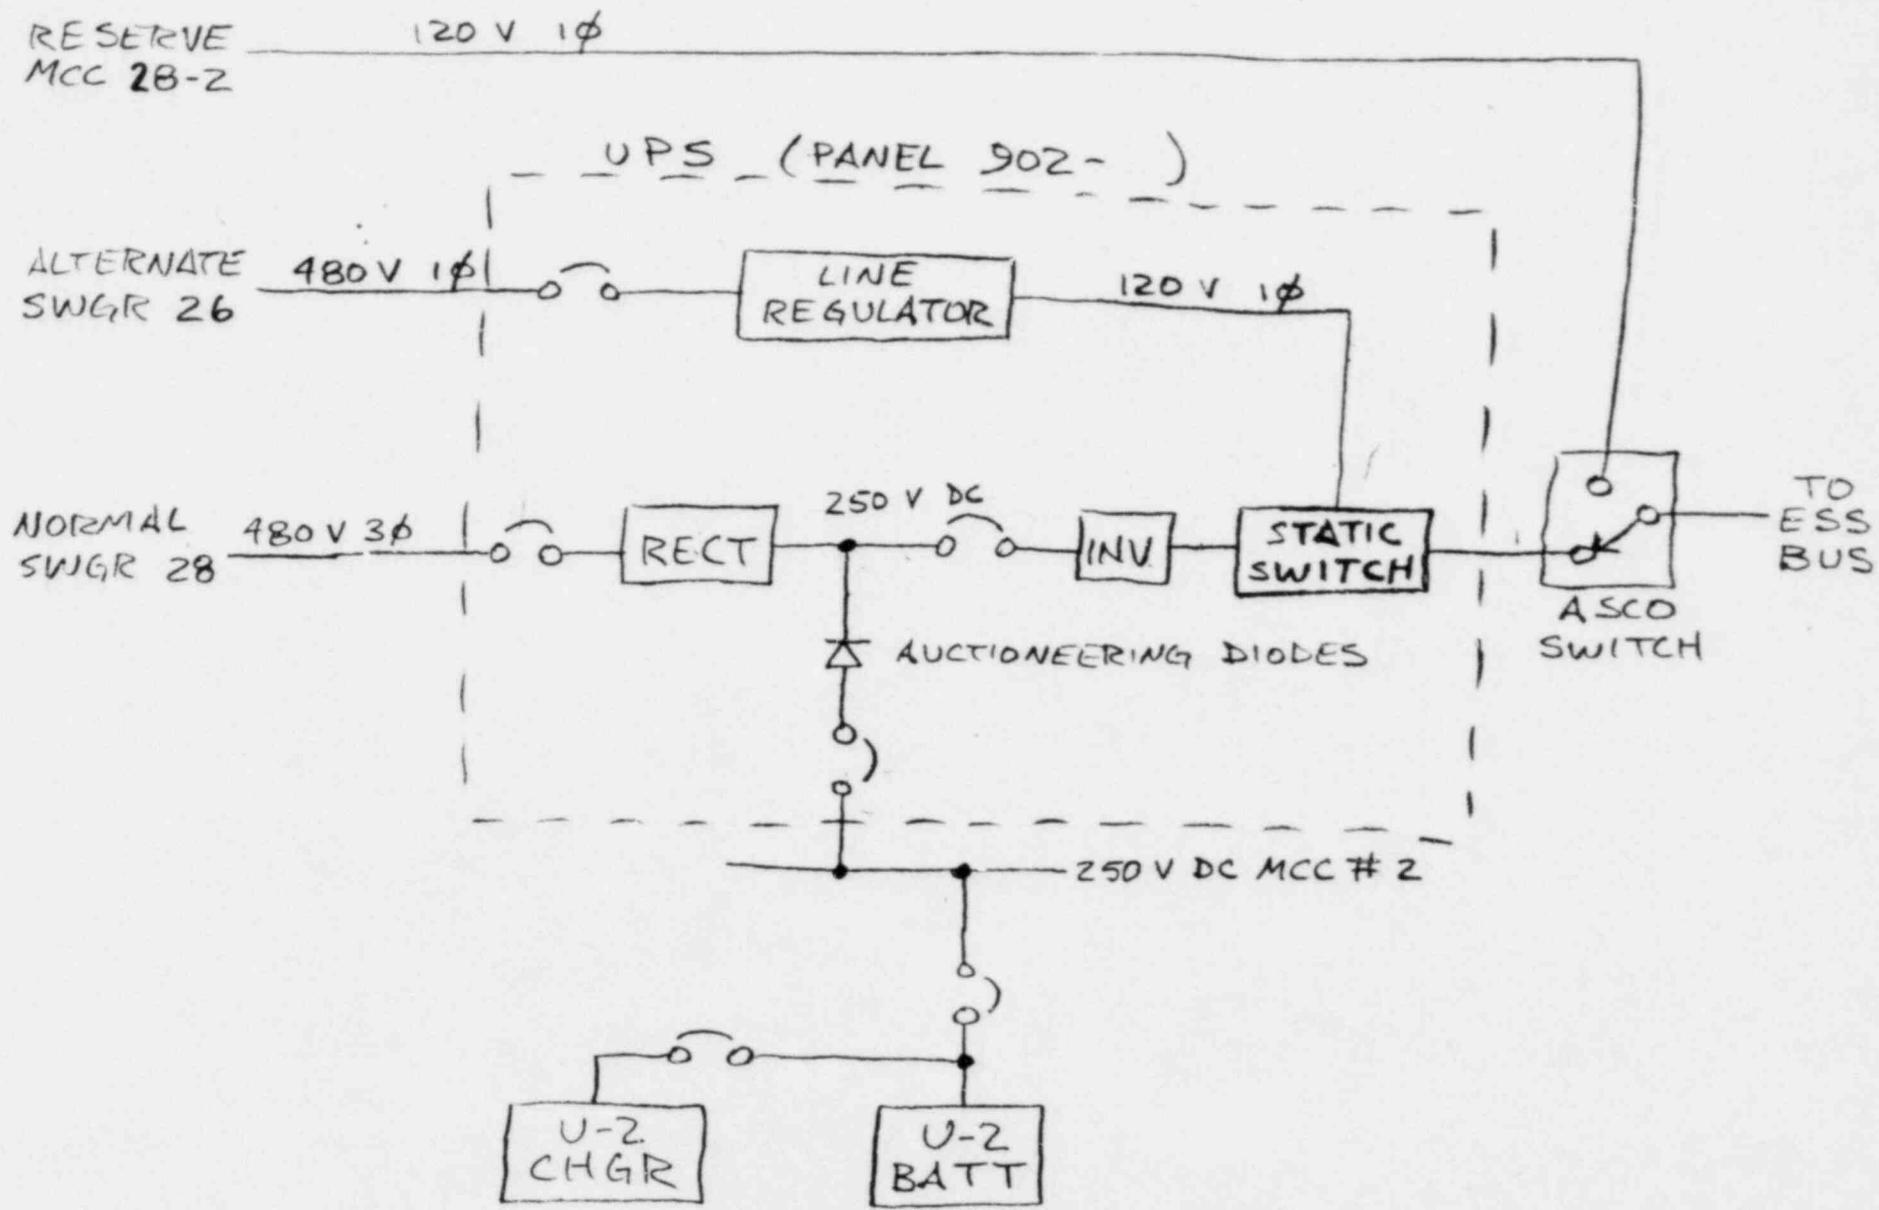
UNIT 2 ESSENTIAL SERVICE UNINTERRUPTIBLE POWER SUPPLY BLOCK DIAGRAM

Unit 2 Essential Service System Description

A total loss of ESS for a sustained period of time is very unlikely due to the diverse backup power sources available, and the reliability of these sources. These sources are switched over automatically, and the bus is intended to remain in continuous service even if all other sources of A.C. electrical power (including the diesel generators) should fail. Both A.C. power supplies came from an emergency 480 V bus, supplied by a Diesel Generator. The 250 VDC source is reliable, since it comes from the Station Battery System.
