Docket No. 50-213
B14507

Haddam Neck Plant
Proposed Revision to Technical Specifications
Reactor Coolant Pump Flywheel Surveillance

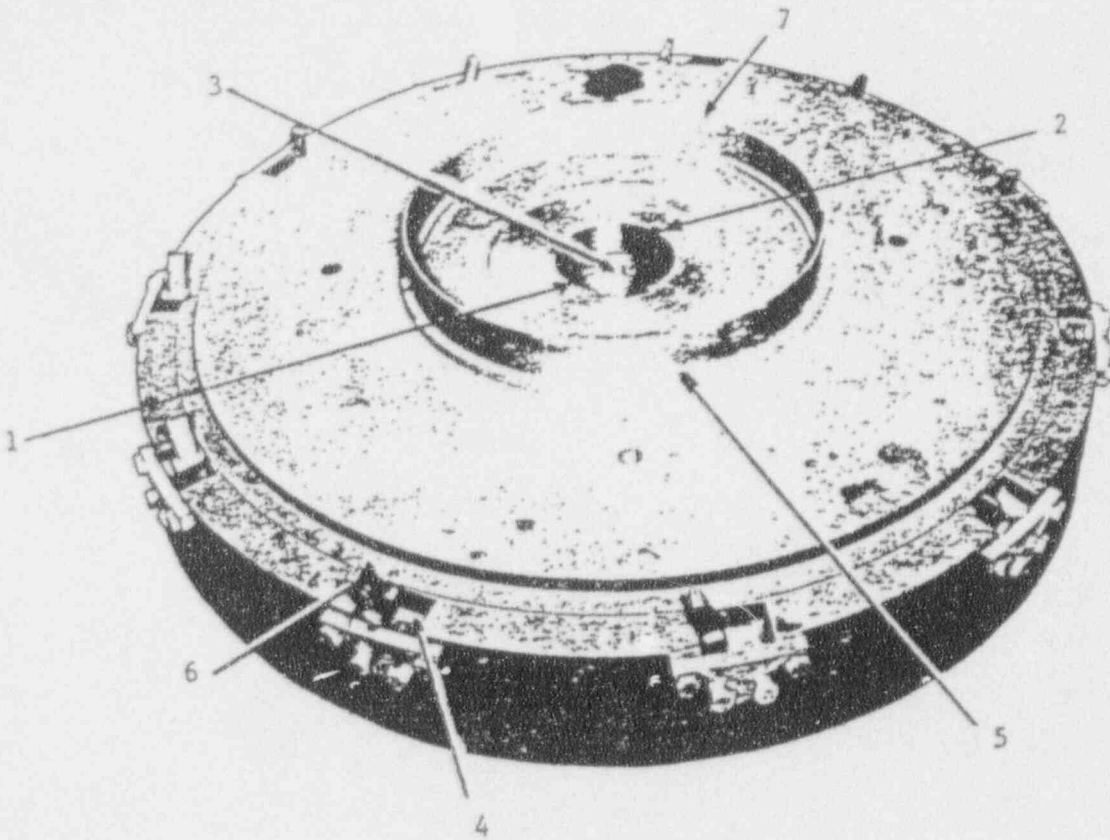
FIGURE 1 FLYWHEEL AREAS/PARTS

Bottom View of Flywheel

Critical Areas/Parts

Currently, Technical Specification Surveillance Requirement 4.4.10 identifies Regulatory Guide (RG) 1.14,⁽¹⁾ as providing the criteria for the inspections of the reactor coolant pump (RCP) flywheels at the Haddam Neck Plant. This RG recommends volumetric and surface examinations on different areas of the RCP flywheels at varied inspection frequencies. In order to satisfy these recommendations, CYAPCO has established an examination schedule which requires that at least two flywheels be examined during each refueling outage. An illustration of the RCP flywheel is provided in Figure 1 for your information. This figure details both critical and noncritical areas of the RCP flywheel.
