Pacific Gas and Electric Company

Re: Docket No. 50-275, OL-DPR-80
Docket No. 50-323, OL-DPR-82
Diablo Canyon Units 1 and 2
Licensee Event Report 1-92-006-01
Diesel Fuel Oil Transfer System Degradation due to General
Corrosion

LICENSEE EVENT REPORT (LER)

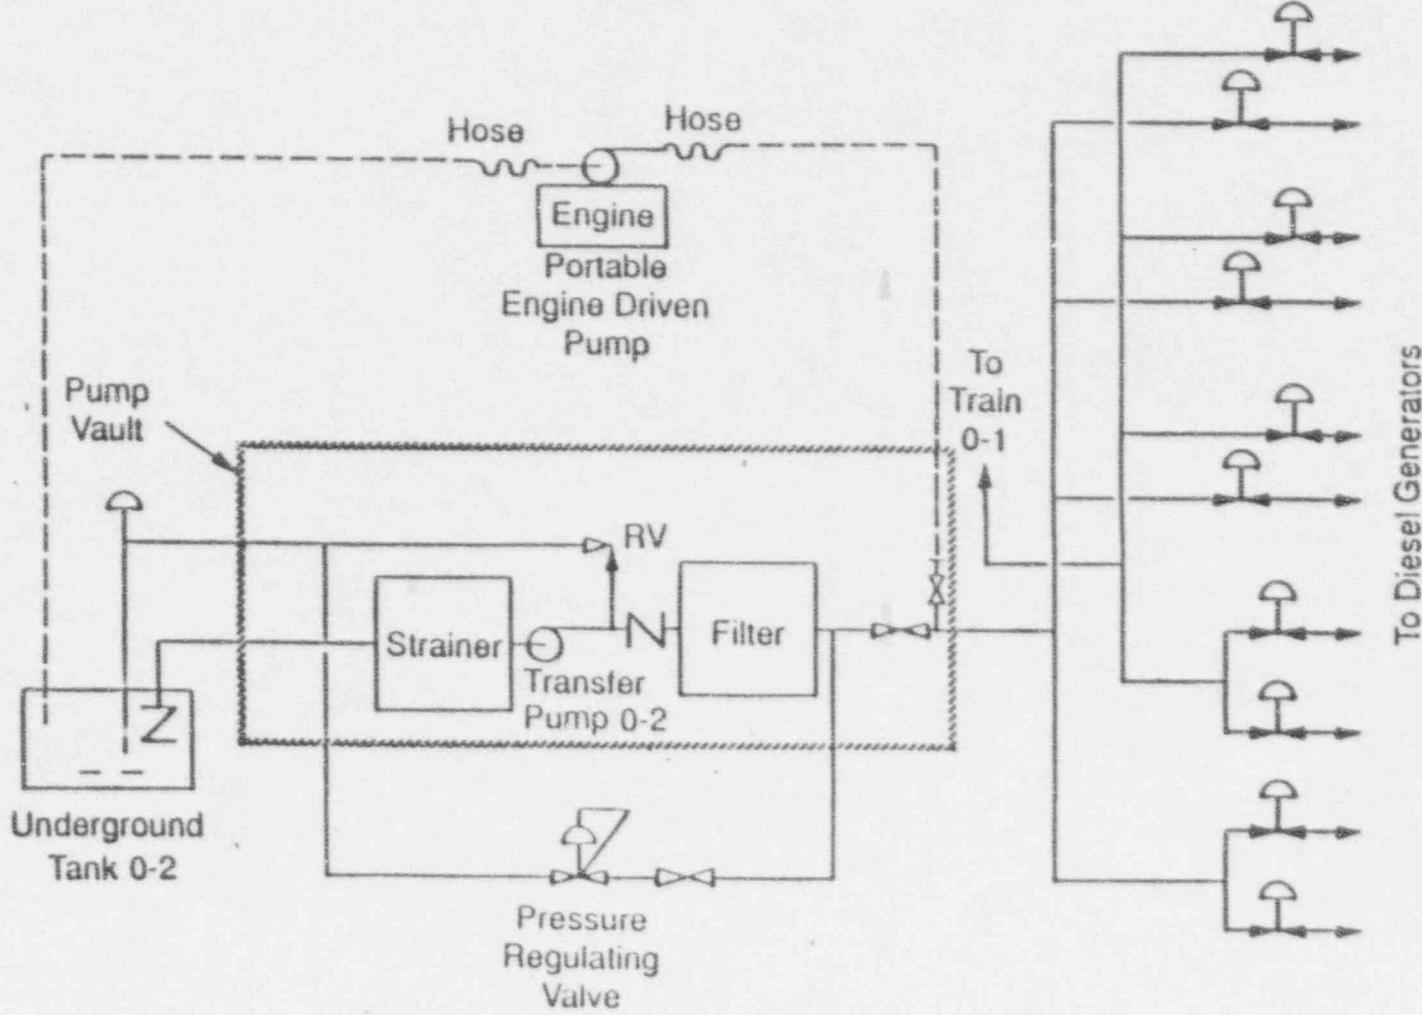
Figure 1
DFO Transfer System

Diesel Fuel Oil Transfer System

The DFO system supplies fuel oil to the Units 1 and 2 EDGs. There are two redundant DFO pipe trains, 0-1 and 0-2. These two trains each consist of a 40,000 gallon underground DFO storage tank (DE)(TK), a fuel oil transfer pump (DE)(P), and associated piping, filters (DE)(FLT), and valves (DE)(V) (refer to Figure 1).
