NUREG/CR-5812
BNL-NUREG-52309

Managing Aging in Nuclear Power Plants: Insights From NRC Maintenance Team Inspection Reports

Prepared by
A. Fresco, M. Subudhi, W. Gunther, E. Grove, J. Taylor

Brookhaven National Laboratory

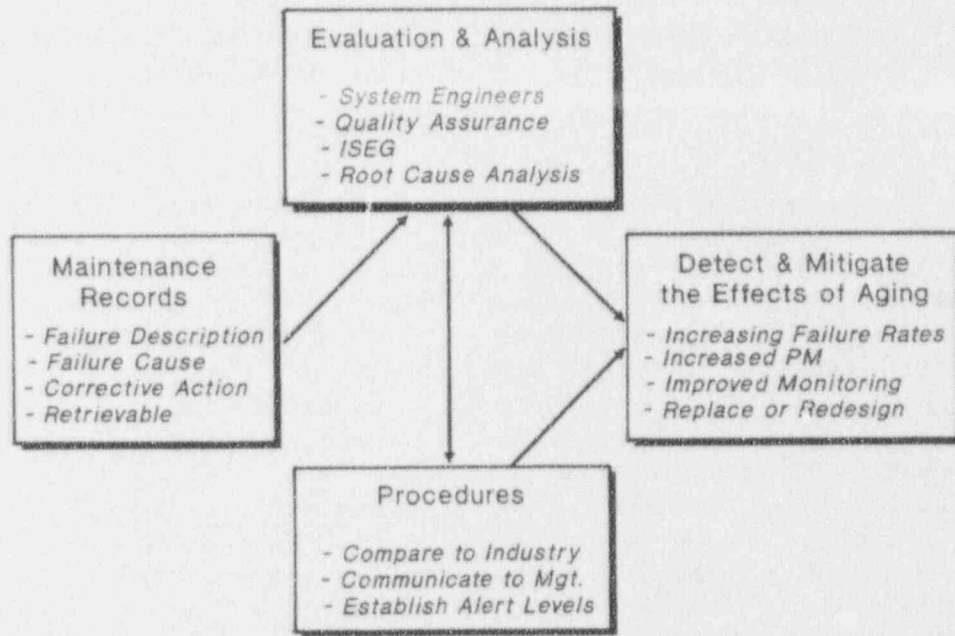
Figure 3.1. Trending program for managing aging

One of the methods for managing the aging of critical components and systems is to monitor their performance by evaluating the statistical pattern of performance indicators or component failures over a period of time. These performance indicators can be derived from records of certain plant activities, such as deficiency reports, maintenance and test evaluation reports, total job management records, maintenance work requests, and component/system functional parameters. If sufficient statistical data are available, then surveillance, preventive maintenance, or replacement can be sched-

uled more effectively on the basis of performance or functional indicators and failure trends.
