UNITED STATES
NUCLEAR REGULATORY COMMISSION
REGION II
101 MARIETTA STREET, N.W., SUITE 2900
ATLANTA, GEORGIA 30323-0199

Report Nos.: 50-424/94-01 and 50-425/94-01

Facility Name: Vogtle 1 and 2

This special, announced inspection was conducted to investigate the 500 Kv switchyard problems that resulted in a turbine trip and subsequent reactor trip of Unit 2 on January 7, 1994.

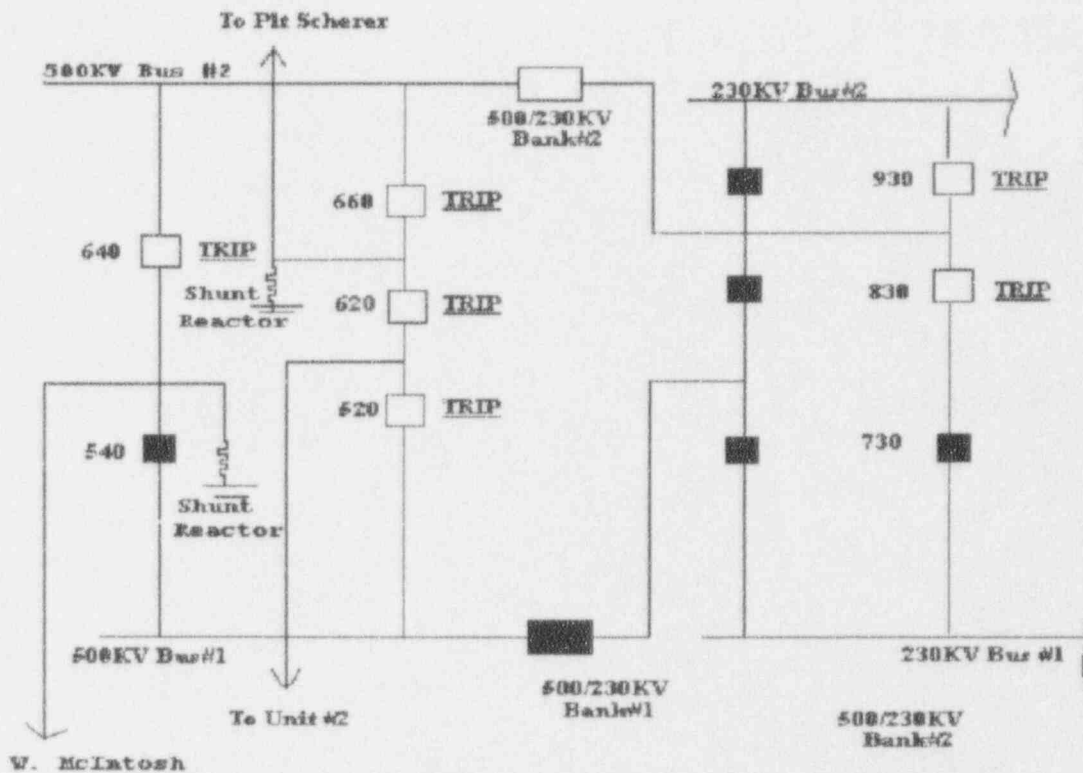
Vogtle Unit 2 connects to the Georgia Power Company (GPC) transmission grid system through 500 and 230 Kv switchyards. Unit 2 output power is connected to the 500 Kv switchyard via a step-up transformer through 500 Kv power circuit breakers (PCBs) 520 and 620. Unit 1 is connected to the 230 Kv switchyard via a step-up transformer and 230 Kv breakers.

500/230Kv Switchyard Configuration

The 500 and 230 Kv switchyards are tied together through two autotransformers shown in Figure 1 as 500/230 Kv Banks 1 and 2. Preferred offsite power for safe shutdown of both plants is provided via the 230 Kv switchyard.

Preliminary Event Analysis: To understand the arrangement of the electrical distribution system at Plant Vogtle see Figure 1 below.
