Virginia Electric and Power Company
North Anna Power Station
P. O. Box 402
Mineral, Virginia 23117

Report No. 50-338/94-001-00

LICENSEE EVENT REPORT (LER)

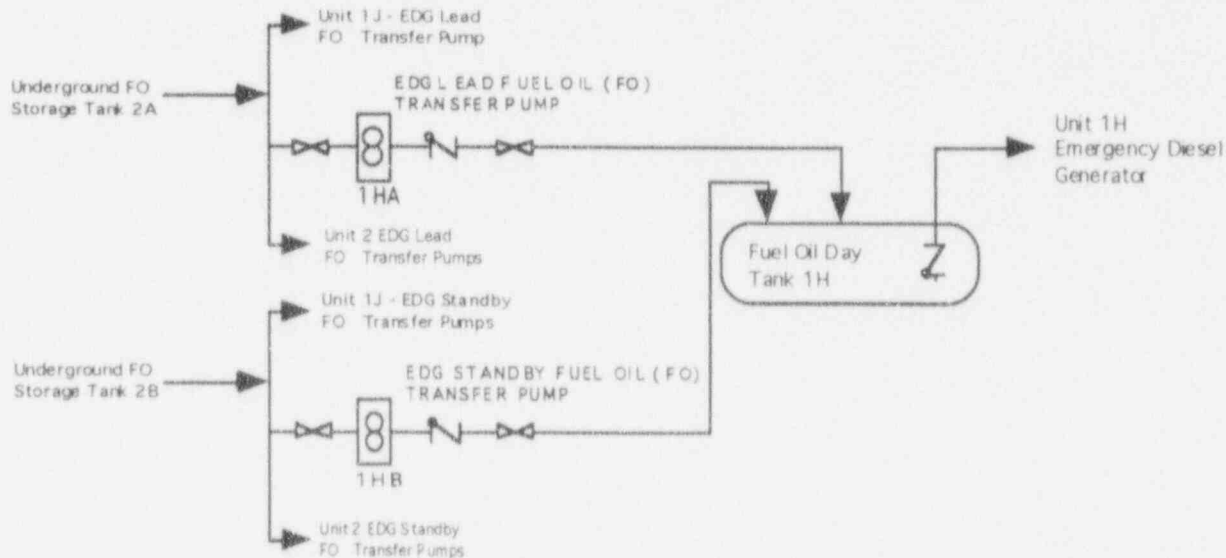
North Anna Units 1 & 2 each have two Emergency Diesel Generators (EDG) with two fuel oil (FO) transfer pumps per EDG for a total of eight FO transfer pumps. Each EDG has a lead FO transfer pump and a standby FO transfer pump. The FO transfer pumps are located in an unheated building. The four lead pumps are in one room with the four standby pumps in a separate room. Continuous forced ventilation with outside air is provided to reduce the amount of fuel fumes in the rooms. As a result, the temperature in the rooms closely follows the outside air temperature.
