NUREG/CR-3001
PNL-4342

Fuel Performance Annual Report for 1981

Prepared by W. J. Bailey/PNL
M. Tokar/NRC

Pacific Northwest Laboratory
Operated by
Battelle Memorial Institute

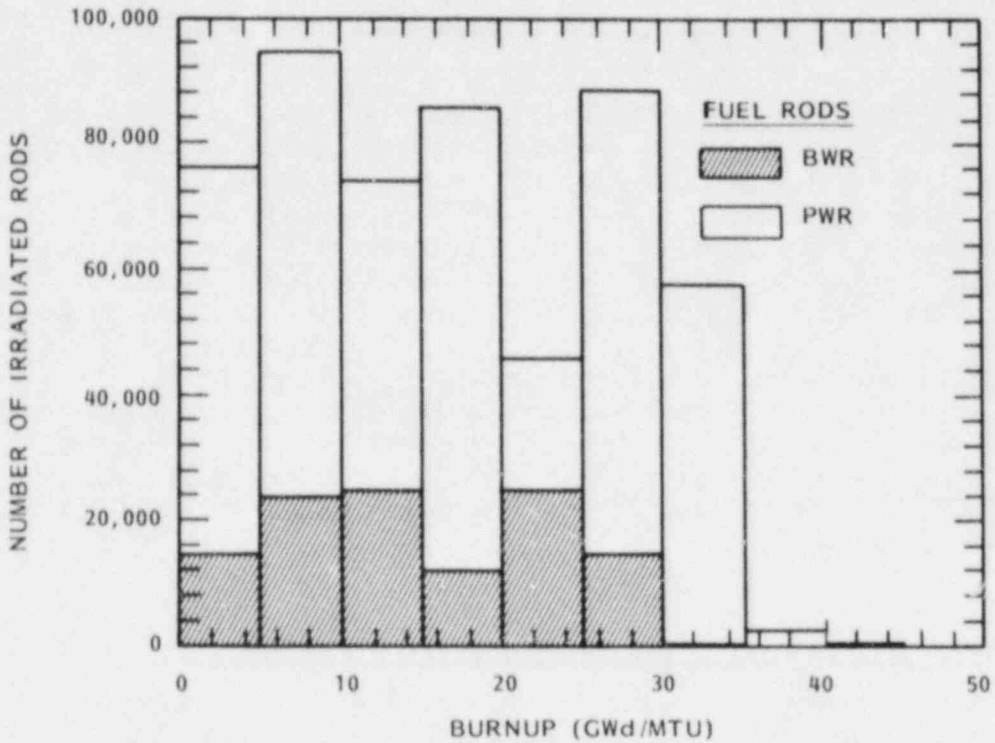
FIGURE 1. Exposure of Irradiated Exxon Nuclear Fuel as of December 31, 1981

A report (Refs. 29 and 30) summarizing the ENC fuel performance through December 31, 1981 has been published. Additional information is provided in Refs. 31-33. ENC has irradiated a total of 527,856 fuel rods in 4024 fuel assemblies and the fuel integrity levels achieved have been 99.987% and 99.43%, respectively. See Section 4.0 for information on the fuel failures. ENC fuel has been loaded into 23 domestic and foreign reactors (includes 9 BWRs and 14 PWRs). During 1981, 11 ENC fuel assemblies (3 in domestic plants and 8 in foreign plants) were found by sipping or by visual inspection to contain leaking fuel rods. Table 8 (Ref. 29) summarizes the ENC fuel assembly distribution and fuel rod performance as of the end of 1981. The maximum assembly average burnups attained were 39,100 MWd/MTU in BWRs and 46,800 MWd/MTU in PWRs. The exposure range of ENC fuel is shown in Figure 1. ENC fuel failures observed in 1981 are listed in Table 9. Tables 8 and 9 and Figure 1 are from Ref. 29.

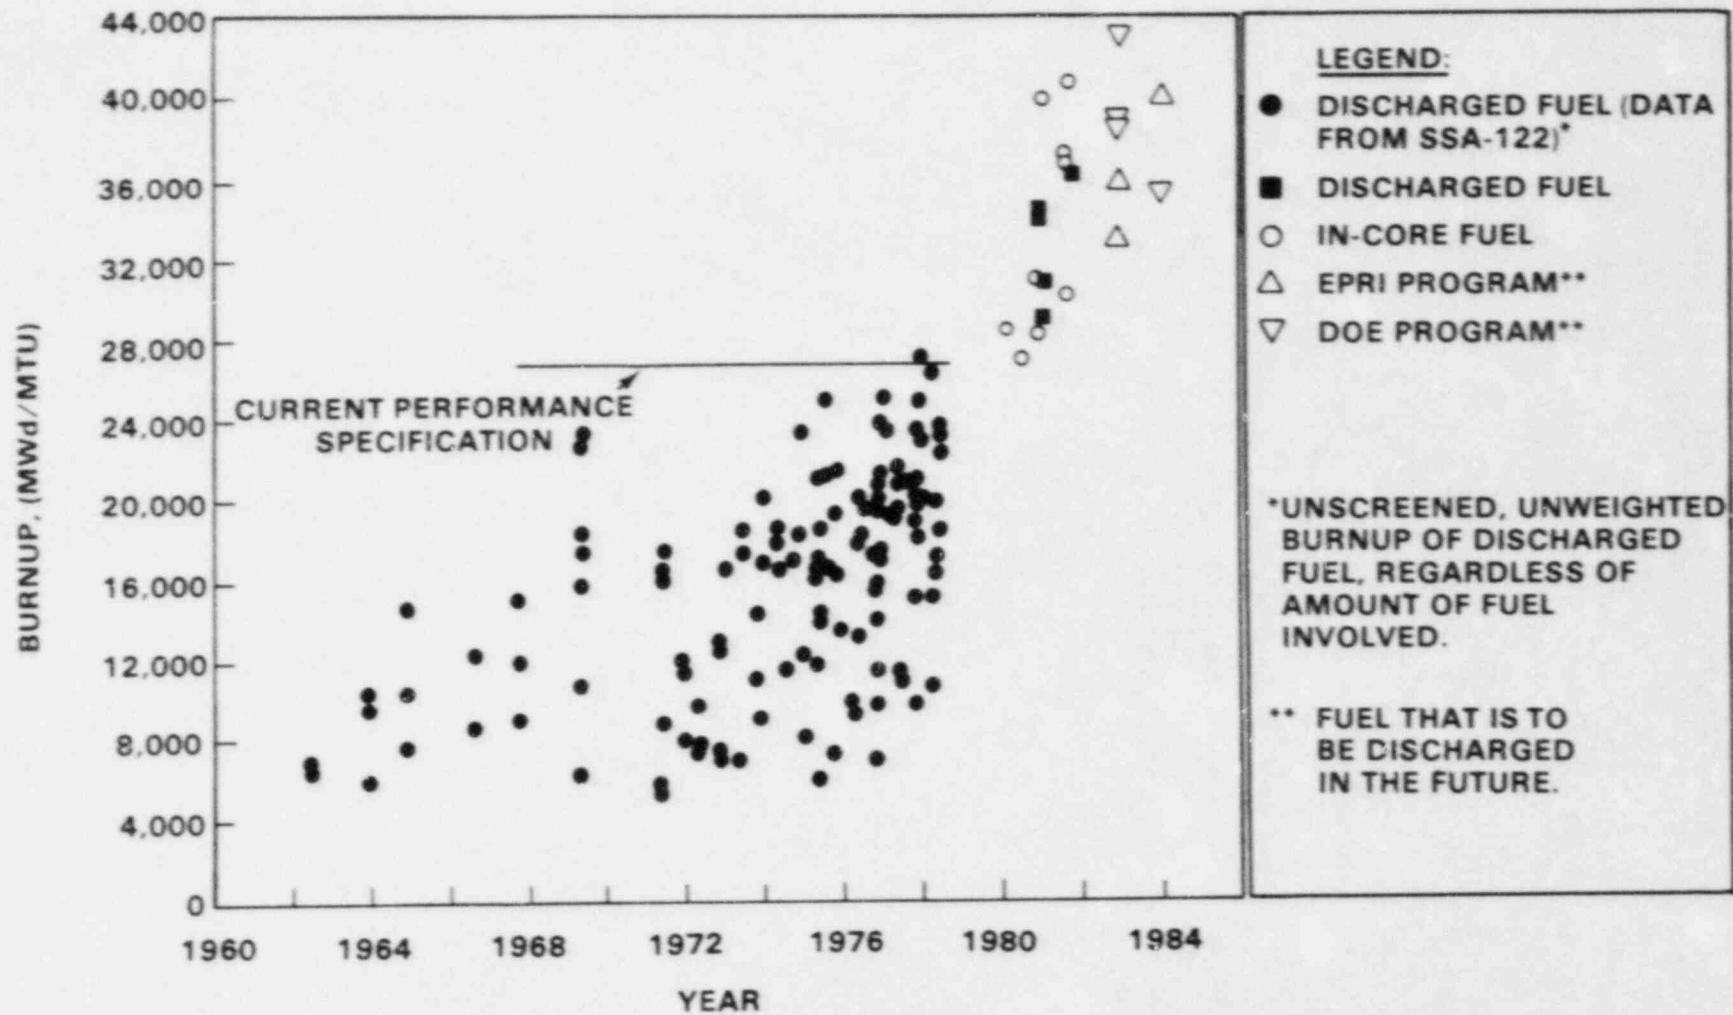
FIGURE 3. Domestic BWR Fuel Burnup Experience

Domestic BWR fuel burnup experience is summarized in Figure 3. Domestic PWR fuel experience is summarized in Figure 4. Most of the data on fuel discharged prior to 1979 was obtained from Ref. 233.

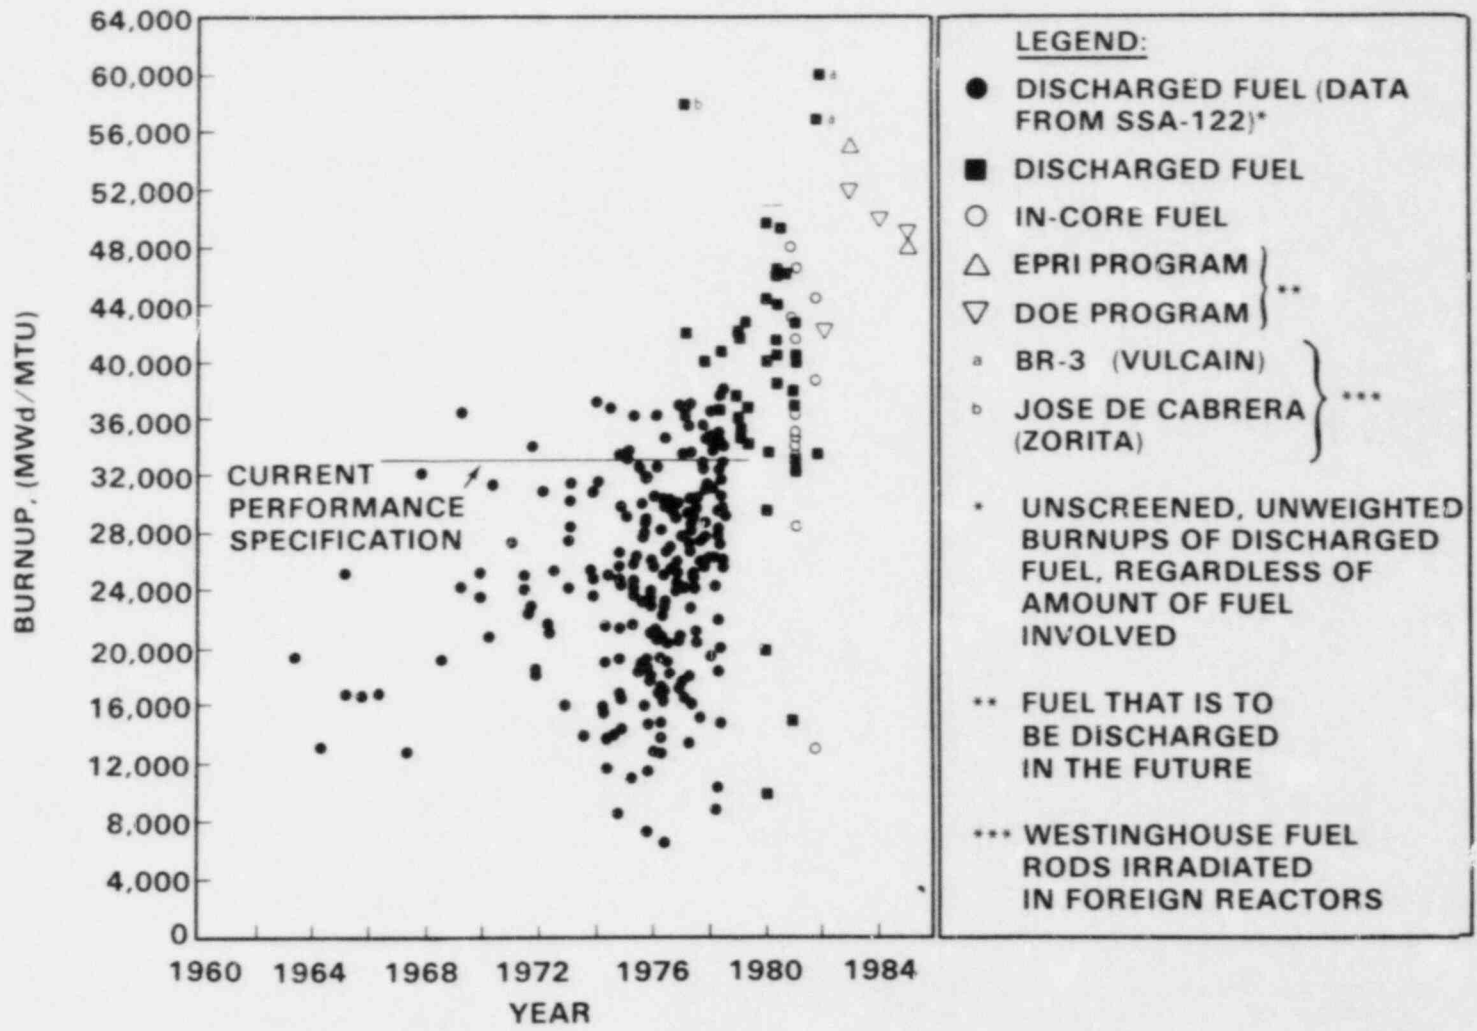
FIGURE 4. Domestic PWR Fuel Burnup Experience
