September 30, 1980

Docket No. 50-336
B10094

Millstone Nuclear Power Station, Unit No. 2
Additional Information - Cycle 4 Reload

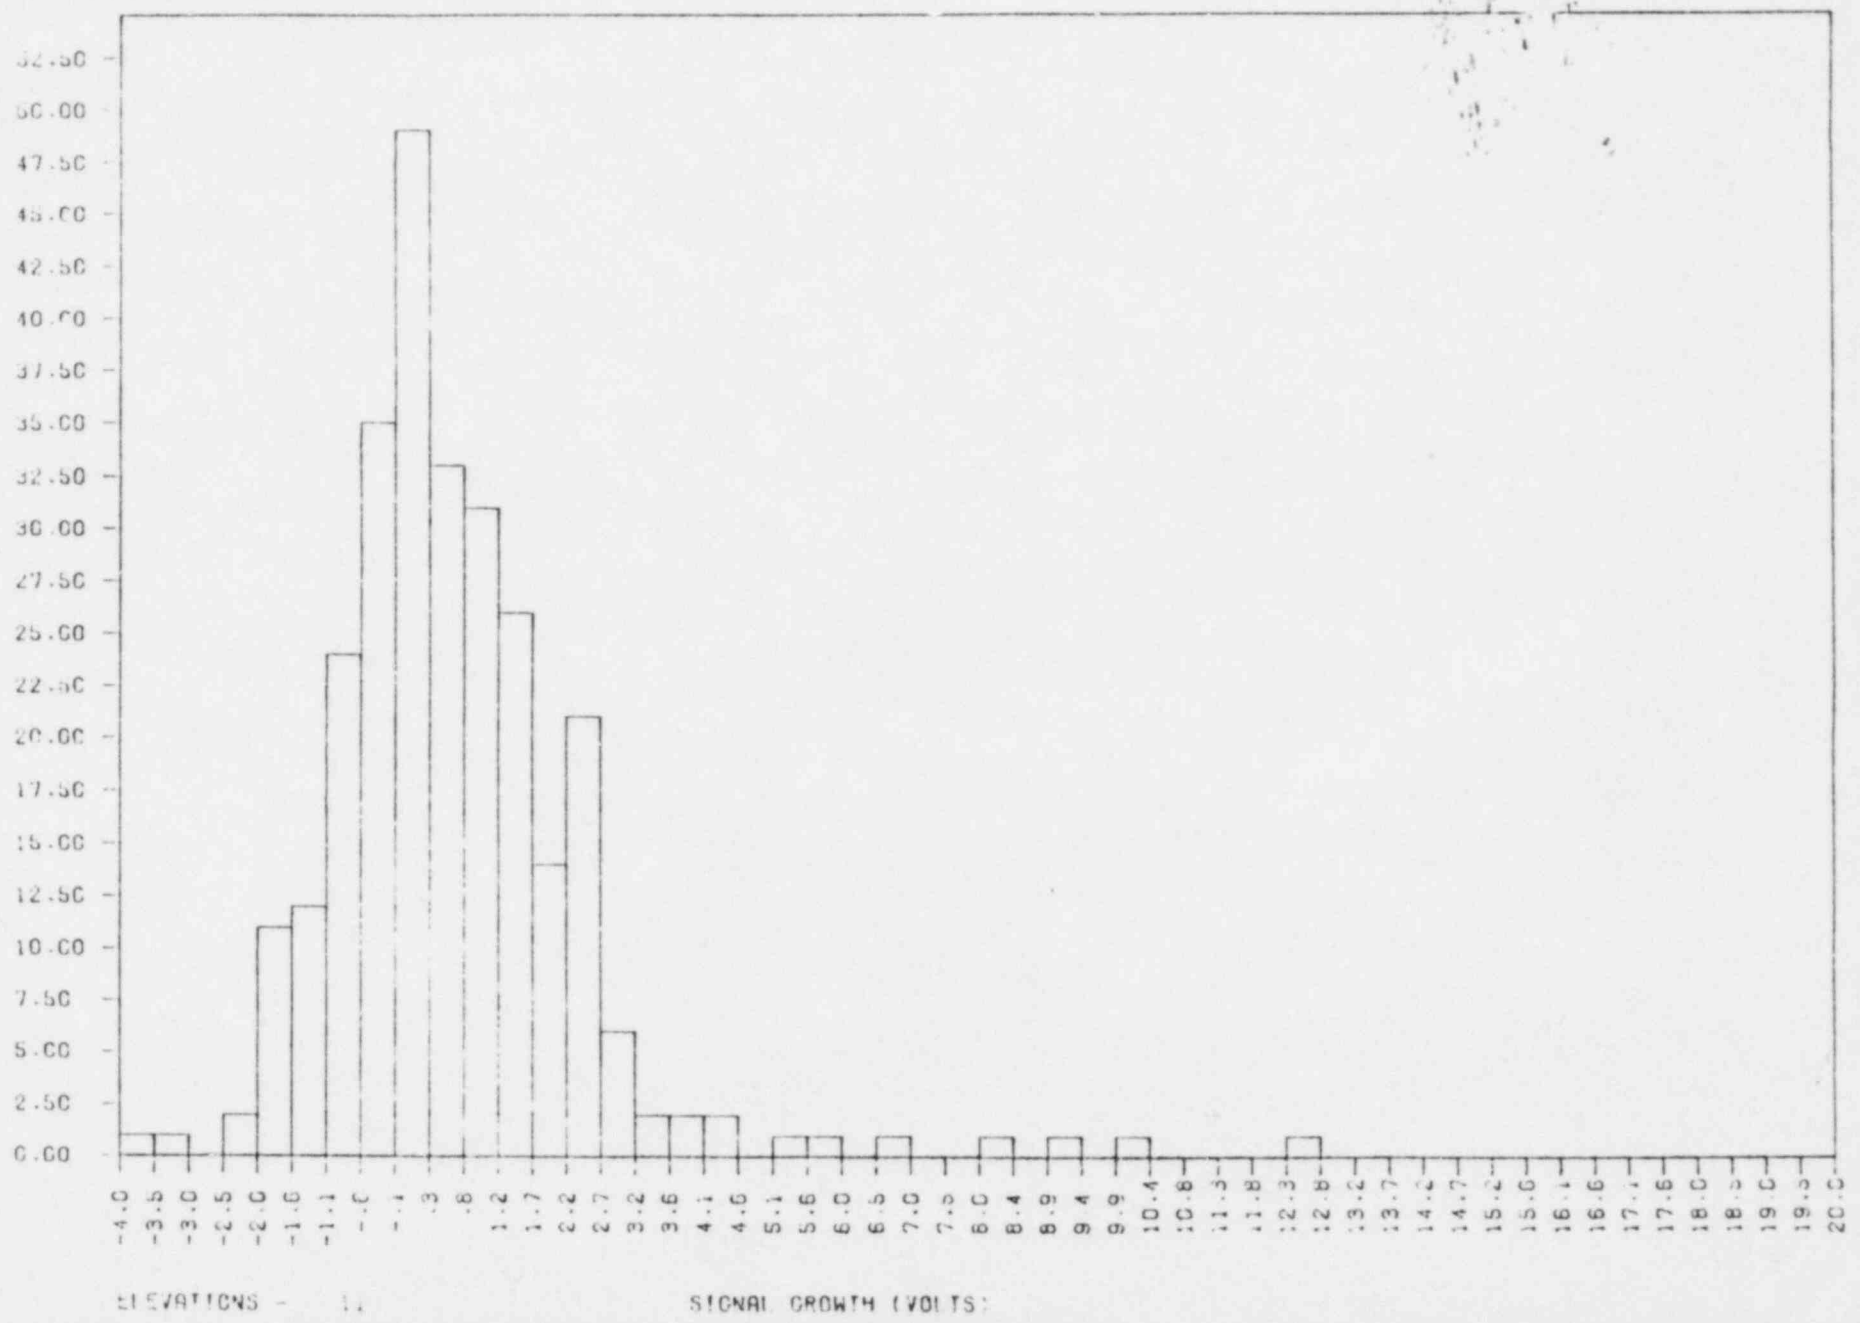
MILESTONE II
 STEAM GENERATOR 2 HOT SIDE
 SIGNAL GROWTH VS. NUMBER OF OCCURENCES

INSPECTIONS - MARCH 17, 1979
 AUGUST 26, 1980

The Millstone Unit No. 2 Steam Generator inspections were conducted during the 1980 refueling outage in accordance with plant Technical Specifications and supplementary commitments described in Reference (4). A combination of multi-frequency and single frequency eddy-current methods were utilized to identify both defects and dents in the steam generator tubes.
