U. S. NUCLEAR REGULATORY COMMISSION  
REGION I

Report Nos. 50-277/94-02, 50-278/94-02

Facility Name: Peach Bottom Atomic Power Station (PBAPS)

Areas Inspected: Contamination control, ALARA, and radiological discrepancy investigation.

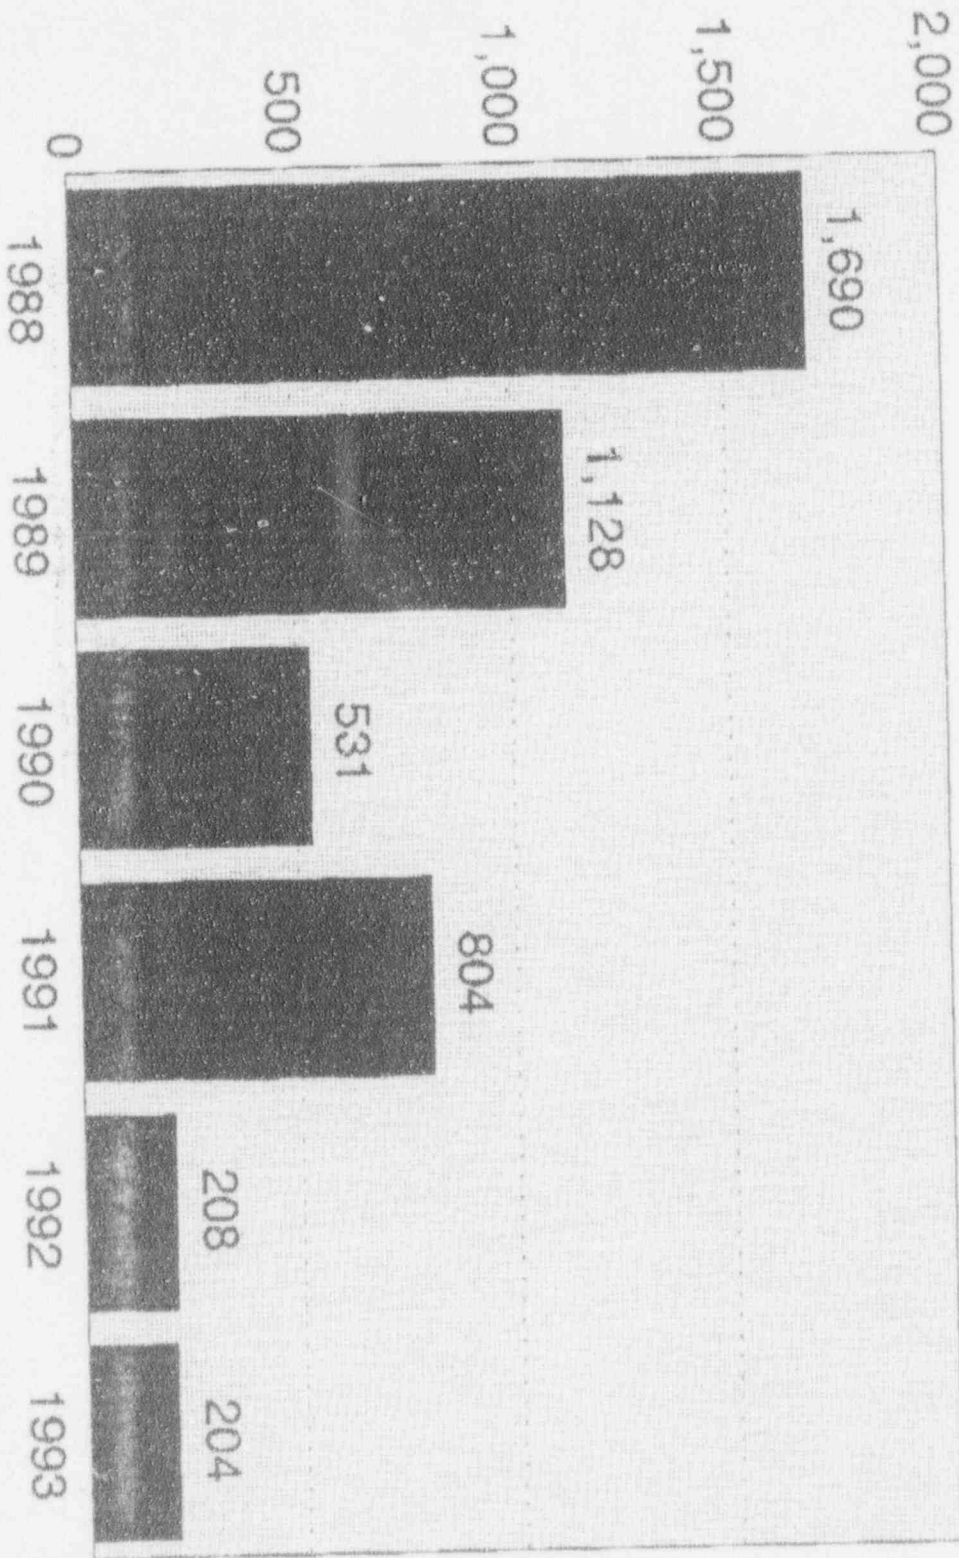
# PEACH BOTTOM ATOMIC POWER STATION PCR HISTORY

DATA AS OF 01/01/94  
pcrhisto

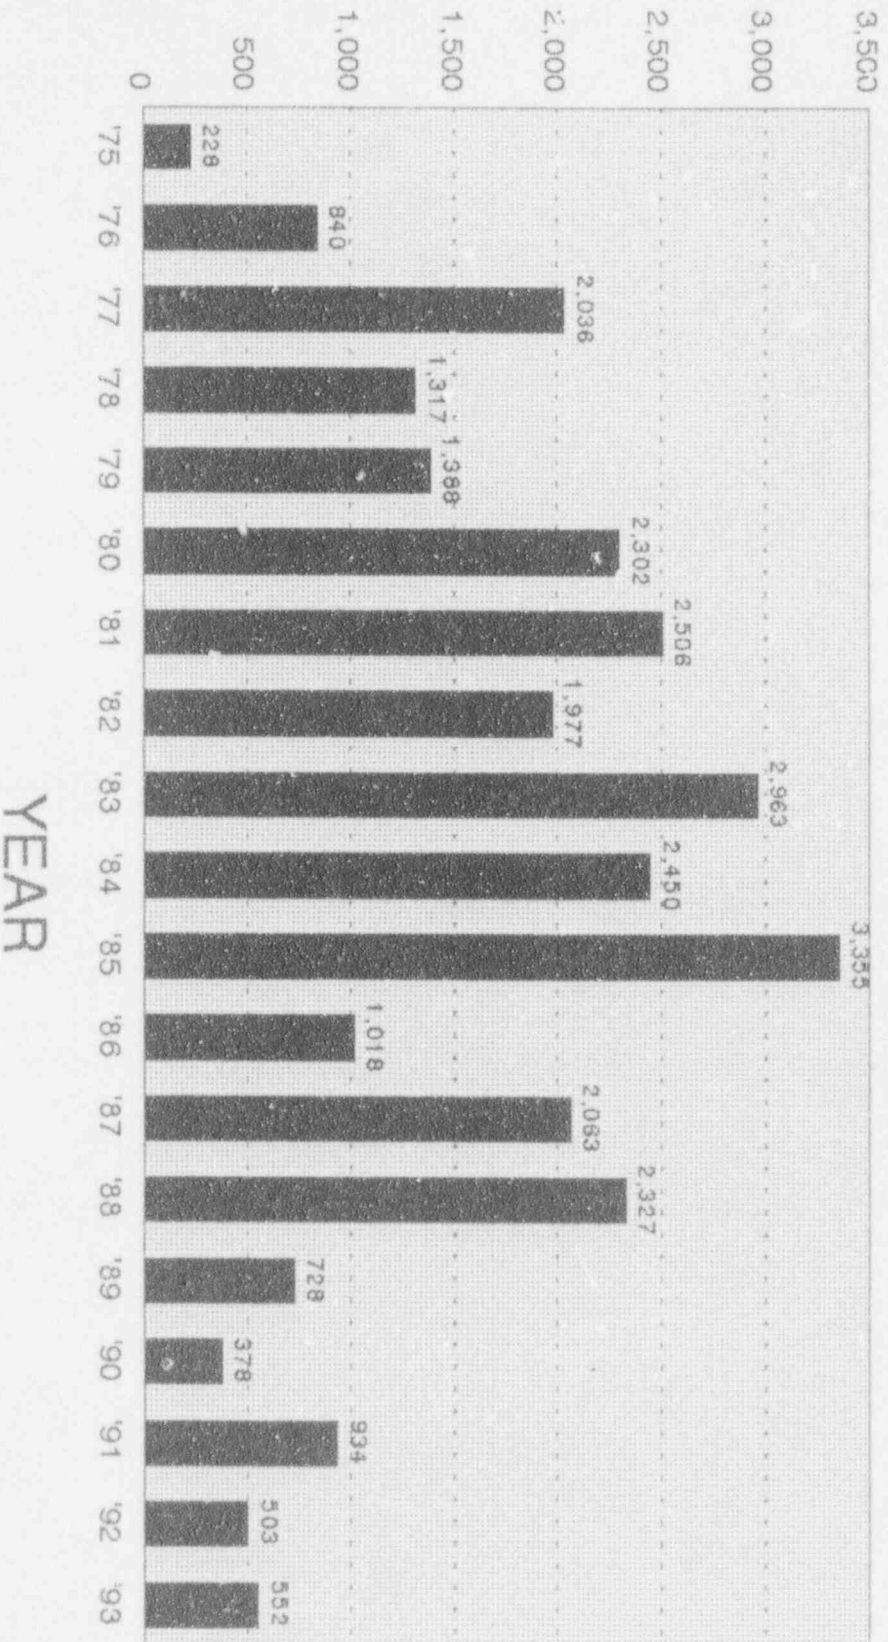
# PEACH BOTTOM ATOMIC POWER STATION ANNUAL DOSE HISTORY BY TLD

MAN-REM

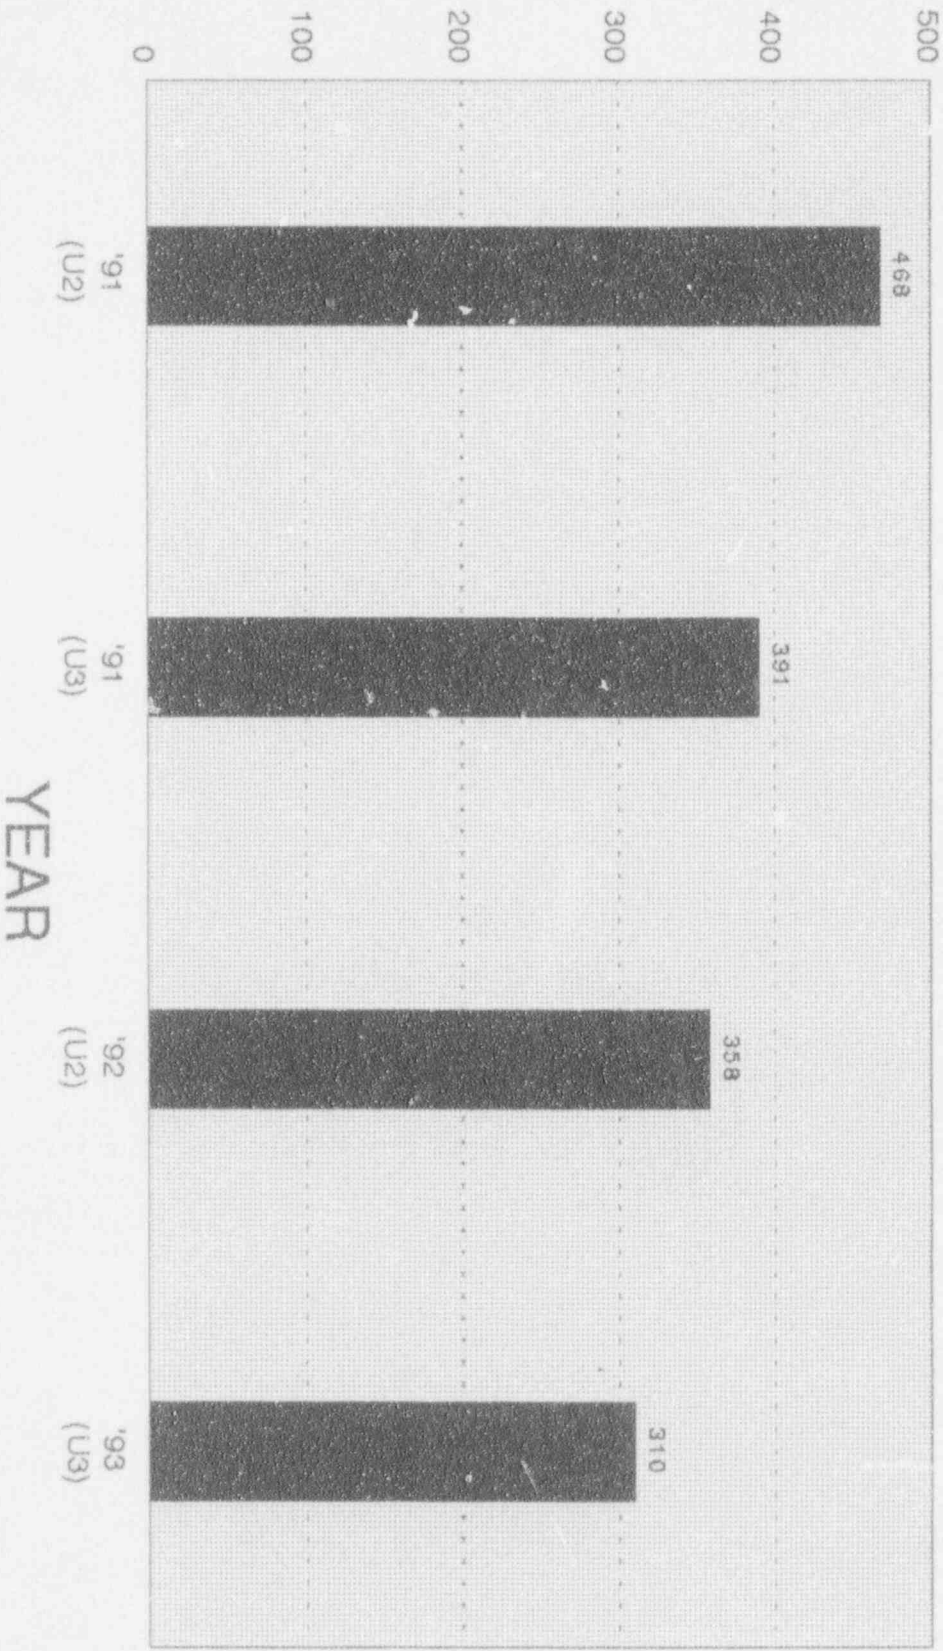
# REFUEL OUTAGE EXPOSURE HISTORY BY DRD

PEACH BOTTOM ATOMIC POWER STATION

MAN-REM

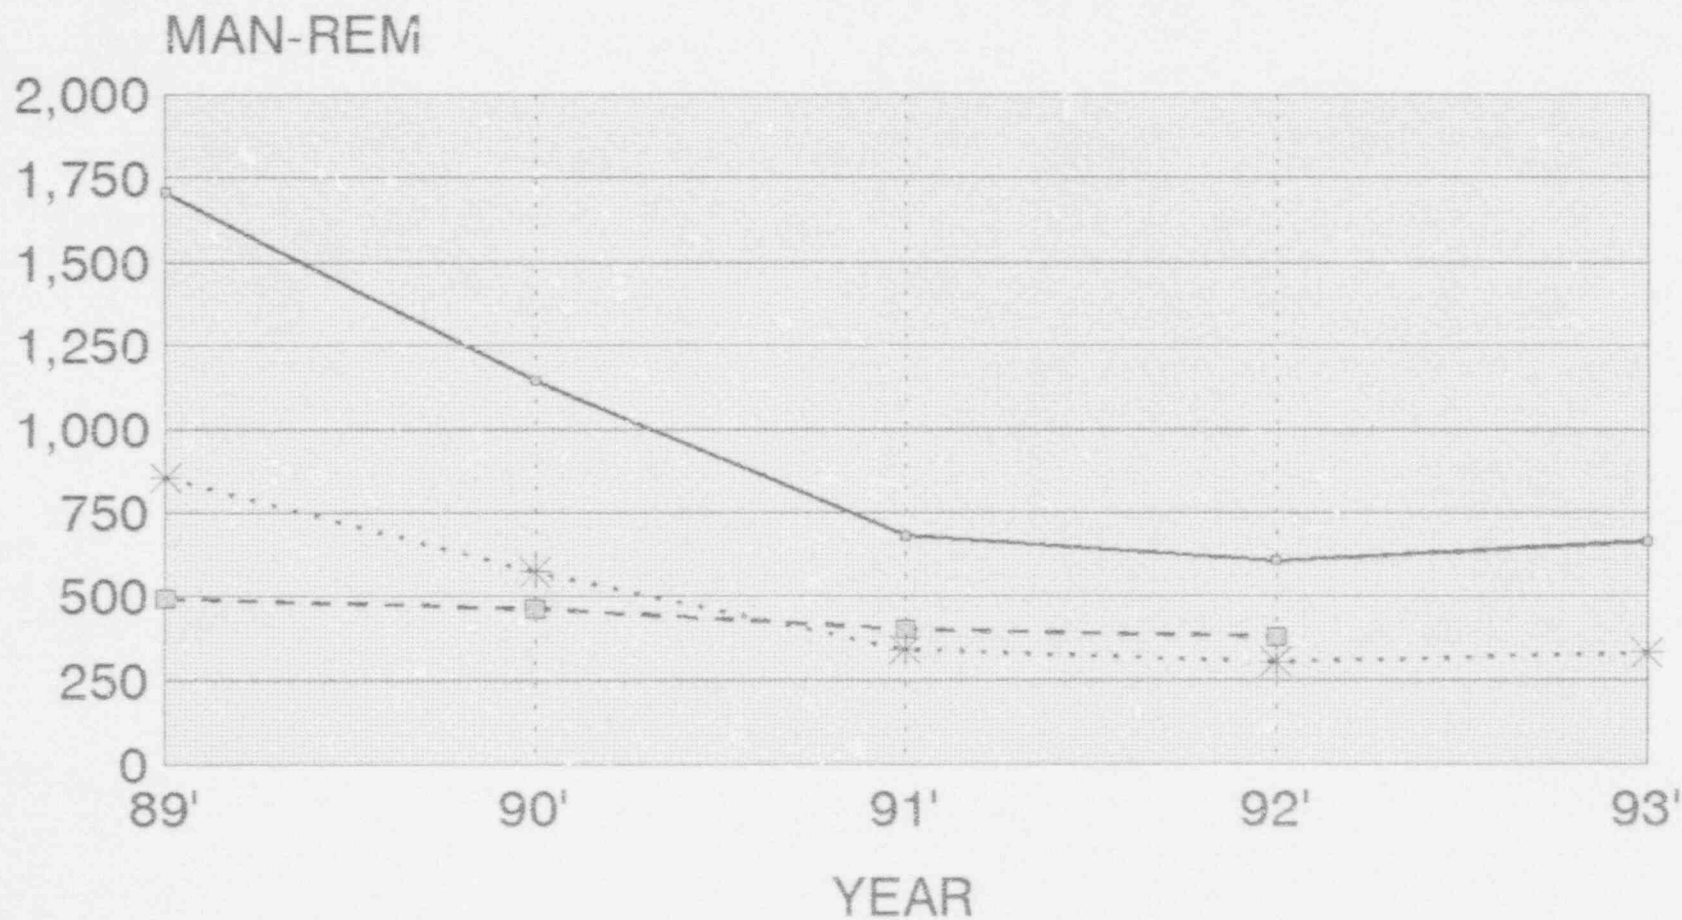
ATTACHMENT 4

# PBAPS DOSE- 3 YEAR ROLLING AVERAGE

1989 THROUGH 1993

○ PBAPS SITE 3 YR RA
