**Commonwealth Edison**

Subject: Byron Station Units 1 and 2  
Braidwood Station Units 1 and 2  
Locked Rotor and Shaft Break  
Transients  
NRC Docket Nos. 50-454, 50-455,  
50-456, and 50-457

This is to provide additional information regarding reactor coolant pump locked rotor and shaft break transients at Byron and Braidwood stations. Review of this information should close Confirmatory Issue 34 of the Byron SER.

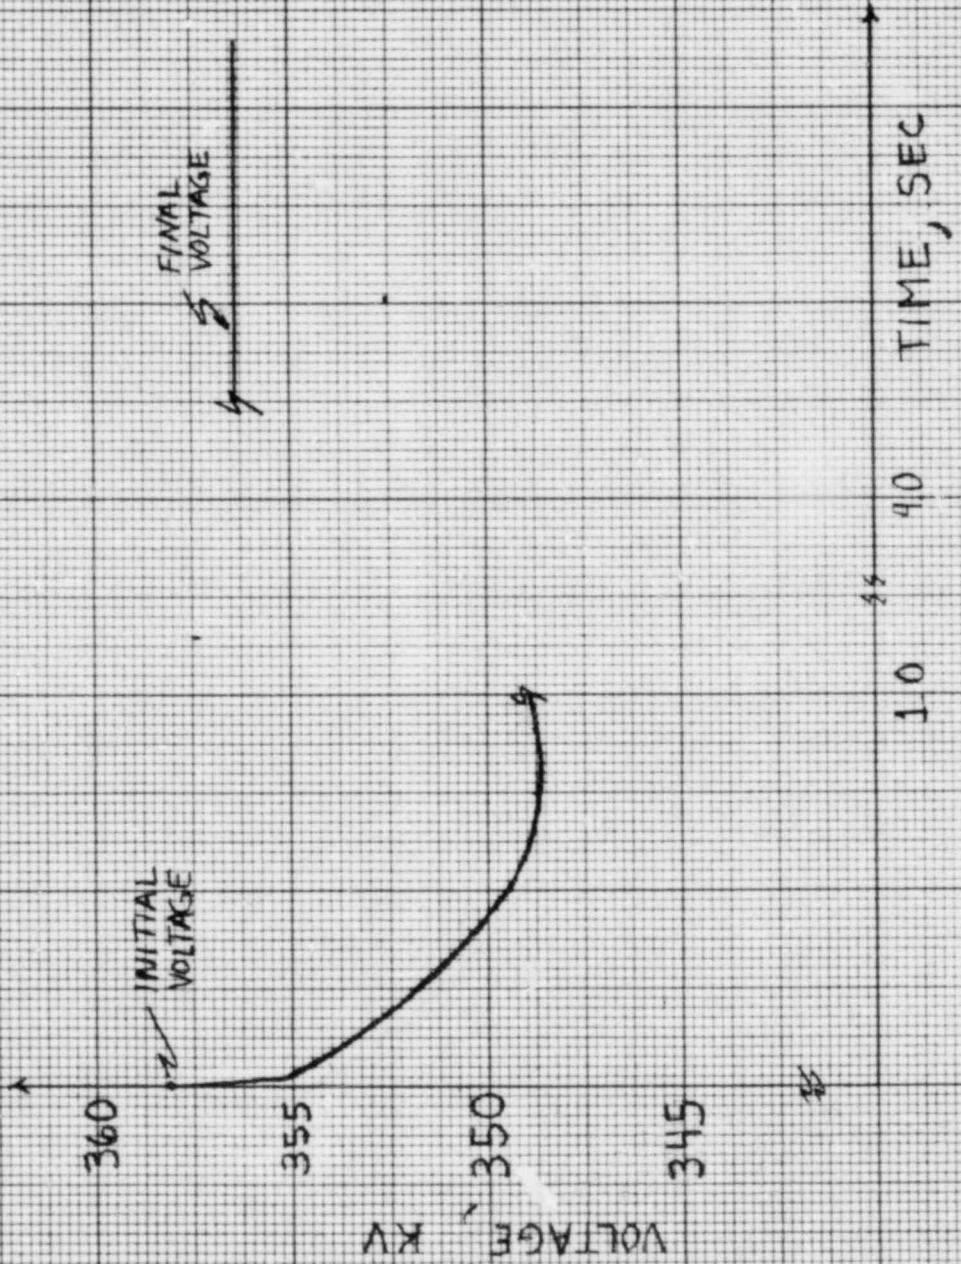
FIG. 2  
VOLTAGE AT BRAIDWOOD  
345 KV BUS VS. TIME  
FOR TRIP OF BRAIDWOOD UNIT

Figure 2 shows the calculated transient voltage at the Braidwood 345 kV bus following the unit trip. The maximum excursion is less than 3% and the voltage recovers in several seconds to a steady state value about 0.5% lower than that before the trip. The voltage recovery is due to the automatic regulator action of other units on the system.
