UNITED STATES  
NUCLEAR REGULATORY COMMISSION  
WASHINGTON, D. C. 20555

Enclosed, at the request of Dr. Henry Myers of your staff, are responses  
to his request of October 17, 1990, concerning Seabrook welds.

RESPONSE TO DR. H. MYERS' REQUESTS OF OCTOBER 17, 1990

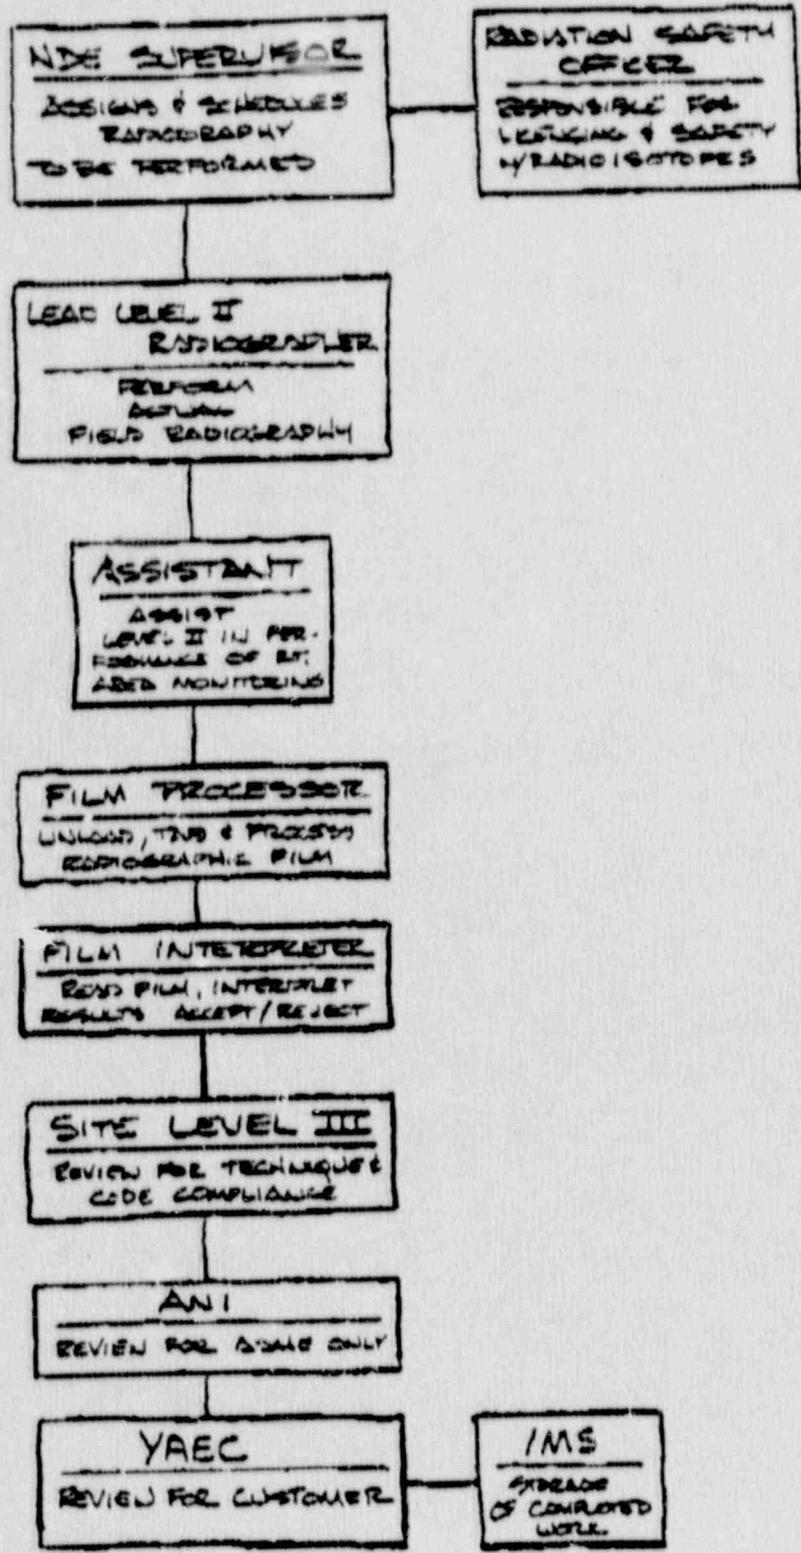
# STRUCTURE

He was not involved with the processing or interpretation/evaluation of any radiographs, eliminating the possibility of penetrameter enhancement. The attached chart shows the overall structure of the radiography program & why J. Padovano's participation would not have a negative effect.
