Nuclear Power Plant Operating Experience - 1980

Annual Report

Oak Ridge National Laboratory

Prepared for
U.S. Nuclear Regulatory
Commission

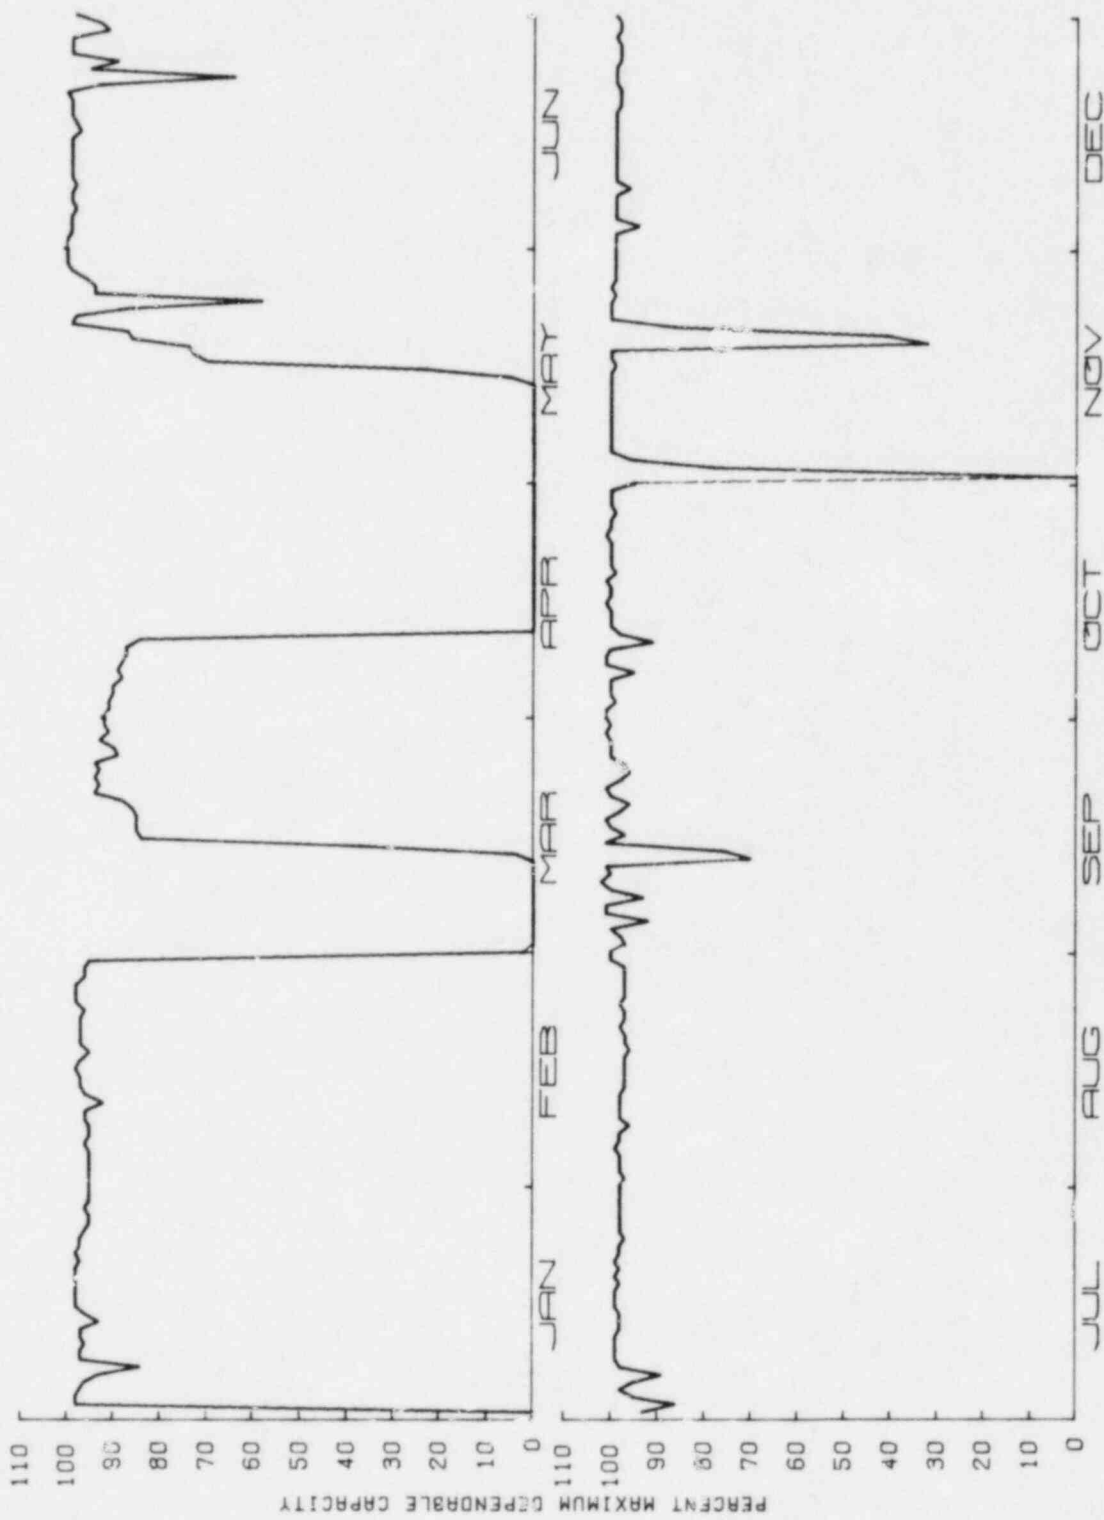
DESIGN ELEC. RATING = 497 MAX. DEPEND. CAP. = 495 (100%) POINT BEACH 2

After the outages for steam generator tube testing and repairs starting on February 28 and for refueling starting on April 11, Point Beach 2 operated routinely for the remainder of the year except for a few brief shutdowns. Unit availability was 86.4%.

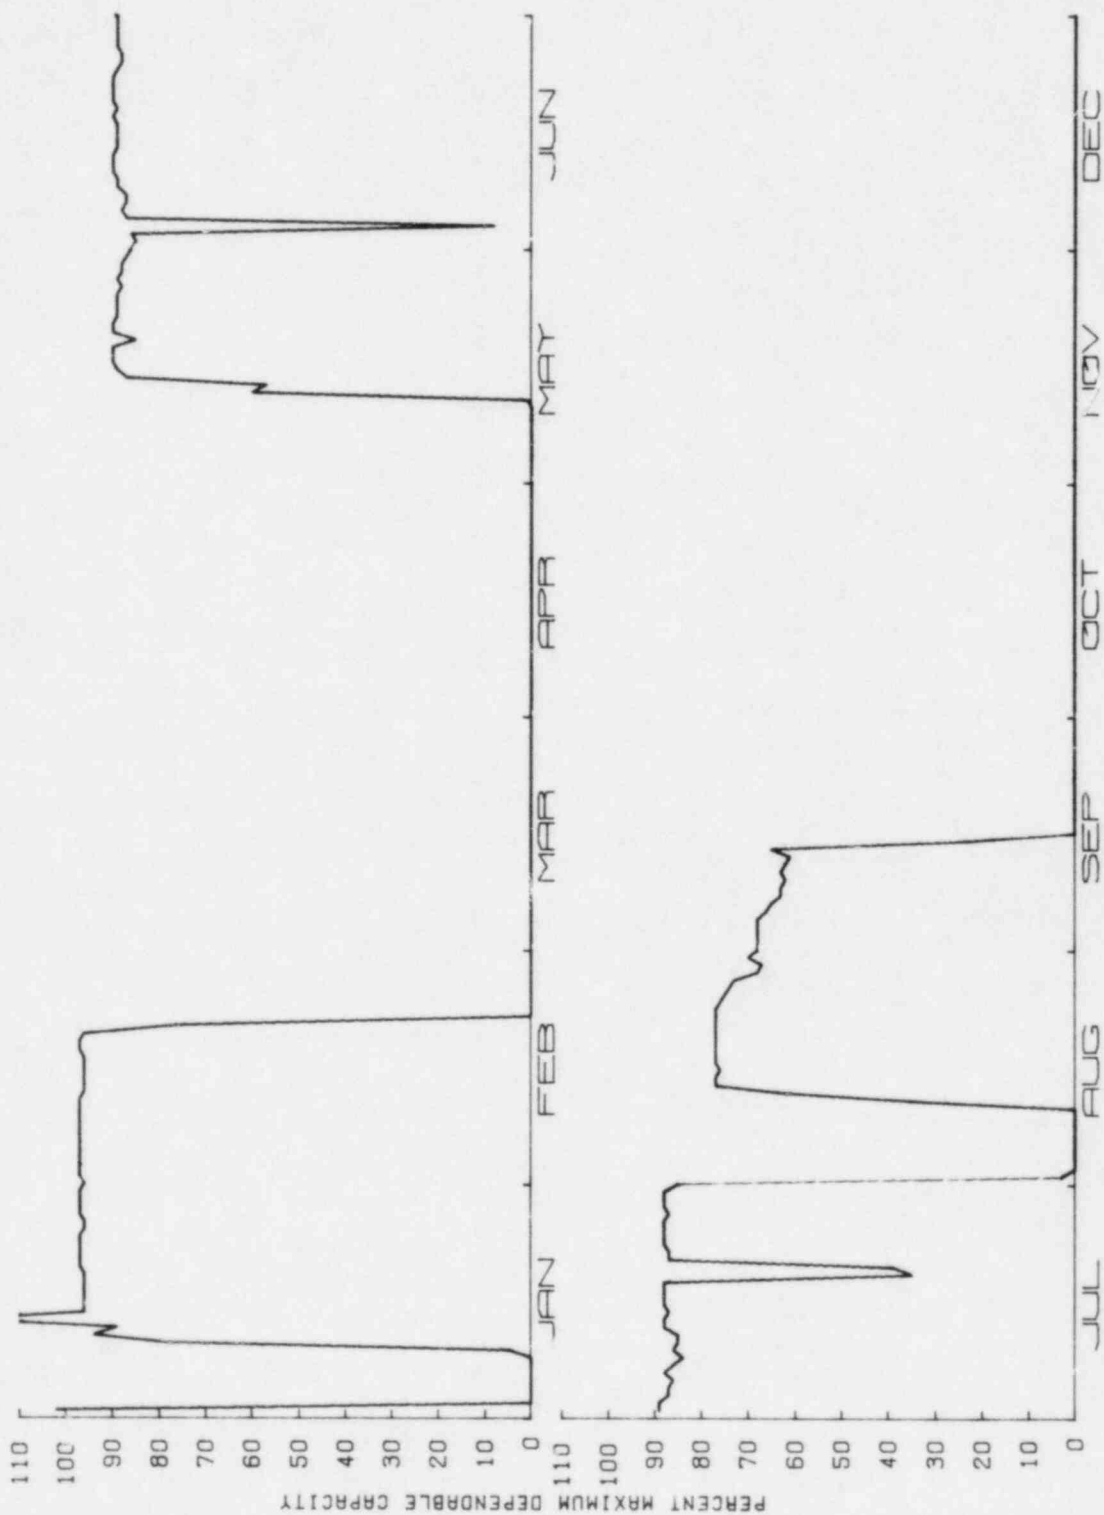
SURRY 1

The unit began 1980 down for replacement of a reactor coolant pump motor and testing of a snubber. Pipe stress reanalysis and turbine inspection per IE Bulletin 79-14 required nearly 12 weeks ending May 11. One steam generator tube was plugged on August 1, but the unit was shut down for the remainder of the year on September 14 to replace the lower shells and tube bundles in all three steam generators.
