NORTHEAST UTILITIES

Re: Inservice Test Program
10 CFR 50.55a(g)

Millstone Nuclear Power Station, Unit No. 2
Second Ten-Year Inservice Inspection Testing Program
Response to NRC Staff Request (TAC 75977)

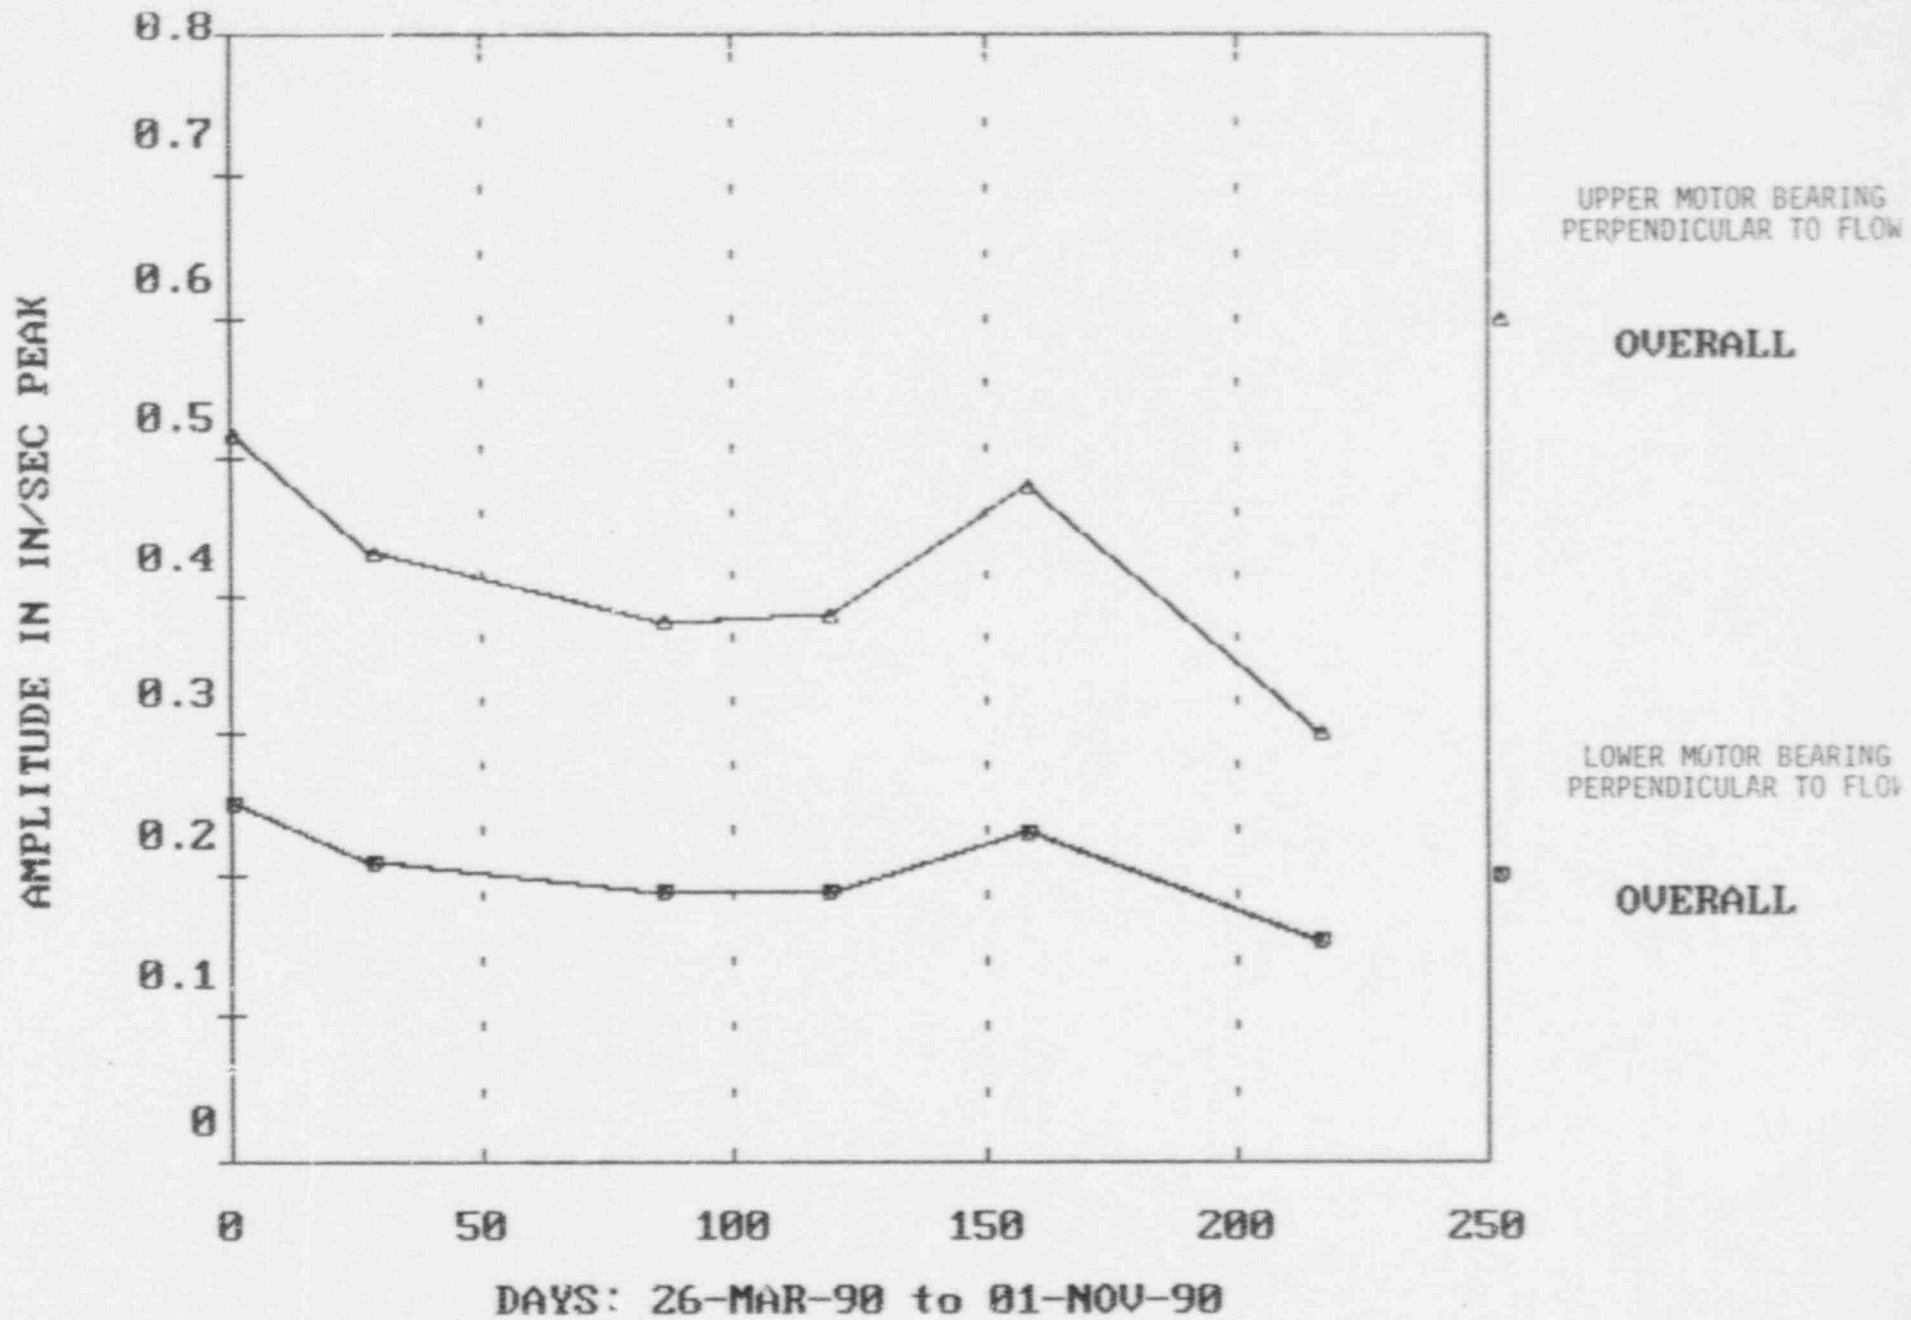
FIGURE 1

Intelli-Trend(R) Multi-Trend Display
Station - Millstone Unit 2

SERVICE WATER PUMP C
OVERALL VIBRATION LEVEL

Experience and testing has shown that vibration at the upper motor bearing housing is two to three times higher than measurements taken closer to the pump. Figure 1 demonstrates the differences in upper and lower motor bearing housing vibration levels. Recent testing performed with temporary accelerometers installed on the pump column, showed that when the upper motor housing vibration level was 0.42 inches per second, the actual pump vibration level was 0.16 inches per second.
