U. S. NUCLEAR REGULATORY COMMISSION
REGION I

Report No. 50-322/93-04

Facility Name: Shoreham Nuclear Power Station

Inspection Period: October 9-December 30, 1993

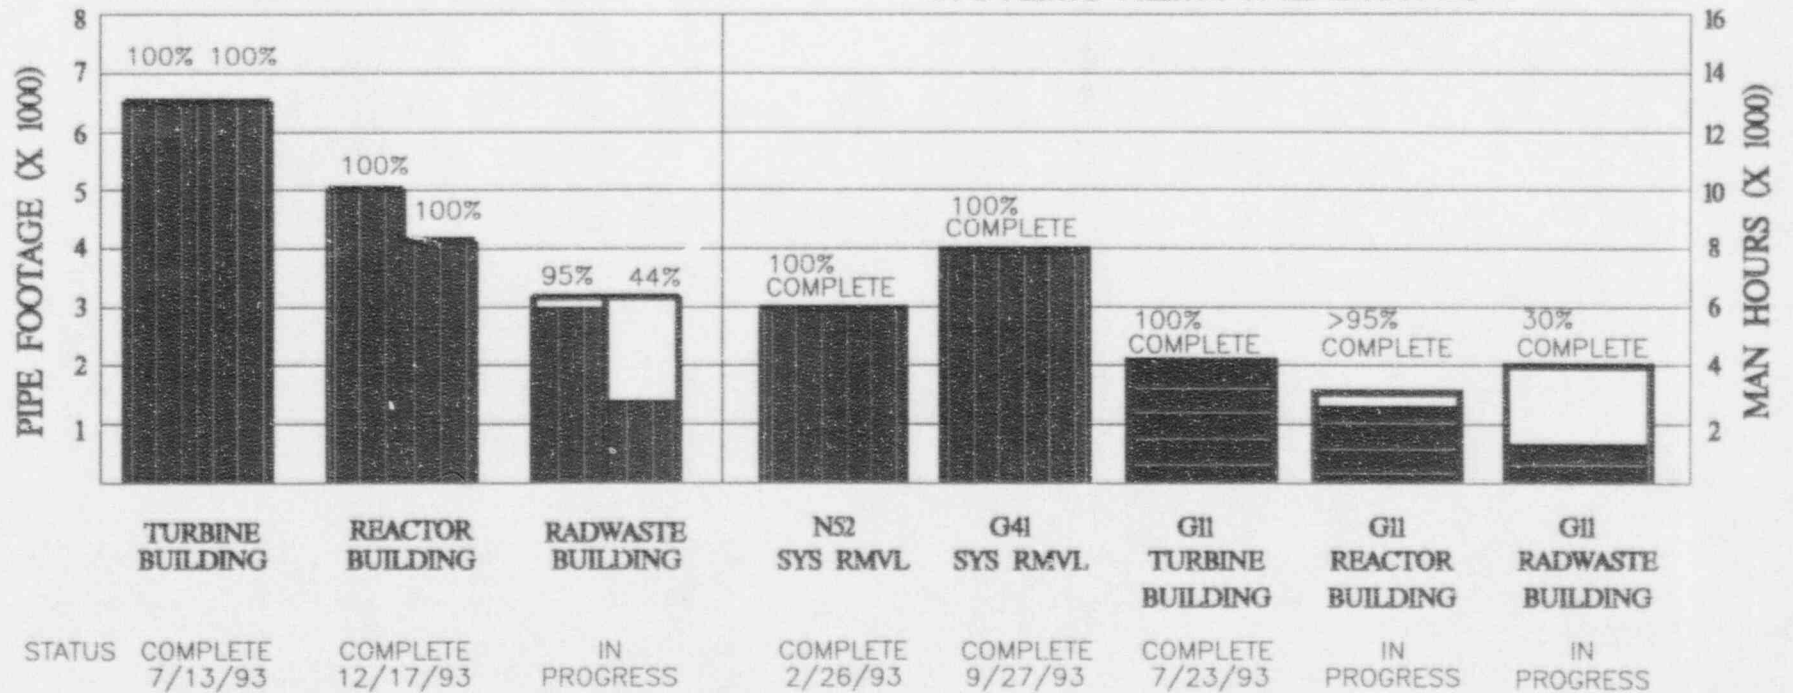
SYSTEMS REMOVAL STATUS

(LEFT SIDE: HYDROLAZING/RIGHT SIDE: TERM SURVEY)

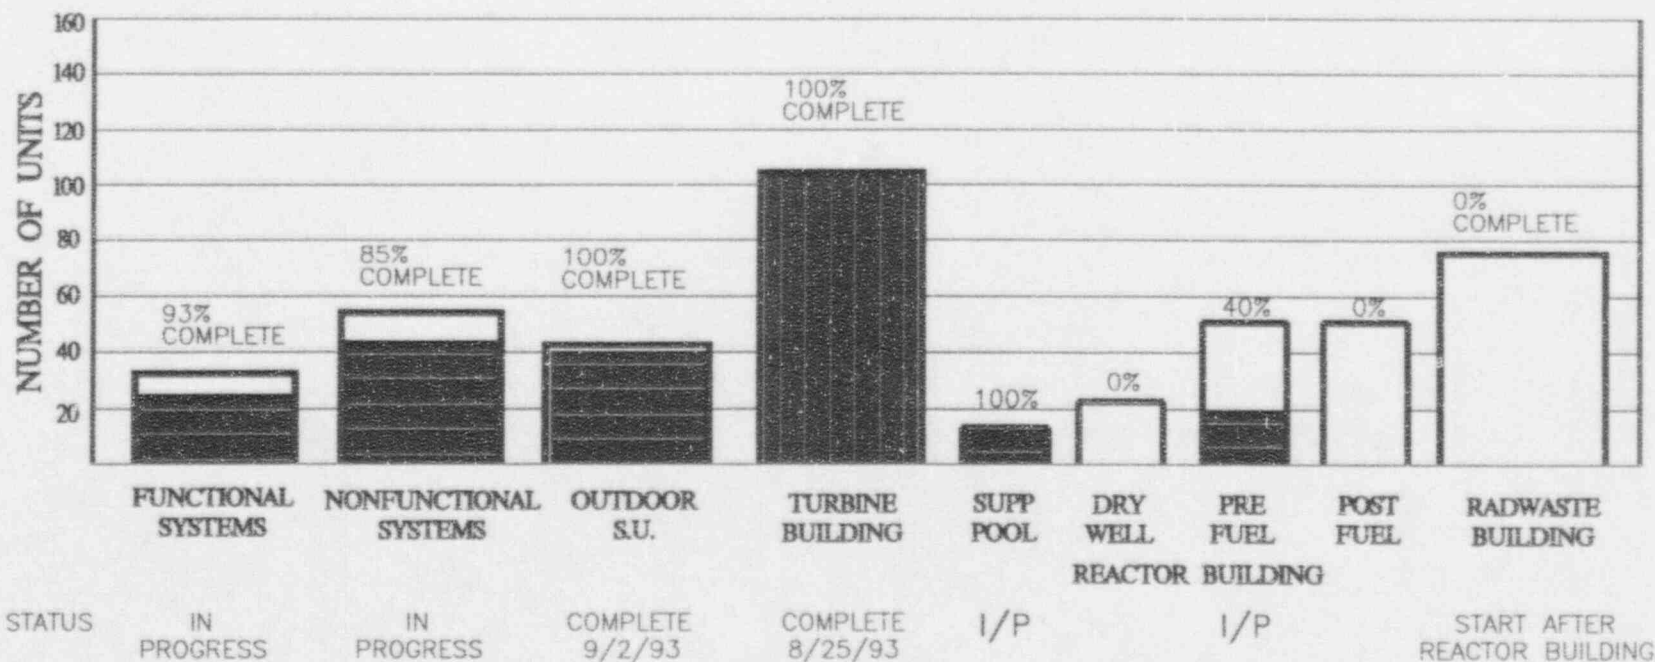
TERMINATION SURVEY STATUS

SHOREHAM DECOMMISSIONING STATUS

DECEMBER 20, 1993 TO DECEMBER 31, 1993
