LICENSEE: Texas Utilities Electric Company (TU Electric)

FACILITY: Comanche Peak Steam Electric Station (CPSES), Units 1 and 2

SUBJECT: SUMMARY OF MEETING ON CPSES UNIT 1 DIESEL GENERATOR RACK
TEETH INSPECTION SCHEDULE

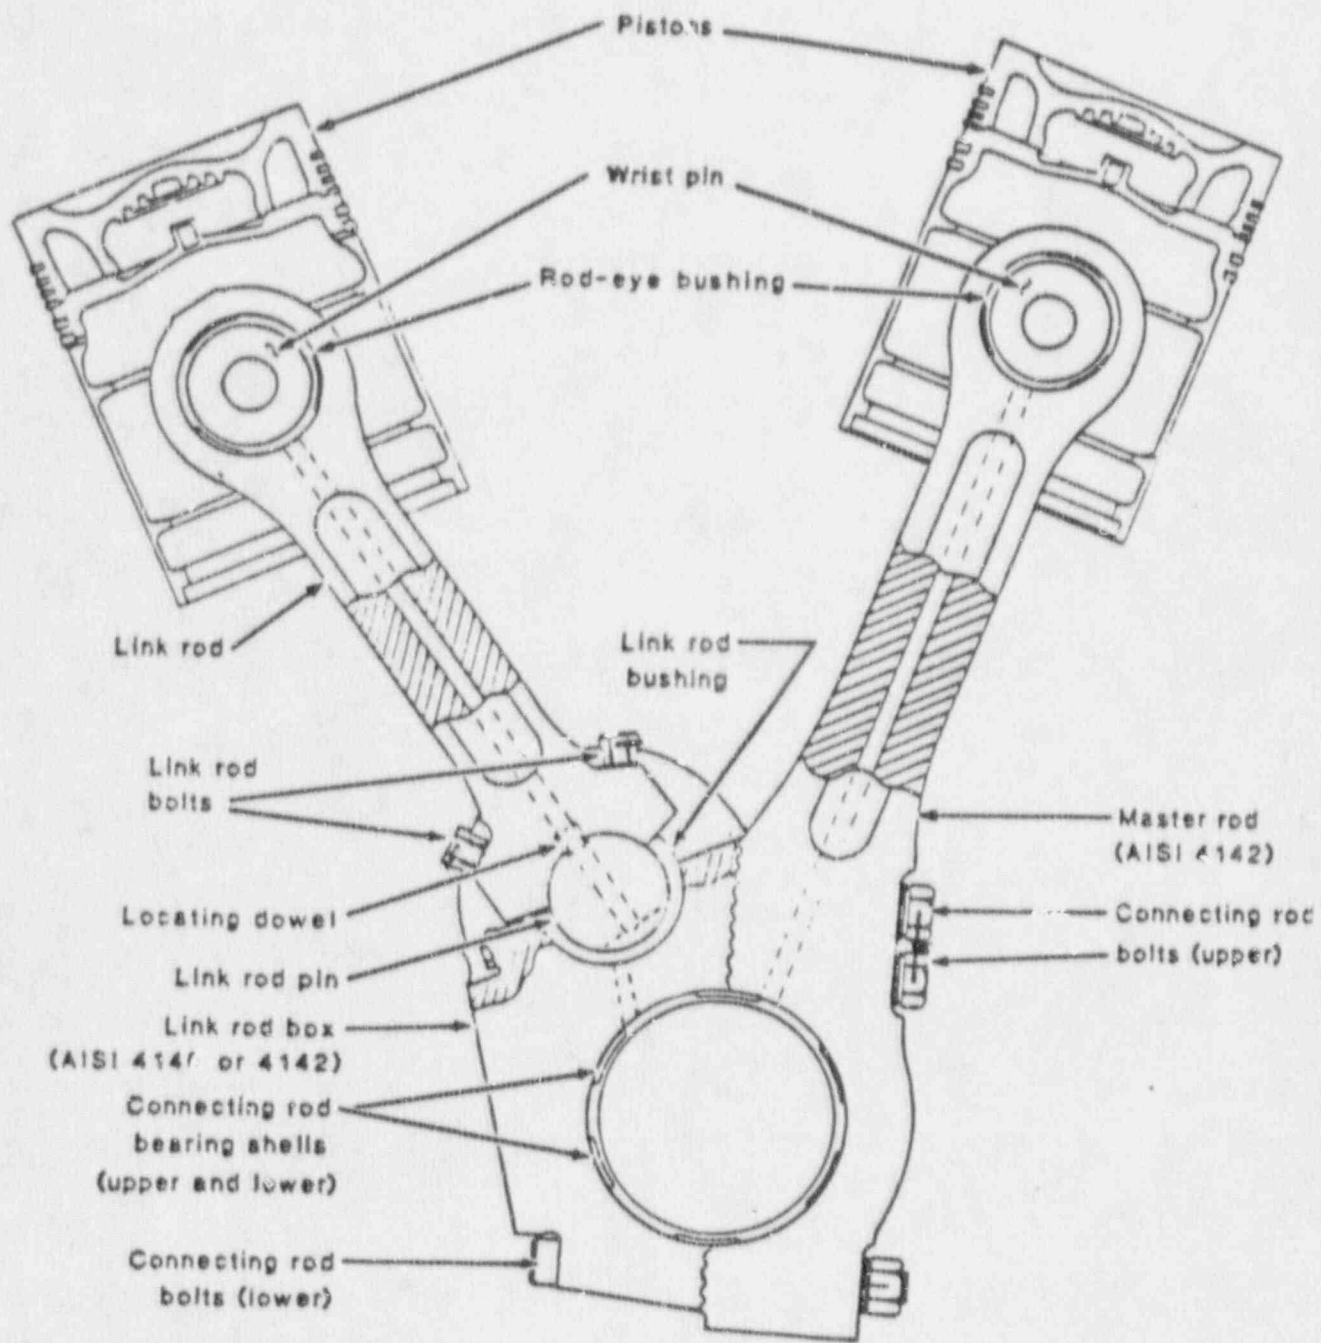
Figure 1-1. V-engine connecting rod, model RV-4 engine.

- o FRETTING IS METAL TRANSFER THAT CAN OCCUR BETWEEN MATED SURFACES WHEN EXPOSED TO HIGH COMPRESSION AND/OR SHEAR FORCES.
- o THE CONNECTING ROD RACK TEETH ARE EXPOSED TO HIGH COMPRESSION AND SHEAR FORCES WHILE IN NORMAL USE. A PROPERLY FITTED AND ASSEMBLED JOINT WILL EXPERIENCE MINOR FRETTING EVEN AFTER ONLY A FEW HOURS OF OPERATION.
- o ABNORMALLY HIGH LEVELS OF FRETTING-ALTHOUGH NOT A PROBLEM BY ITSELF-IS INDICATIVE OF EXCESSIVE MOVEMENT OR FLEXURE WHICH CAN CAUSE BOLT FAILURE.
- o SINCE SURFACES CANNOT BE REASSEMBLED EXACTLY AS THEY WERE DISASSEMBLED, HIGH SPOTS DUE TO FRETTING-AS GOOD PRACTICE-SHOULD BE REMOVED PRIOR TO JOINT ASSEMBLY.

- One failure analysis identified bowed rack surface pitch lines of the master rod and box as the root cause of the failure. The bowed pitch lines resulted in contact between the master rod and box only at the outer teeth of the joint.

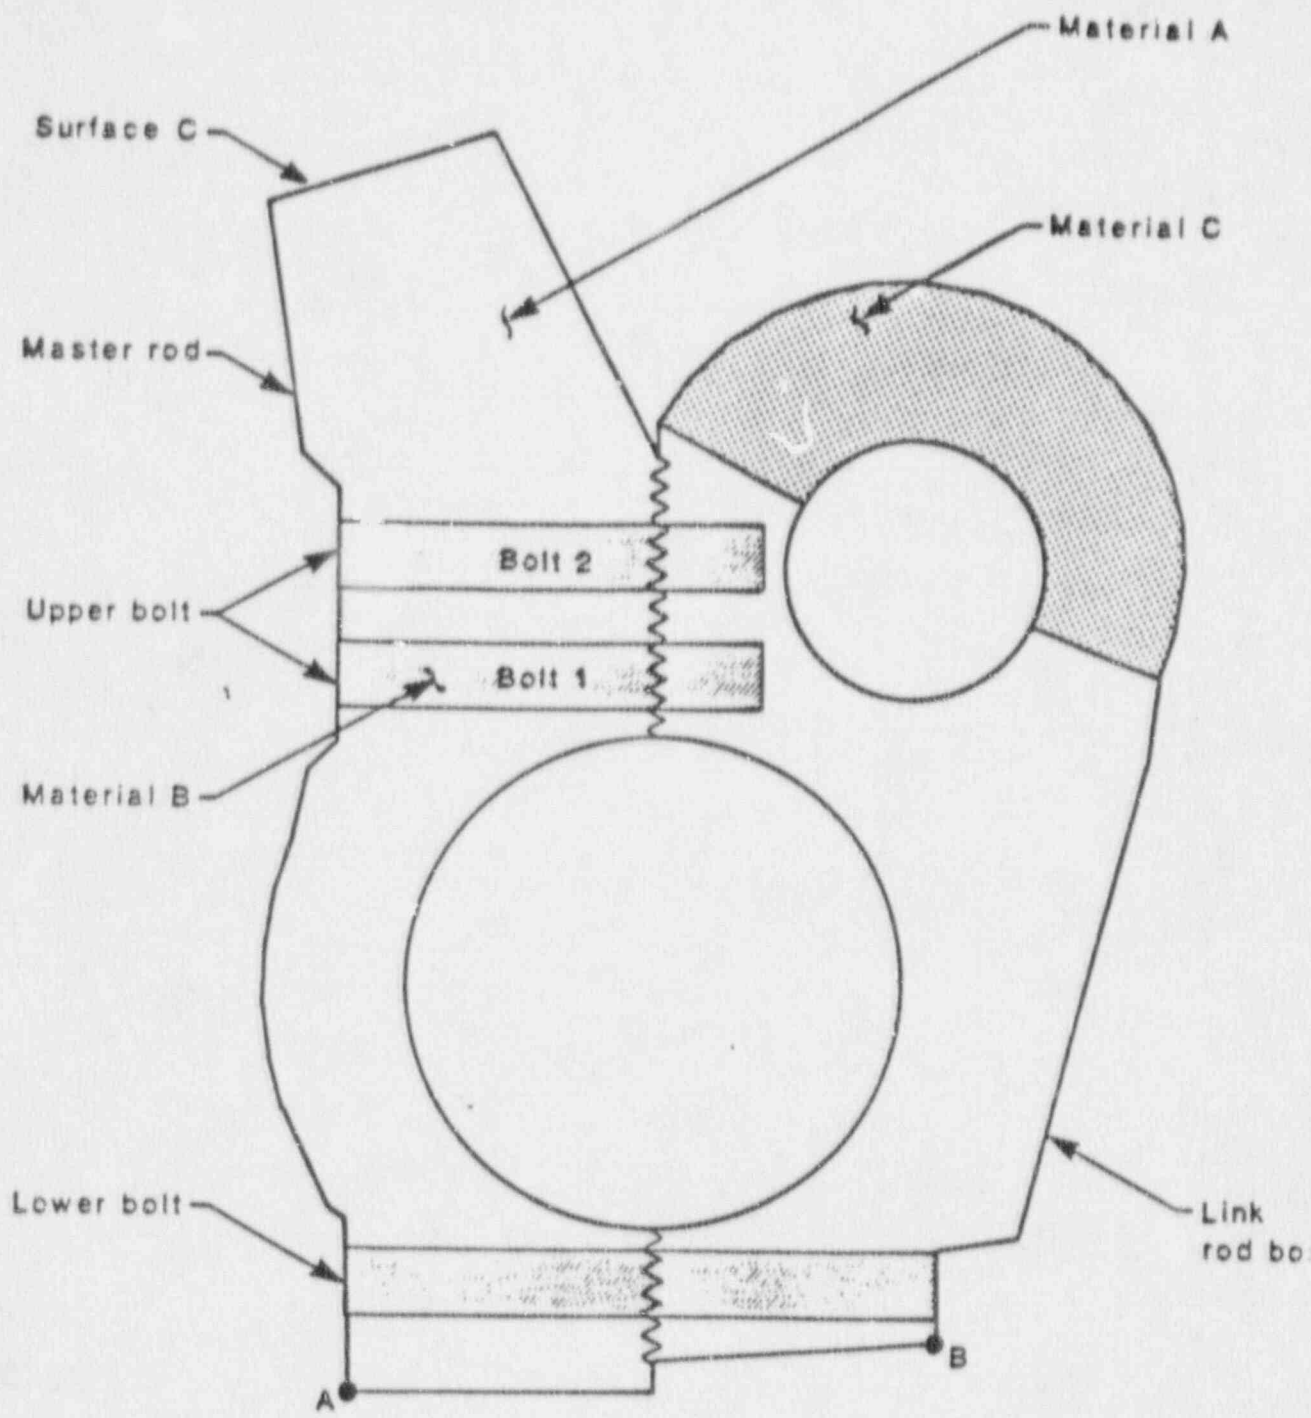
Figure 2-2. V-engine connecting rod assembly.

- Initial RV-4 engine design incorporates an articulated rod with 1-7/8" fasteners.
- Some failures of this rod assembly occurred from various manufacturing causes.
