CONNECTICUT YANKEE ATOMIC POWER COMPANY

Docket No. 50-213  
B10723

Haddam Neck Plant  
Systematic Evaluation Program Integrated Assessment

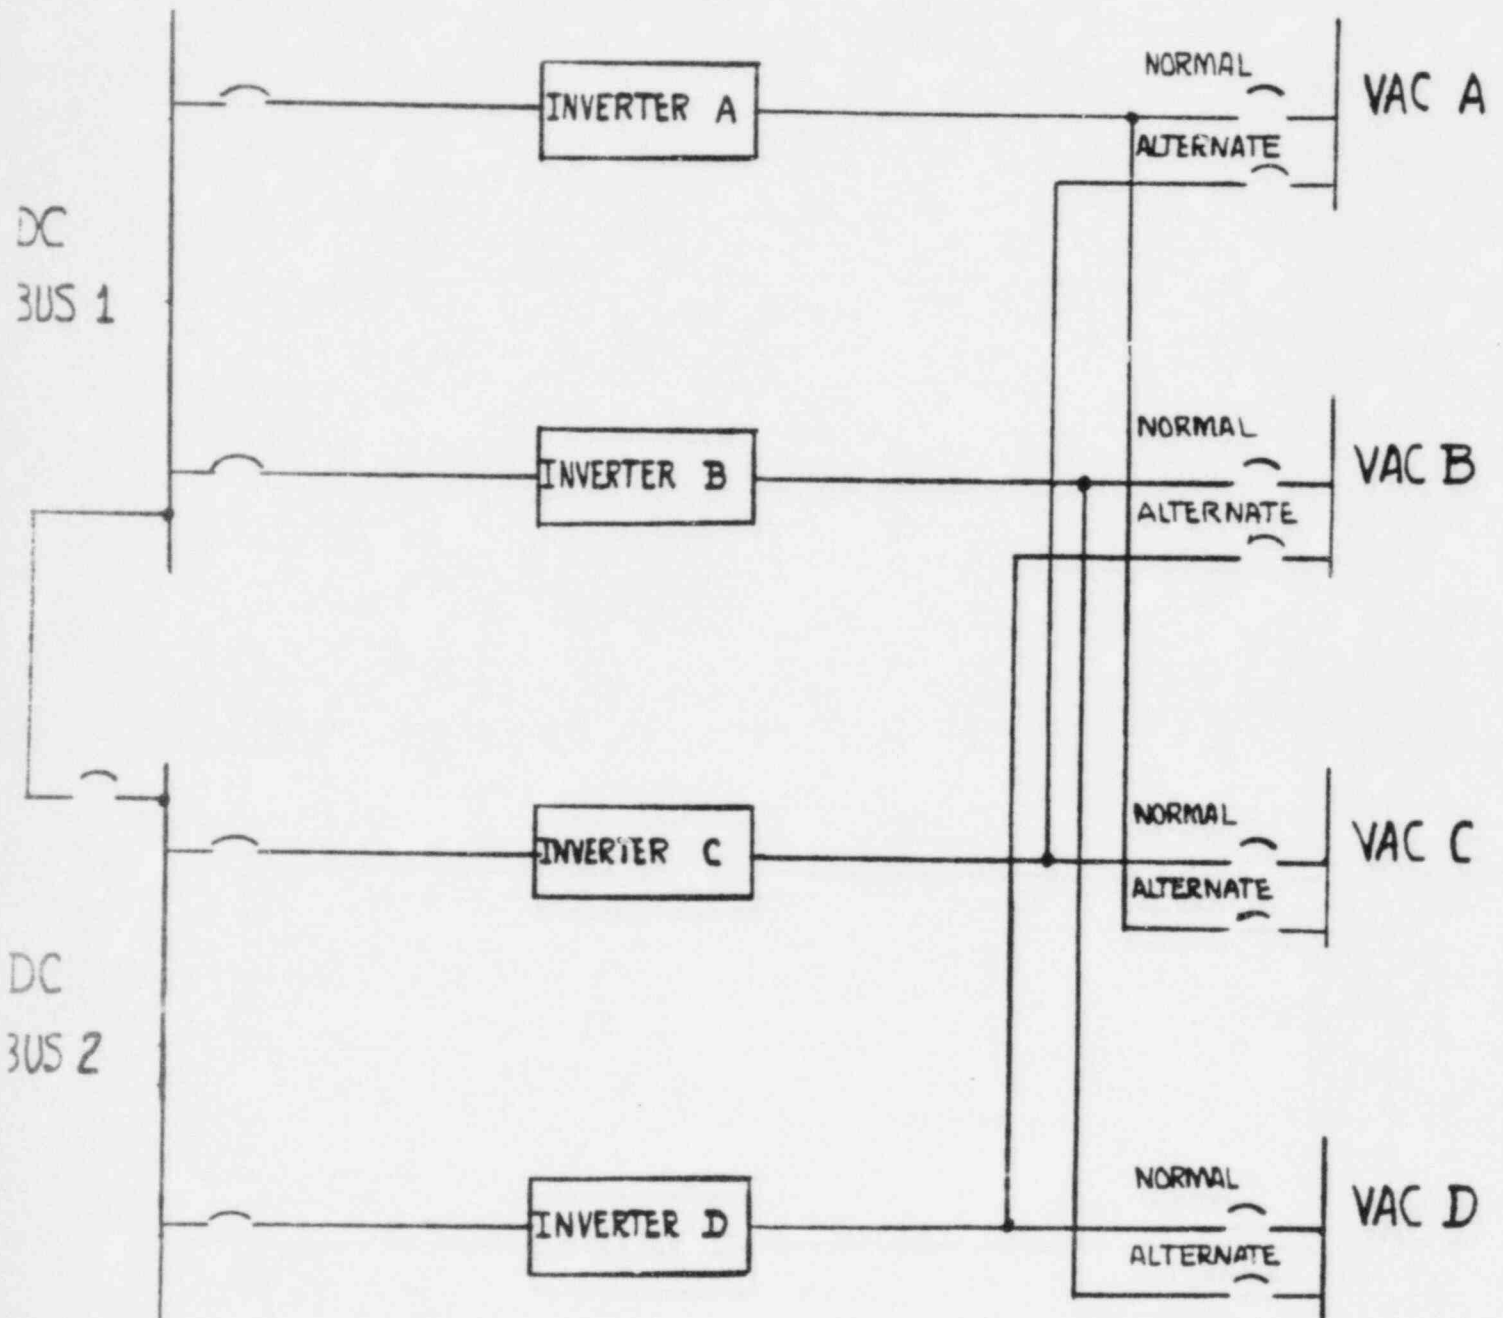
CONNECTICUT YANKEE  
PRESENT DC BUS / VITAL AC BUS ARRANGEMENT

Each of the four inverters supplies a separate vital AC bus. Each of the vital buses has an alternate source of power which can be switched into service manually. The alternate source breaker for each vital bus is interlocked with the normal source breaker so that both cannot be closed at the same time. Presently, however, the alternate source of power for each vital bus is supplied by an inverter from the redundant division. Thus, if one vital bus is fed from its alternate source, three vital buses would be receiving power through two inverters from one battery. CYAPCO intends to modify the existing alternate feeds to the vital buses so that the alternate source for each vital bus is taken from the other inverter in the same division. Therefore, it will not be possible to power three vital buses from one battery. Sketches of the existing and proposed arrangements are attached. CYAPCO intends to complete these modifications in conjunction with the modifications planned as a result of the Appendix R Fire Protection review.
