MEMORANDUM FOR: Docket File No. 40-1341
FROM: T. L. Johnson
Licensing Branch I
Uranium Recovery Field Office
Region IV
SUBJECT: REVIEW OF NEED FOR ADDITIONAL MONITOR WELLS -
EDGEMONT MILL

SUBJECT: ORNL Review of Draft License Condition No. 27 Related to the Decommissioning of the Edgemont Uranium Mill

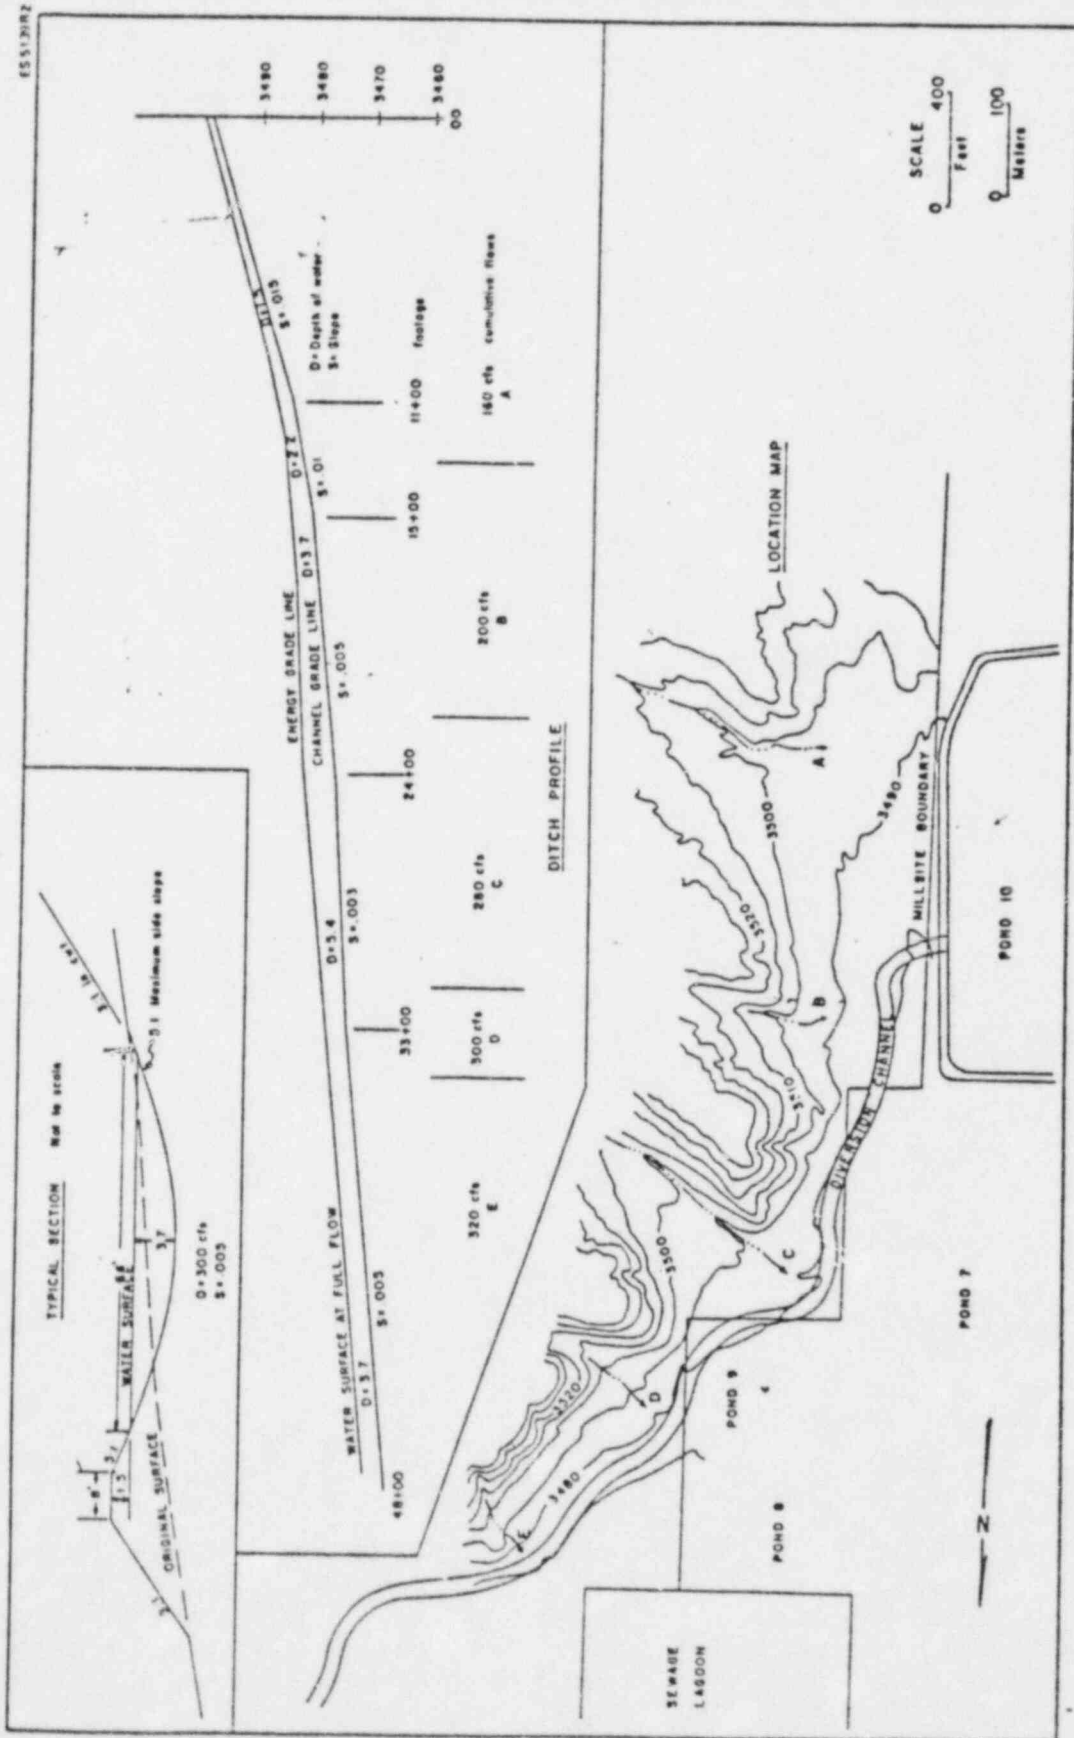
Fig. 2.7. Conceptual design of diversion channel along eastern perimeter of mill site. Source: Modified from ER, rev. 1, Fig. 3.5-1.

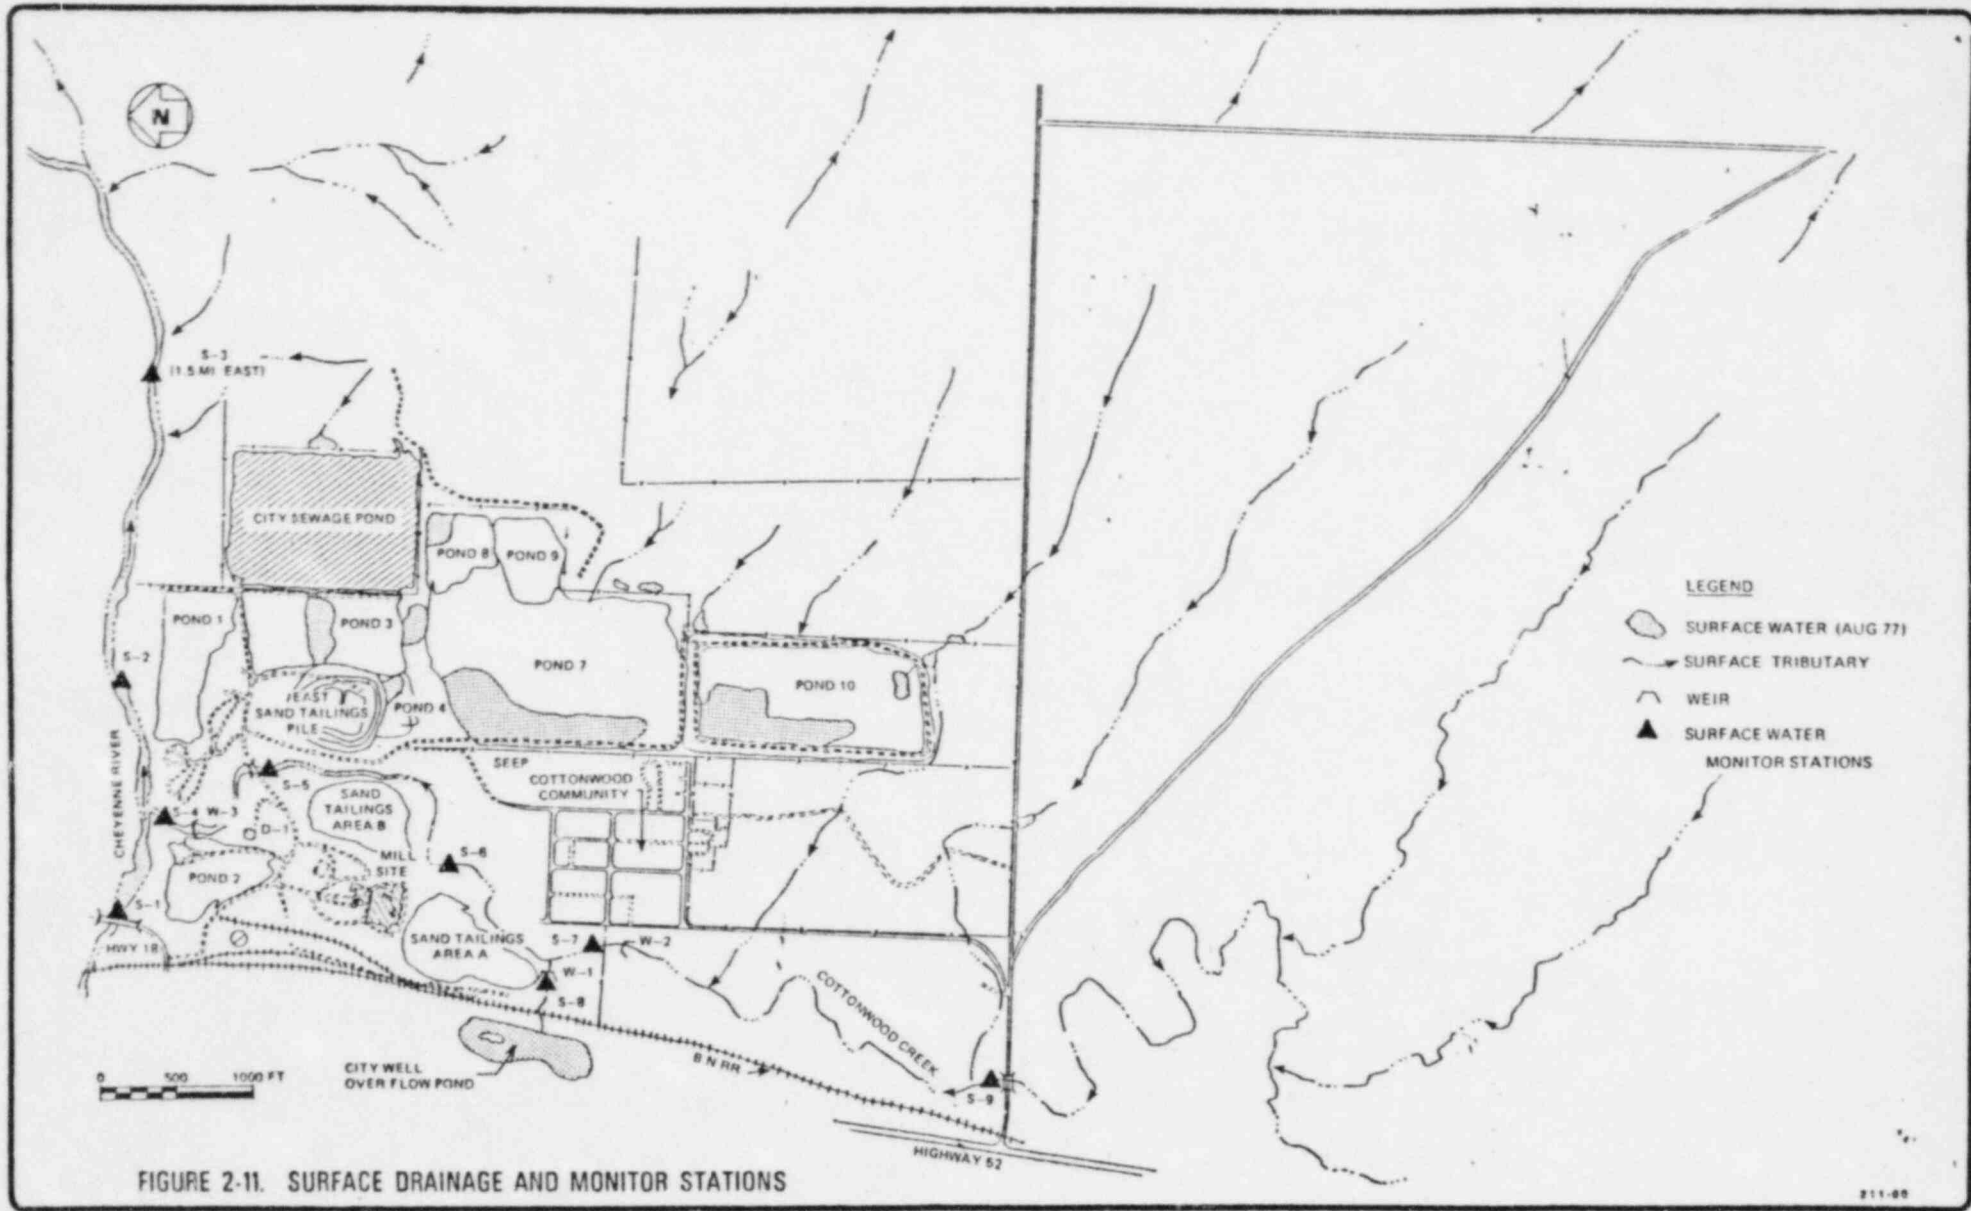
211-00

FIGURE 2-11. SURFACE DRAINAGE AND MONITOR STATIONS
